Inspection Report

Property Address:
222 TrueNorth Rd.
Whitby ON L127R9

AmeriSpec Inspection Services Toronto East

1.1 The report below was undertaken as a **Pre-listing inspection report** specifically for the use of the seller of this property/signed parties to the agreement. Its intended use is solely for the seller to identify areas of concern, deficiencies, end-of-service life of systems as well as give an overview of the general condition of the house on the interior and its exterior and the major systems which are identified as being a part of this inspection according to the Canadian Association of Home and Property Inspectors (CAHPI) guidelines which are available upon request or online. The report below can be used as a reference for potential purchasers of this property/home however the signed agreement is between the seller/parties to the agreement, and AmeriSpec Inspections of Toronto SE and the report remains the property of the signed parties to the agreement. Any third-party use of this information is for reference only and cannot be used by any third party to bring about any liable actions against AmeriSpec Inspections of Toronto SE under any conditions including

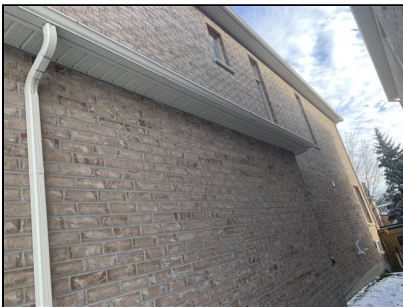
2.1 Item 1(Picture)

2.1 The exterior wall cladding is comprised of brick veneer and stone as observed that appears to be installed over a wood framed structure. It is important to maintain all exterior finishes, sealing and caulking all exterior wall penetrations as part of annual maintenance recommended to prevent water penetration. The wall cladding appears to be in serviceable condition.

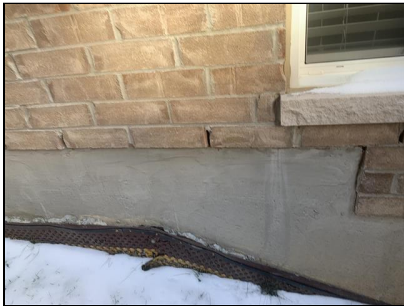
2.13 Item 1(Picture)

2.13 Foundation appears to be in serviceable condition. Hairline cracks are often observed in poured concrete foundations and are of no concern to the inspector unless there are other indicators that the foundation is continuing to settle, or other factors such as a sloped lot are present. Also common in poured concrete foundations is 'corner' cracking where the corners at the top of the foundation wall crack in a 'V' shape and is not a concern unless the inspector specifically calls this out in the report as a deficiency. Sealing/caulking can be applied to these types of cracks as desired to help deter the entry of moisture.

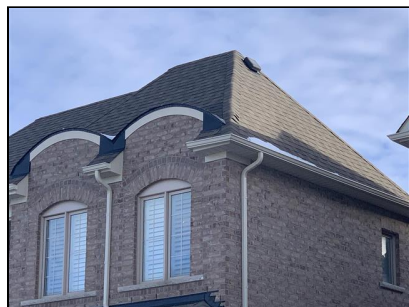
3.4 Item 1(Picture)

3.4 Roof is approx. 5 years old as per sellers information provided at the time of inspection. Roof shows normal wear for its age and type. No damaged, deteriorated, or missing roofing materials were observed; it appears to be in serviceable condition at time of inspection.

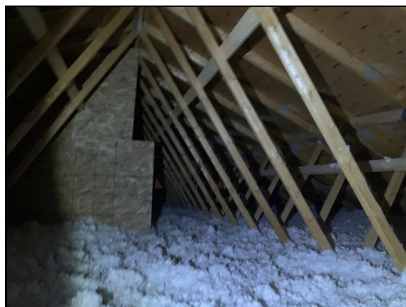
4.1 Item 1(Picture)

4.1 Wood truss construction noted. Trusses are often used to provide additional headroom and wider spans than is common with rafters.

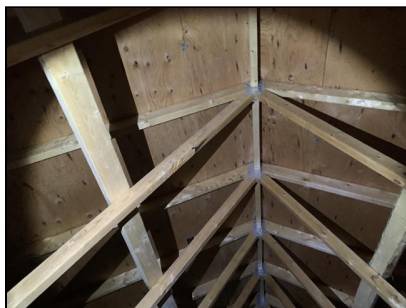
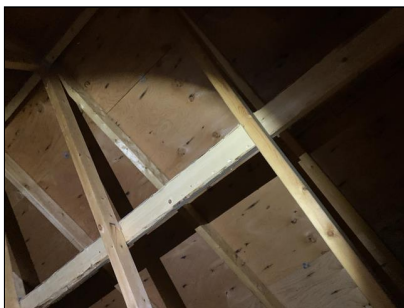
4.2 No discernible evident of moisture or active leaks was observed on the sheathing at the time of inspection. Water stains are often observed in attics however as older homes have often had a number of shingle replacements its possible these stains may be historical in nature. We look for active leaks and signs of excessive moisture in the home. Any signs of current or recent leakage are looked at closely if we are able to access the attic further and safely.

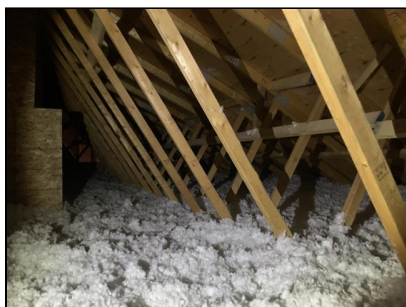
4.3 Item 1(Picture)

4.3 16" to 18" of blown-in (aka Loose) fiberglass/cellulose - which represents an R-Value of approx. R44 to R50 which is at or near the minimum amount of insulation required for new homes built within the past few years. As this amount of insulation appears to be at the current it appears to be adequately insulated. For more information regarding the standards for heating and insulation according to the CMHC guidelines (Canada Mortgage and Housing Corp.) we recommend you use the information contained in their website.

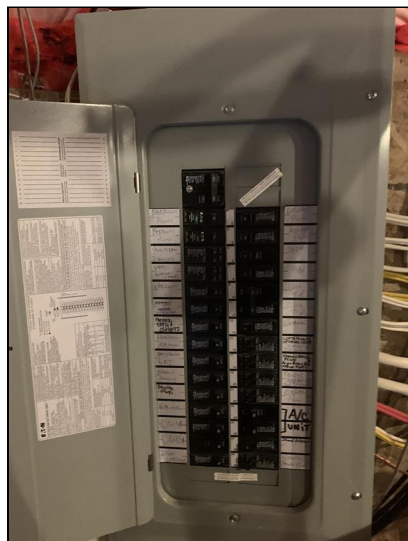
6.2 Item 1(Picture)

6.2 100amp Main Panel appears to be in serviceable condition. Overload protection is provided by breakers. It appears the panel may have available capacity for expansion of the system should client desire upgrades. However, a proper load calculation should be undertaken by a licenced electrician should client wish additional circuits or expansion to the panel.

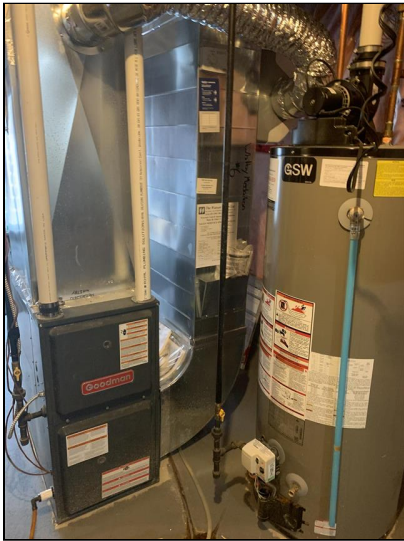
7.3 Item 1(Picture)

7.3 Unit appears to be a high efficiency gas furnace. Due to the sealed compartments on these type units, not all portions are visible. Therefore this is a limited visual inspection of the exterior cabinet only. Unit was operated with normal operating controls and appeared to function properly at time of inspection. If a more detailed review is desired we recommend consulting with a licensed HVAC contractor for dis-assembly of the unit for closer inspection.

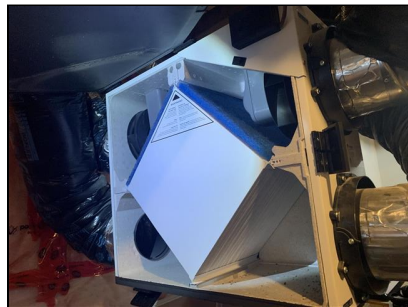
7.7 Item 1(Picture)

7.7 (2) An HRV unit was observed in the home. An HRV is a mechanical system that is used to help regulate relative humidity (RH) in a home. These fairly simple units are often located near the furnace and have ducts which connect to the return air for the heating system, registers in several areas of the house, and insulated ducts that attach to vent hoods on the exterior walls. The main function of an HRV is to remove excessive moisture from the air in a home and replace it with drier, fresh air from outside. These units have filters to prevent clogging of the components and to prevent excessive debris from being circulated through the house. Maintenance on these units is quite easy however

must be done regularly to keep these units in serviceable condition. These units are properly balanced when they are installed. Any renovations to a home can create a new imbalance and should be tested post-renovations. A licenced heating contractor can re- balance these systems should it be required. One critical component of this system is a control, typically located in the central portion of the living space near the furnace thermostat, which has an integral humidistat. The idea is to set the humidistat to a desired RH, allowing the unit to activate when that level is exceeded in the house air. Note: An HRV should not run continuously. Recommended air changes in a home is approx. .30 per hour. For more information on HRV's recommend consulting the CMHC (Canada Mortgage and Housing Corporation) website.

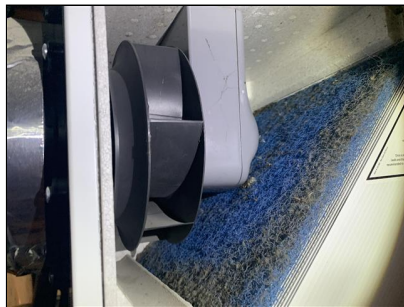
7.7 Item 2(Picture) HRV Filter - clean every 3 to 4 months

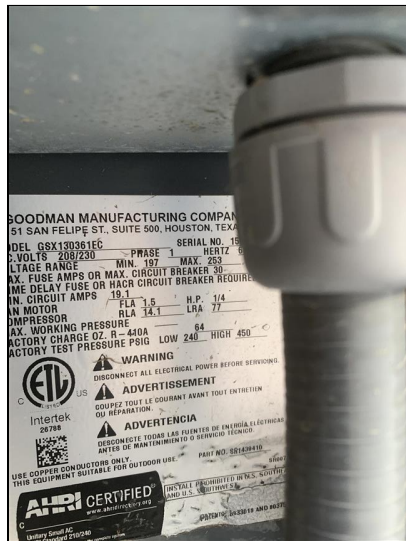
8.0 Item 1(Picture)

8.0 Goodman, 2015, 3 tonne unit

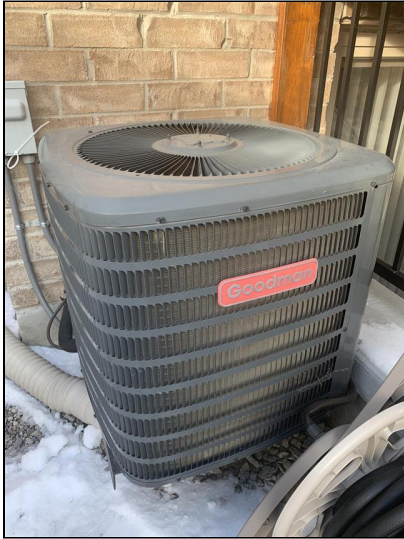
8.1 Item 1(Picture)

8.1 This unit contains R410A refrigerant, a more environmentally friendly choice for refrigerants that lessens the damage to the ozone layer. Air Conditioners with this refrigerant type have the highest energy efficiency (Between 14 and 16 SEER) which results in energy savings. See Comments below on SEER Ratings.

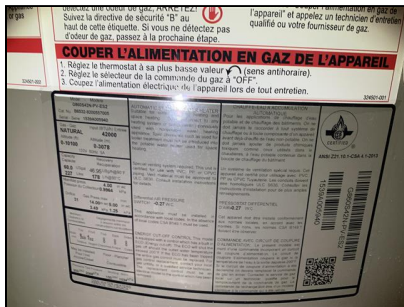
9.0 Item 1(Picture)

9.0 GSW, 2016, 60 gallon

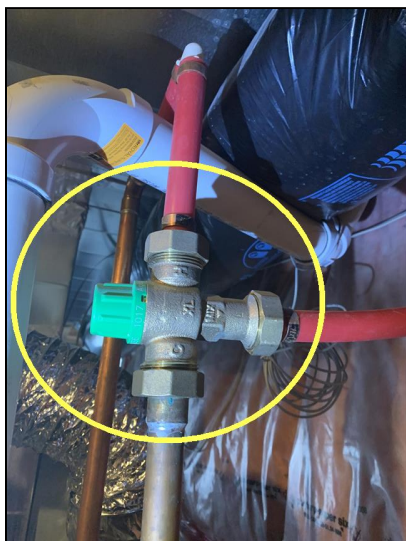
9.5 (2) A mixing valve present on this unit. A mixing valve provides tempered water (adds cold water to the outgoing hot) to the household for use and is has pre-set temperature controlled setting. This can be adjusted if needed, however, the controls at the lower control unit should be used to adjust water temperature. If doing this doesn't increase the temperature of the water to a proper setting without having to set the control unit too high, then service of the mixing valve is likely required. Only a licenced plumber should attempt to adjust these valves.

9.5 Item 1(Picture) Mixing Valve

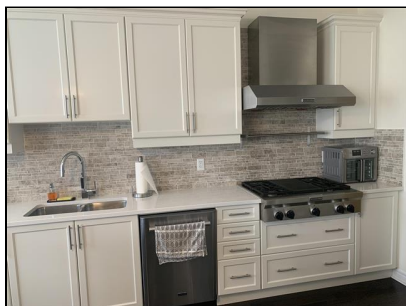
12.7 Item 1(Picture)

12.7 Serviceable.

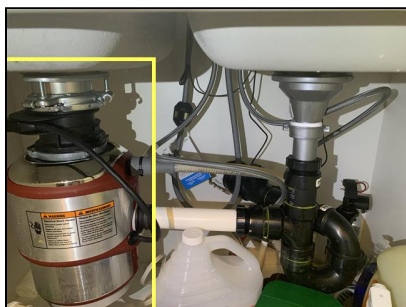
12.12 *If children present in home ensure safety precautions are taken. Also if attempting to clean or maintain, the breaker at the main electrical panel must be shut off.*

12.12 Item 1(Picture) Disposal

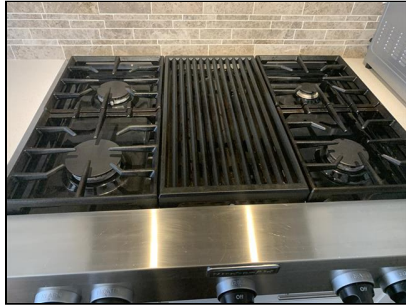
12.14 Item 1(Picture)

12.14 The gas stove/range was tested at the time of inspection and appeared to function properly. Gas shutoff below cabinet as observed.

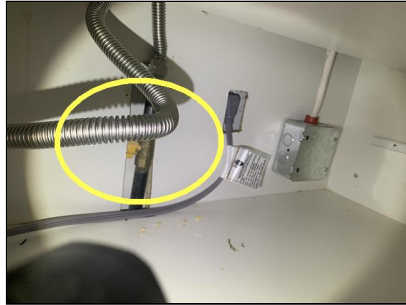
12.14 Item 2(Picture) Gas Stove Shutoff Valve

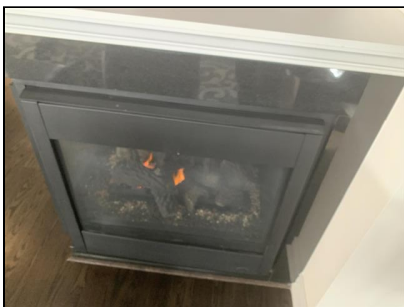
13.7 Item 1(Picture)

13.7 While a traditional fireplace provides an open burning chamber that vents through a chimney, a direct vent fireplace does not require a chimney, and can vent horizontally out a sidewall or vertically to the roof. The direct vent fireplace also has a completely enclosed chamber that is highly efficient, drawing in air for combustion from the outside and expelling gasses to the outside as well. The front glass enclosure is porous, allowing radiant heat to pass into the room. The direct vent fireplace heats a room without robbing it of oxygen or of the heated air it is providing, while also keeping it free of fumes and combustible materials such as embers or ash.

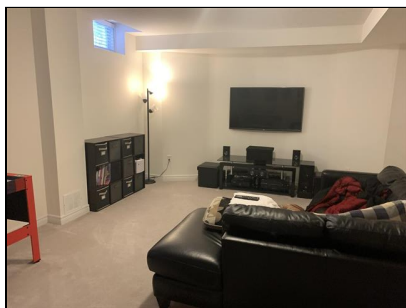
19.0 Item 1(Picture)

19.0 Inspection of the basement is limited due to partial finishing, and is a review of existing conditions of the basement and foundation at the time of inspection. While there may not be visible evidence of water intrusion at the time of inspection, the inspector cannot warranty this or any basement against water entry.

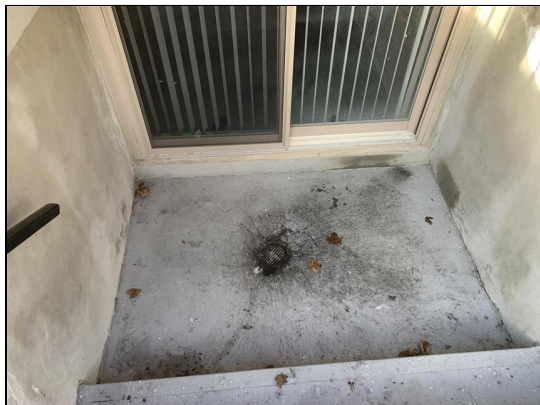
19.5 Item 1(Picture)

19.5 Rear Basement entry with drainage observed.

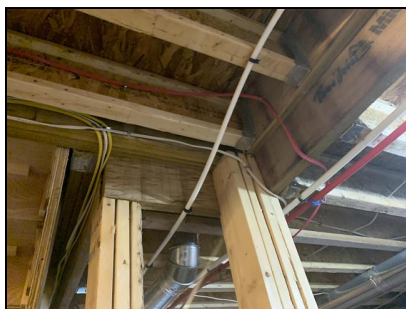
19.6 Item 1(Picture)

19.6 TJI construction was observed. This type of construction is often used to provide additional headroom and wider spans than is common with wood joist systems as well as having truer/level floors for floor finishes above. This is a specialized system which is intended for site-specific engineering. The integrity of a truss joist system depends on the builder following an engineer's instructions, which we do not have. Verifying appropriate installation is beyond the scope of this inspection. Trusses should not be cut or notched as this will damage their structural integrity.
