Doc #: 123456-7890

Date: 17/05/2021

Address: 123 Main Street

AmeriSpec Home Inspection Service

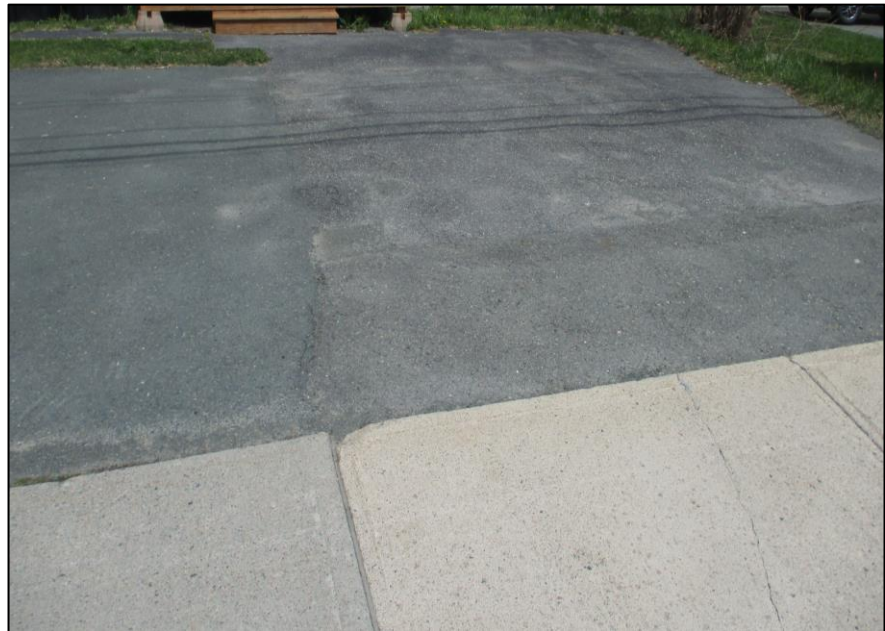
1100.	Driveway	Asphalt. Cracks and tire depressions were observed in the driveway. Recommend all cracks are properly sealed to prevent moisture penetration and subsequent freezing and expansion.
-------	----------	---

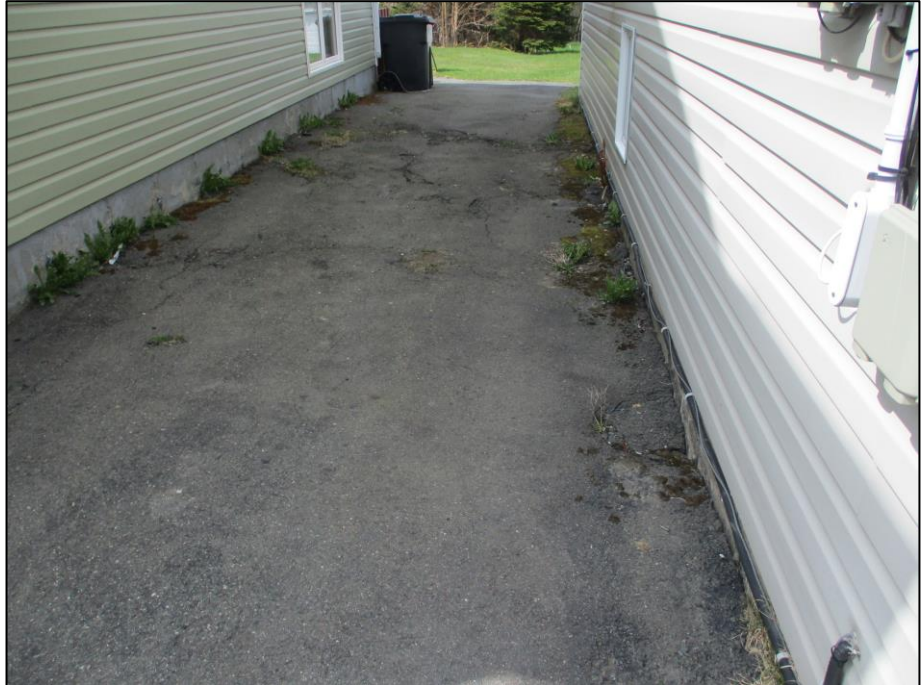
1101. **Walkways** Asphalt. Cracks, heaving and deterioration were observed. This walkway is nearing the end of its useful life. Recommend review for corrections as needed.

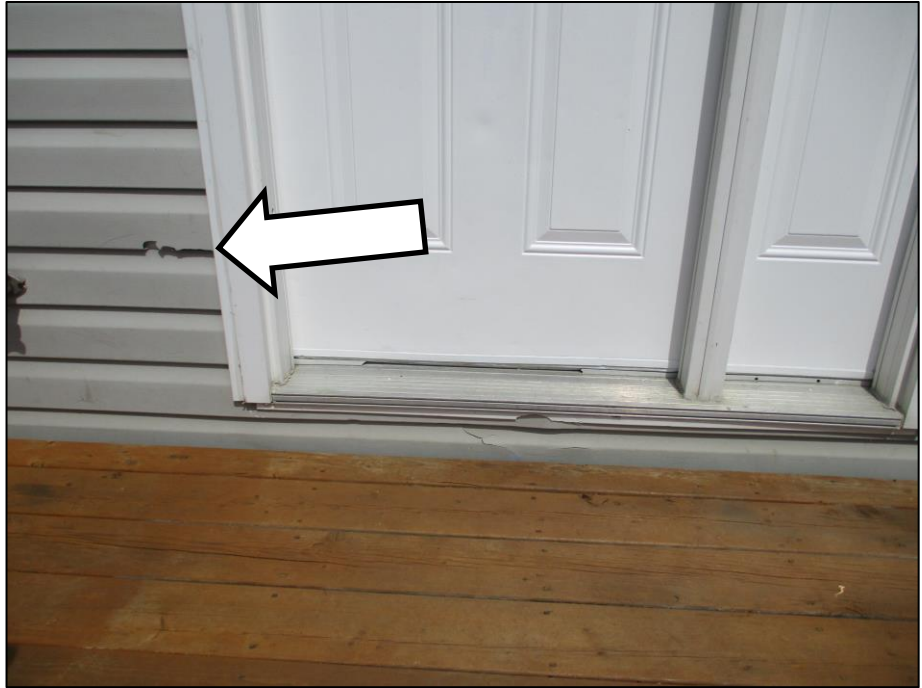
1106. **Siding**

The vinyl siding appeared to be in generally good condition. Some damage was noted at several areas. Recommend this is further reviewed and corrected, as needed, by a qualified contractor.

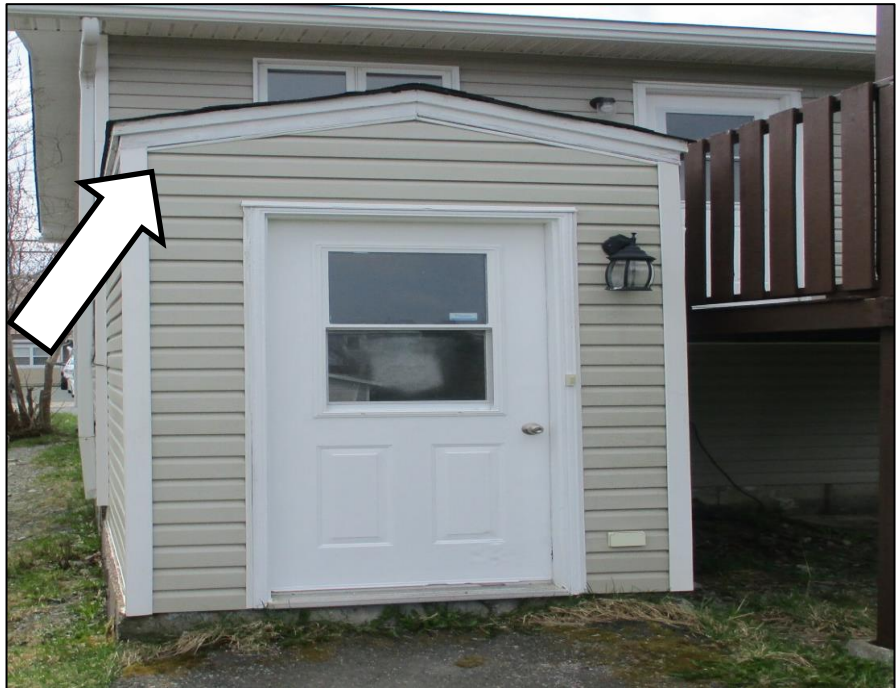
1107. **Trim** The vinyl and metal trim appeared to be in generally good condition. Some minor damage was noted at several areas. Recommend this is further reviewed and corrected, as needed, by a qualified contractor.

Rot was noted in the wooden eave trim. Recommend these areas are further reviewed and corrected, as needed, by a qualified contractor.

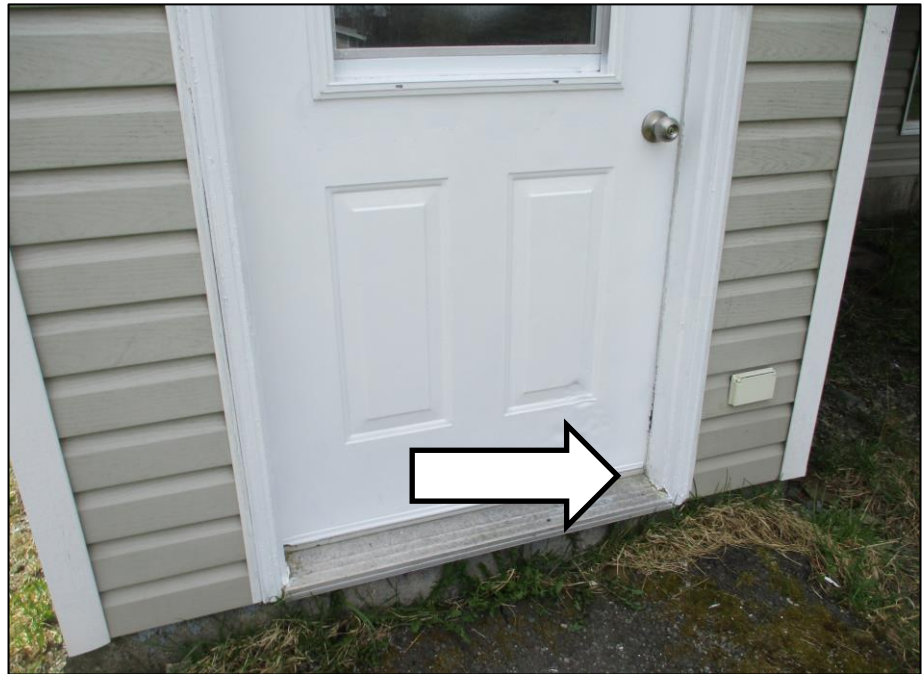
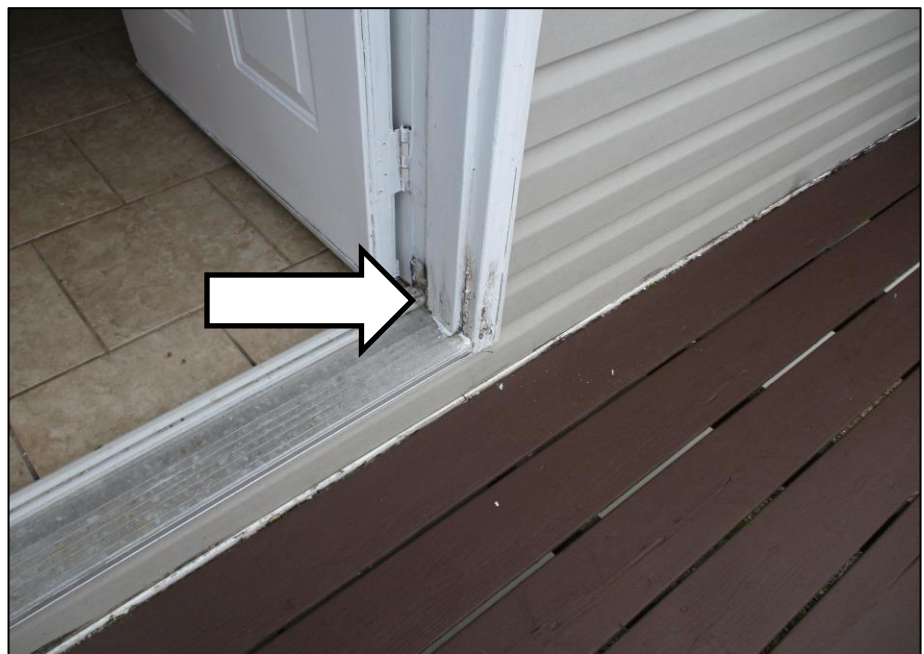
Rot was observed in the basement apartment and main floor rear exterior doors. Recommend further review and corrections as needed by a qualified contractor.

The threshold and weather stripping are damaged on the front and apartment exterior doors. Recommend review by a qualified professional for corrections.

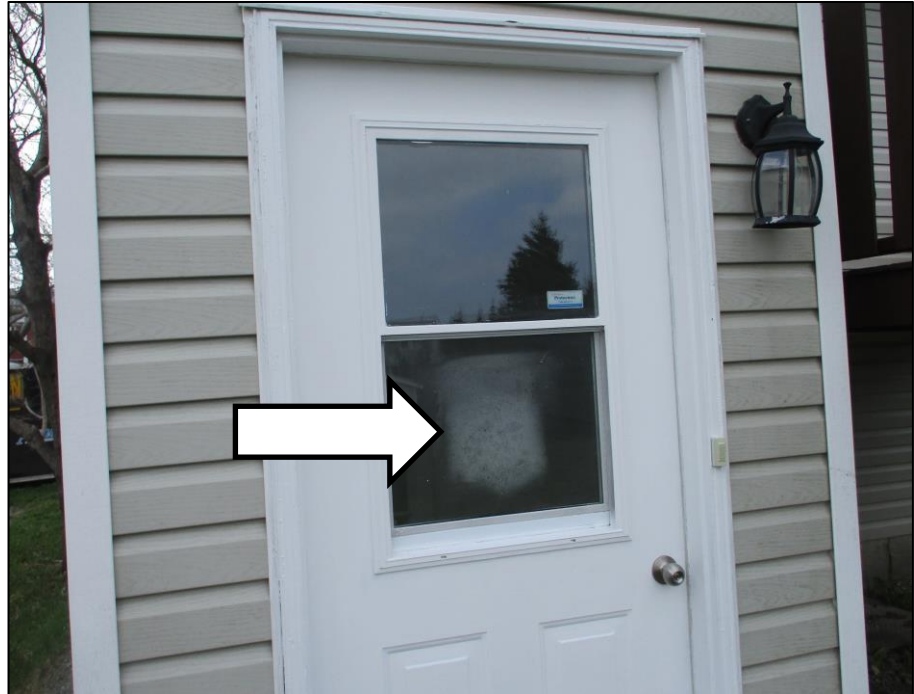
1111. **Exterior Doors** Fog and condensation were noted in the window of the apartment door. This indicates a compromised seal and replacement of the pane is needed. Recommend this is replaced by a qualified window contractor.

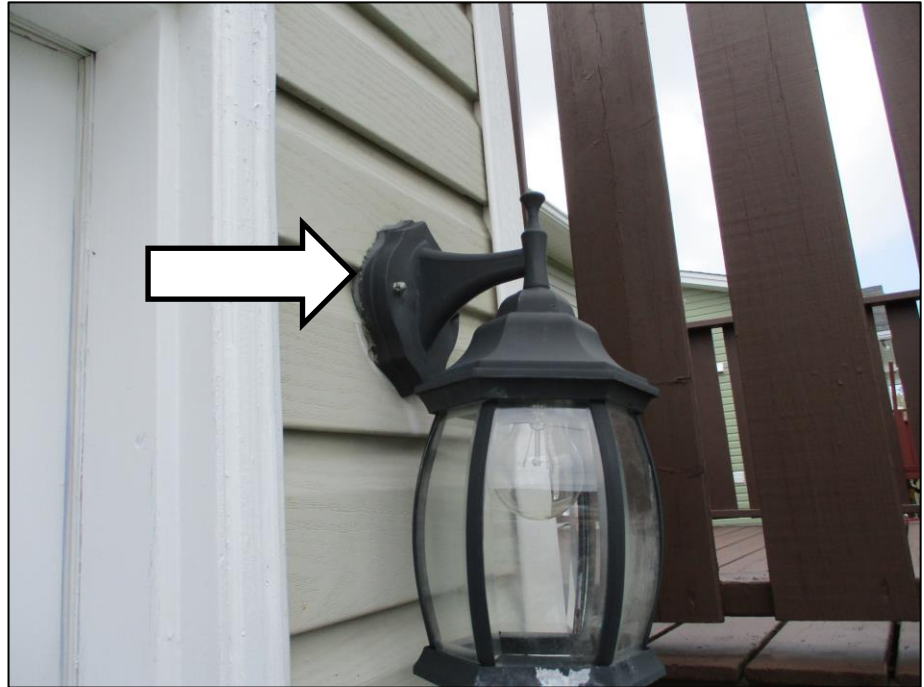
1114. **Electrical** The light fixtures were not properly caulked. Recommend corrections to prevent moisture penetration.

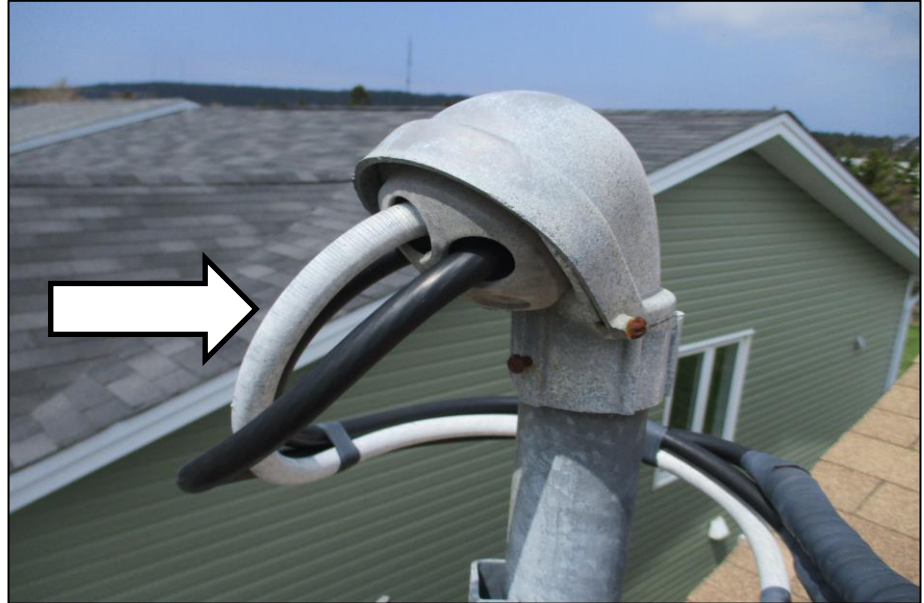
1115. **Electric Meter** The electric meter is located at the left of the home with service entrance overhead. The coating on the white neutral wire is cracking and the wire may need to be replaced. Recommend this is further reviewed and corrected, as needed, by a qualified electrician.

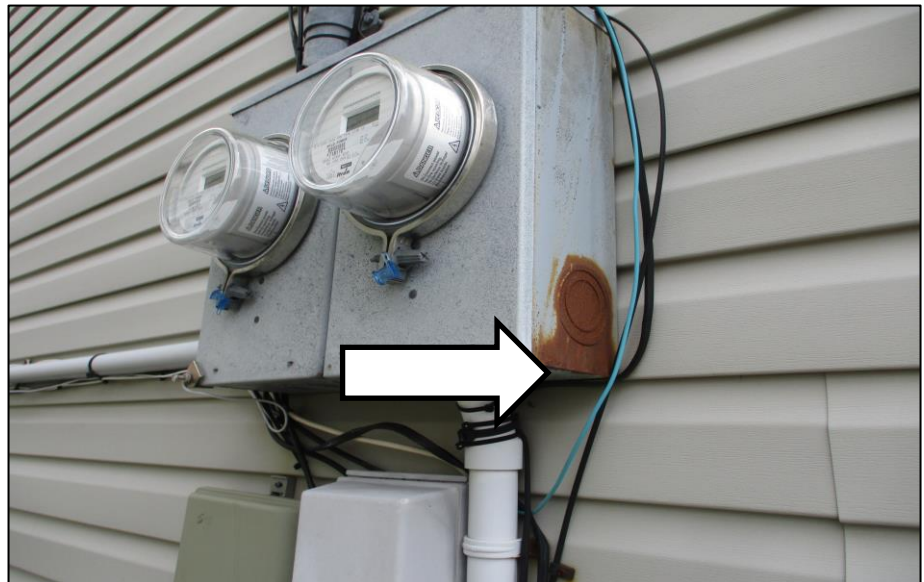
Rust stains were observed on the meter box. No rusting was present in the electric panel. Consult with a qualified electrician to determine if any water/corrosion issues are present inside the meter box.

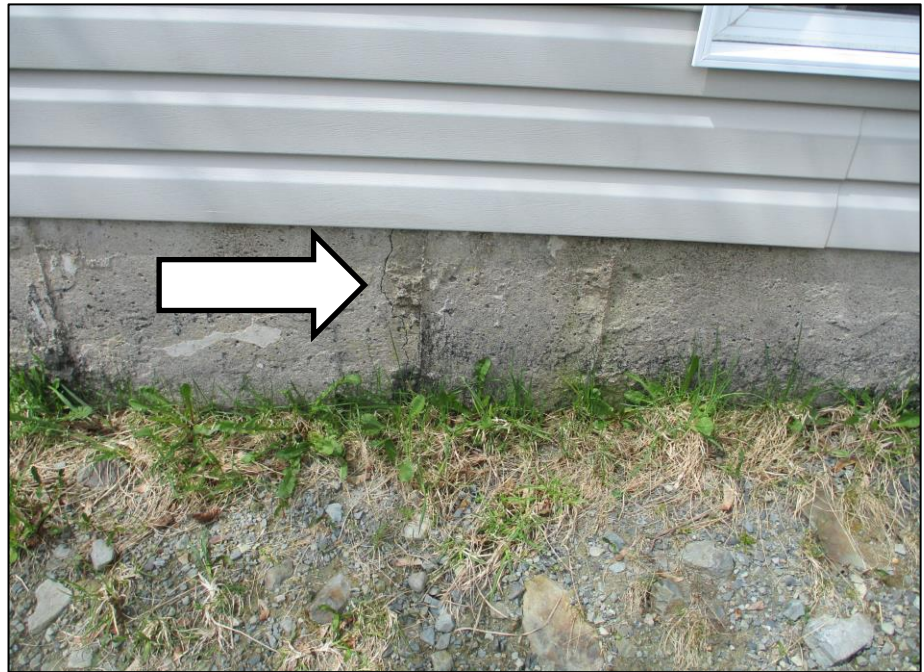
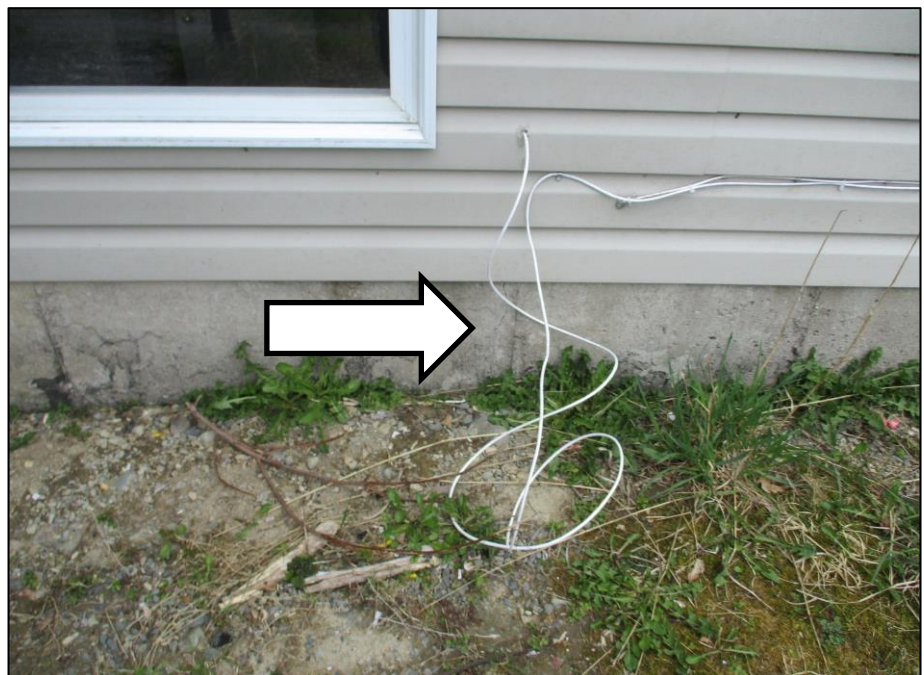
1122. **Foundation / Type** Three (3) cracks in the foundation were observed that do not appear to be a structural concern. It is not possible to determine if any moisture penetration has occurred since the adjacent wall in the basement is finished. Verify if any moisture issues have occurred in the past with the homeowner. Recommend this is further reviewed and corrected, as needed, by a qualified concrete repair contractor.

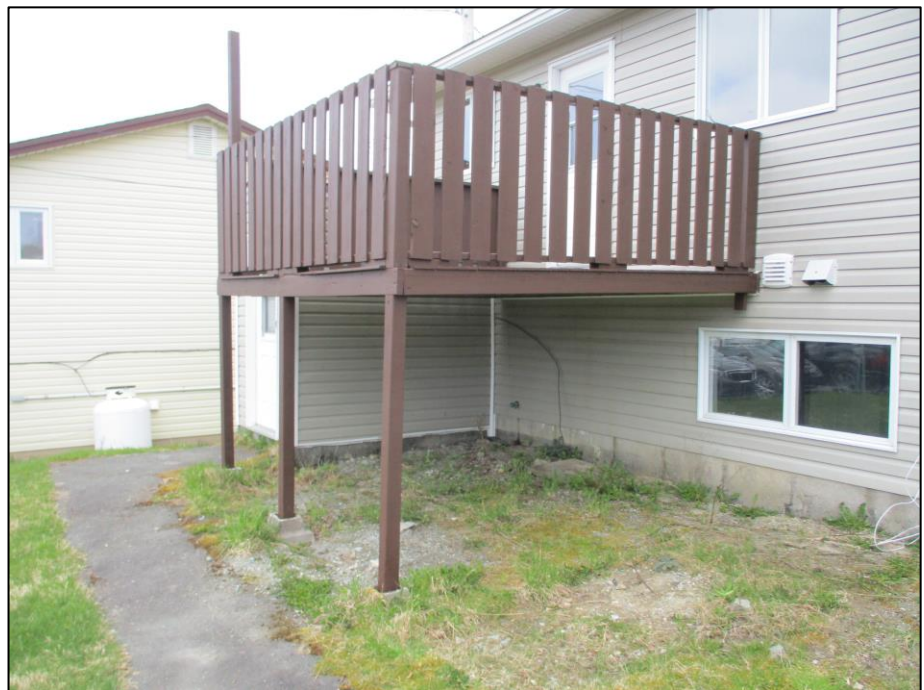
1125. **Back Deck / Stairs** The back deck is shaky, over spanned, missing bracing there is some deterioration at the bottom of the deck posts. Recommend further review and corrections as needed by a qualified contractor.

The deck is attached to the home. We are unable to determine the methods used to prevent water entry into the home and therefore we are unable to determine if the sheathing behind the siding under the deck is damaged.

For added safety recommend lag bolts are properly installed securing the deck to the home.

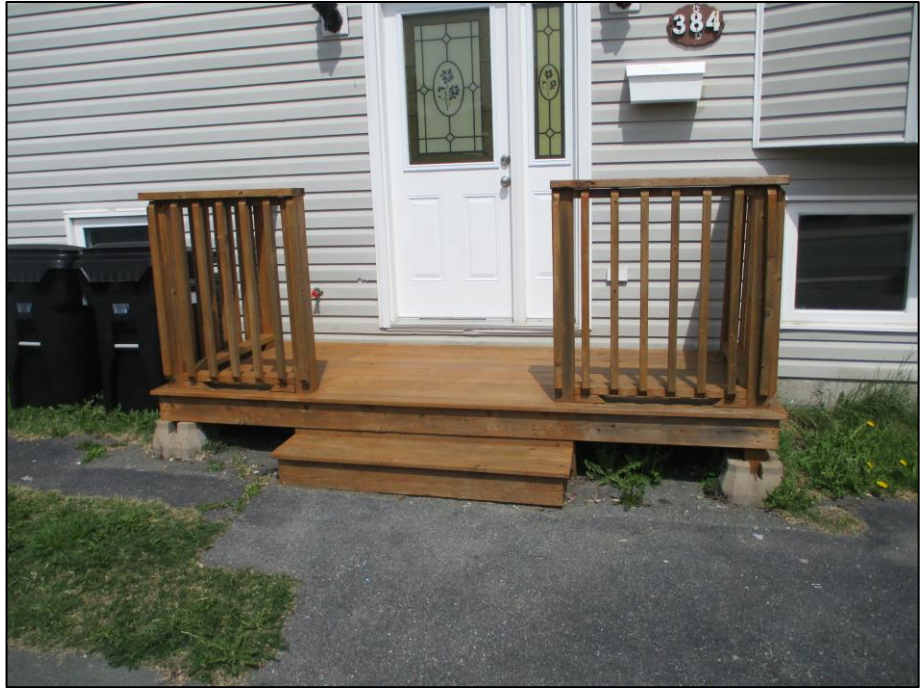
1127. **Front Deck / Stairs** This deck is located close to the ground. It is not possible to determine the condition of the beams, joists and posts. The stairs have uneven riser heights. Recommend further review and corrections as needed by a qualified contractor.

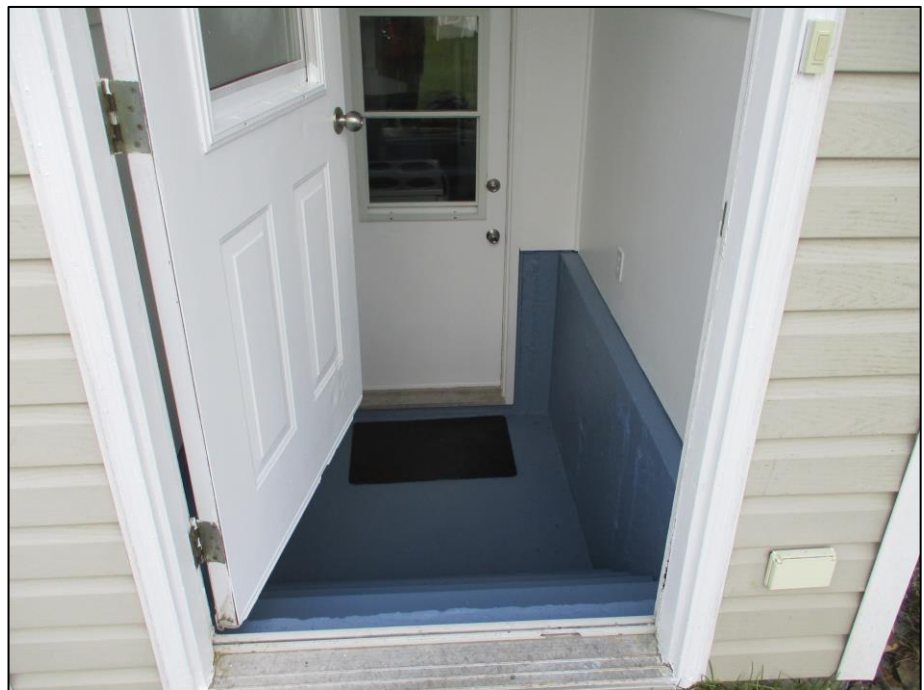
It appears the basement entrance has had a shelter installed since the original construction of the home. This sheltered area is not considered to be a part of the conditioned area of the home. No heat source or air exchange system is present in this area. As well, the drainage system runs under the floor of this area. Recommend this shelter is well ventilated to the exterior to prevent moisture build up issues.

The exterior door swings in over the stairs without a landing. Recommend further review and corrections as needed by a qualified contractor.

The stairs have uneven riser heights and are missing a handrail. Recommend further review and corrections as needed by a qualified contractor.

A high step height was observed at the entrance to the apartment. Recommend further review and corrections as needed by a qualified contractor.

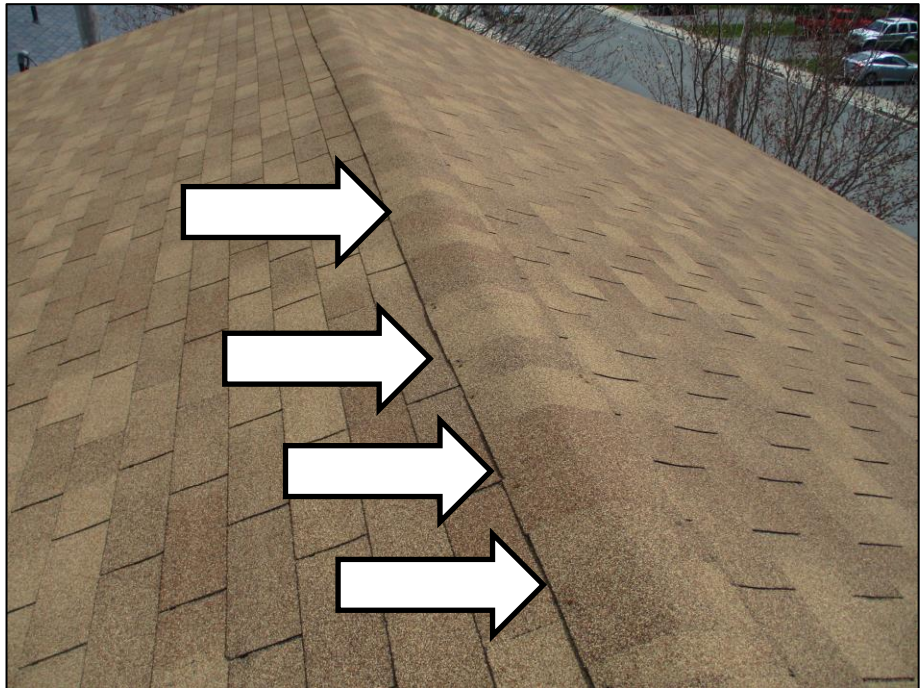
1403. Exposed Flashings / Stacks / Vents Serviceable. The visible flashings appear in good condition. No obvious cracks or openings were noted at time of inspection. No signs of moisture or staining were observed at the flashed areas in the attic. Flashings should be inspected on an annual basis.
1405. **Conditions** The roofing material shows normal wear for its age and type. Multiple exposed nail heads were observed. Recommend properly sealing to prevent any moisture penetration.

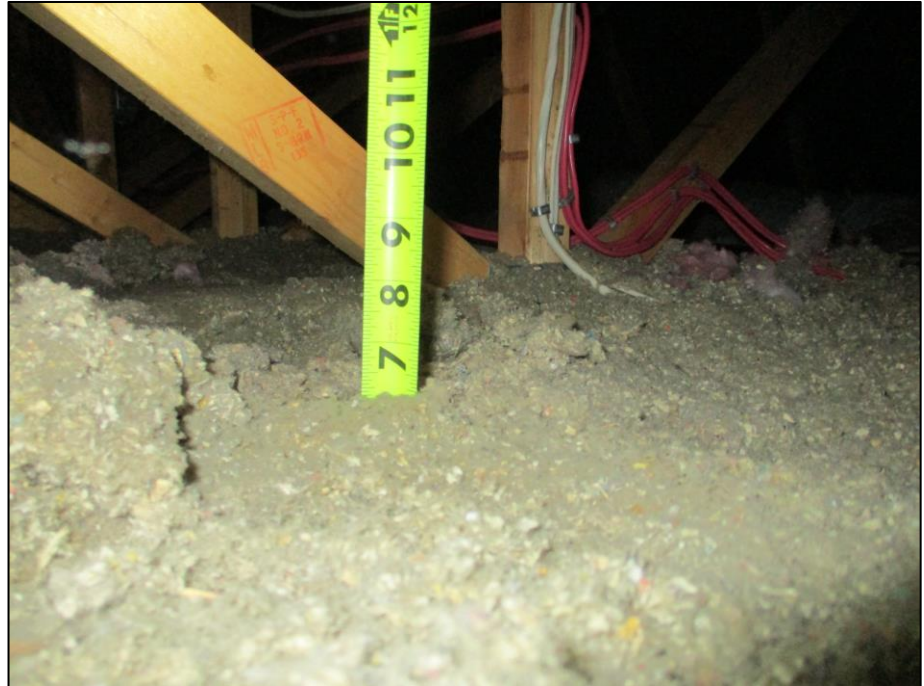
1506. **Insulation** Cellulose is present in the attic with fibreglass batt at the eave. An approximate R-value of 20-25 was noted. Additional insulation should be considered. This is one of the most cost-efficient methods of reducing heat loss.

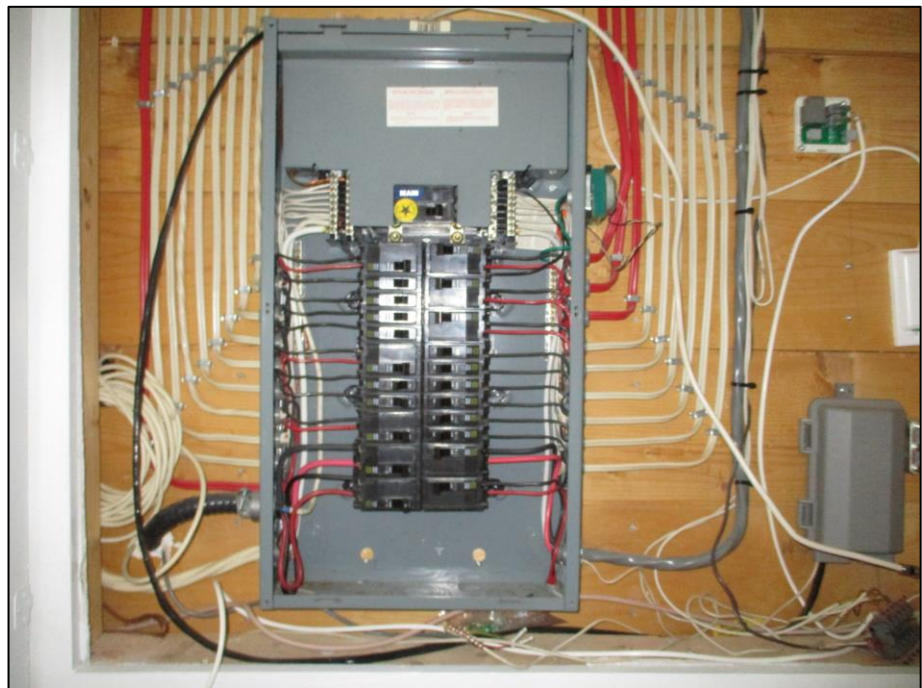
1902. **Electrical Issues** Some of the breakers have not been properly labeled. The breaker for the main floor dishwasher could not be found. The breaker was off but power was still being supplied. Recommend further review and corrections as needed by a qualified electrician.
1905. **Smoke Detectors** Smoke detectors are not tested during a home inspection. Recommend the detectors are checked with the manual test button prior to close. To enhance safety, you should consider installing wired smoke alarms in all bedrooms.

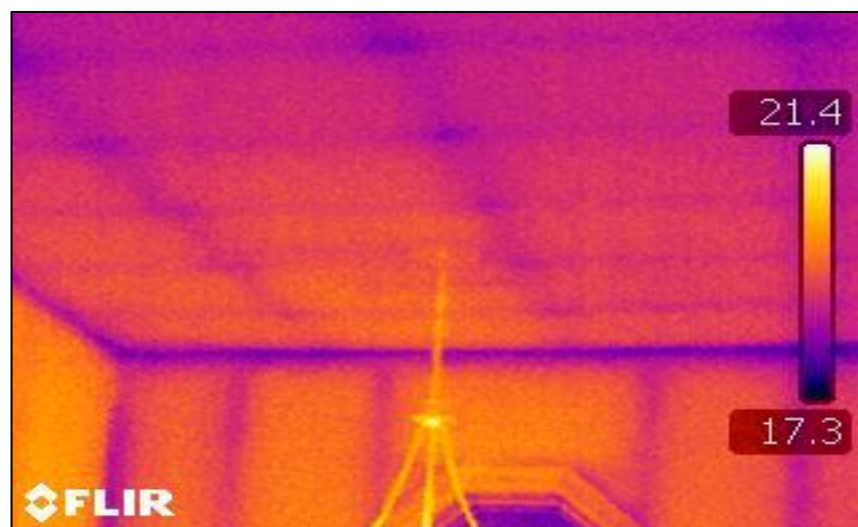
2219. Top Level Ceilings All finished surfaces under the roof were scanned and typical cold zones were detected. Some colder than normal areas were noted at various areas around the perimeter. The images are not characteristic of moisture penetration and appear to be related to air infiltration or wind from the eave entering under the insulation. Some disrupted or missing insulation may be the cause as well. Recommend all attic insulation in firmly secured to reduce heat loss in these areas.

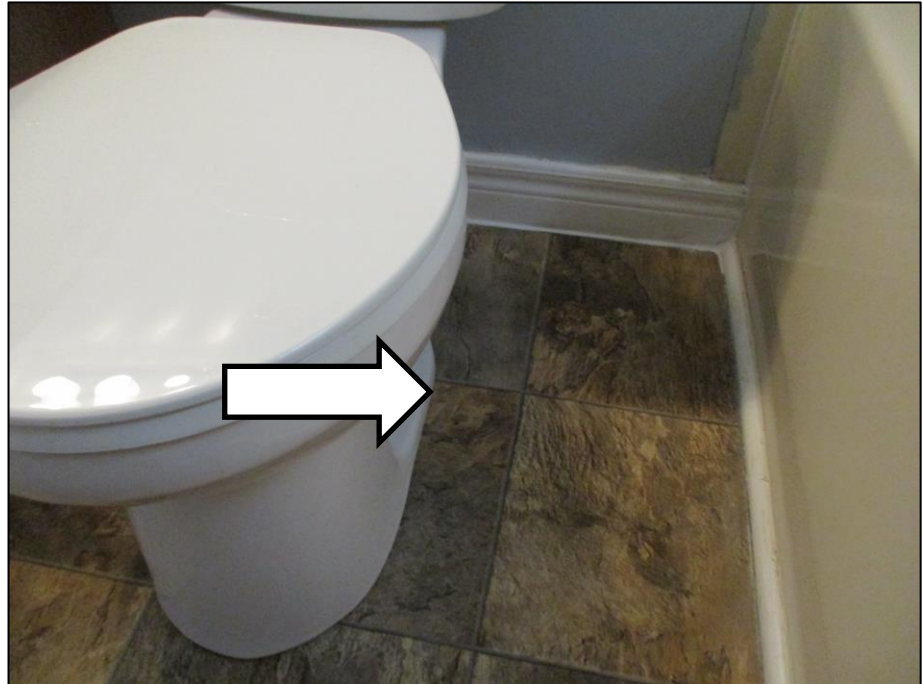
Step #	Component	Comment
2601.2.	Floor	Vinyl. The flooring was probed by the toilet with the moisture meter and high levels of moisture were noted. The wax gasket seal for the toilet may be compromised. Recommend further review and corrections as needed.

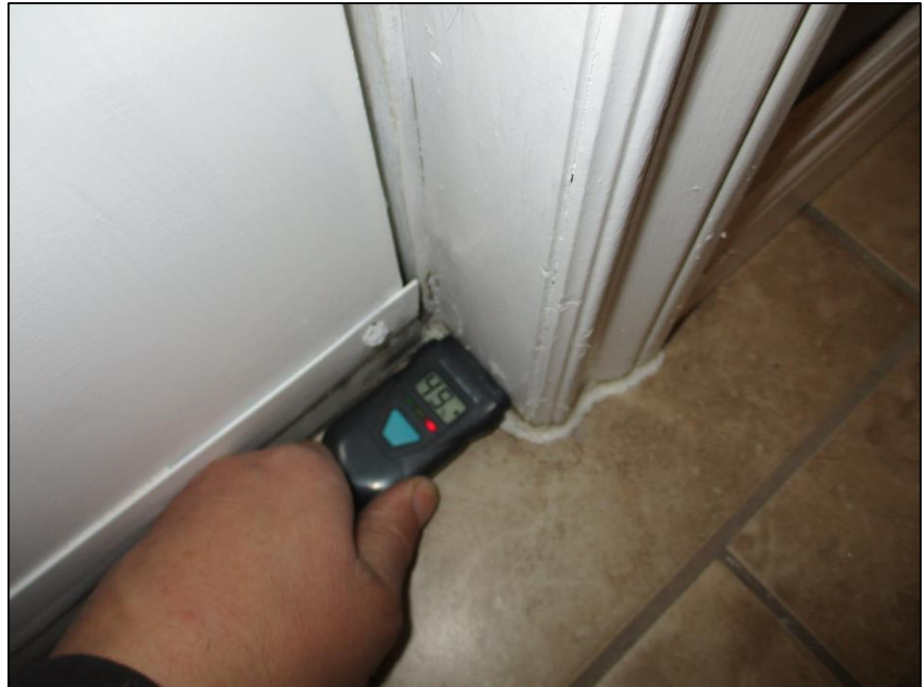
Step #	Component	Comment
3001.	Floor	Wood, Ceramic. The flooring was probed by the exterior door with the moisture meter and high levels of moisture were noted. This may be related to leaking at the door. Recommend this is further reviewed and corrected, as needed, by a qualified contractor.

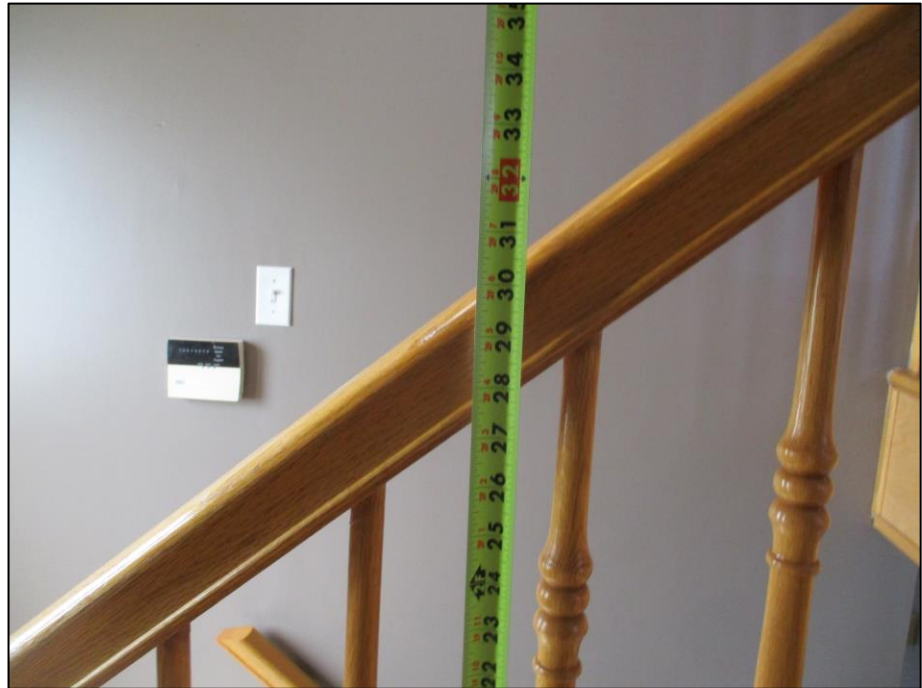
3009. **Stairs** The handrail is low. Recommend review for corrections for safety.
