General Summary

Sample Report

1 Anywhere Road

Doc #:	AB-XXXXXX	Inspector:	Andrew LaRoche
Date:	2023-04-19		
Dwelling Address:	1 Anywhere Road Anytown Ontario O1O 1O1		
Client Name:	Sample Report		
Client's Agent:	No Agent	Real Estate Company:

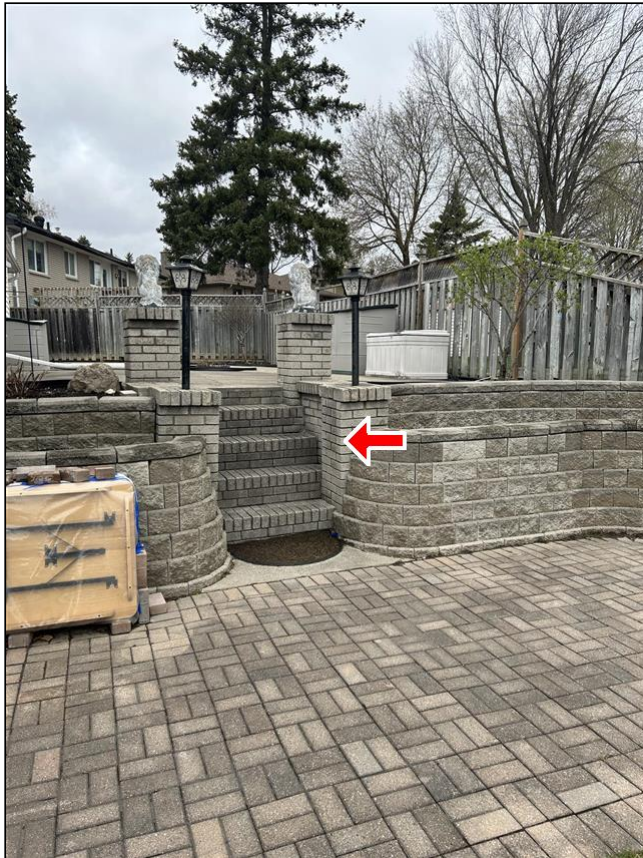
1.11 Item 1(Picture) missing railing

(2) No hand railings noted on steps at rear of home, recommend installing hand rail for safety. When ever four or more risers are present a handrail is usually required.

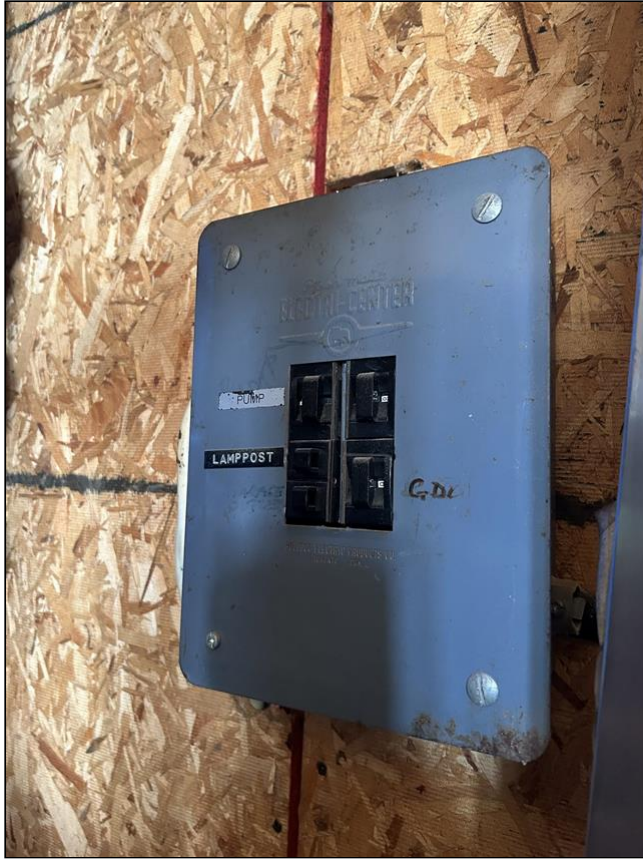
7.3 Item 1(Picture) panel conditions

Bulldog type panel observed in the garage. The cover was not removed as these covers are too close to the main service and have been known to arc. Most electrical experts believe that these panels are problematic and should be replaced. Recommend review by a licensed electrical contractor for replacement.

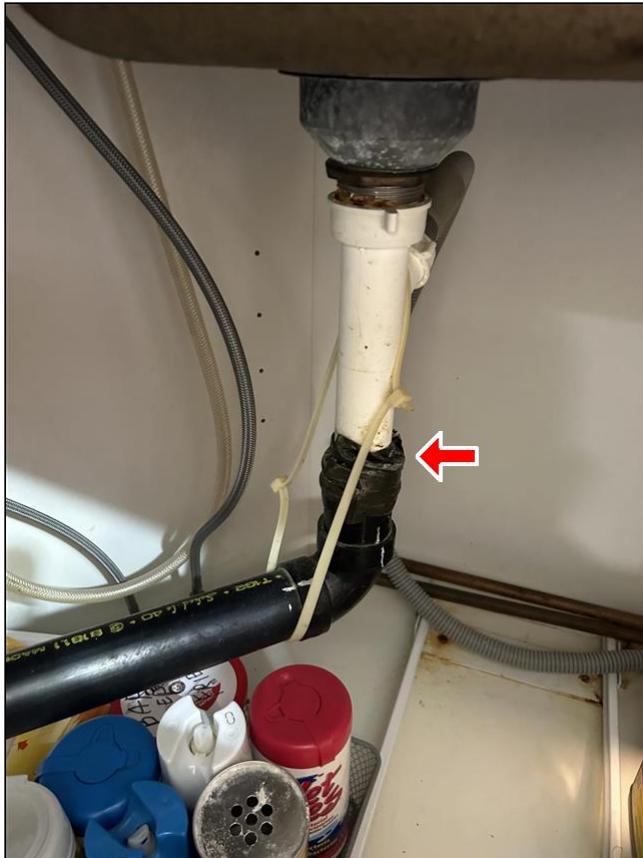
11.8 Item 1(Picture) drain repair

Although no leakage was detected, there are non-standard repairs at the drain line which are temporary in nature, permanent repairs are needed to ensure leak proof conditions.

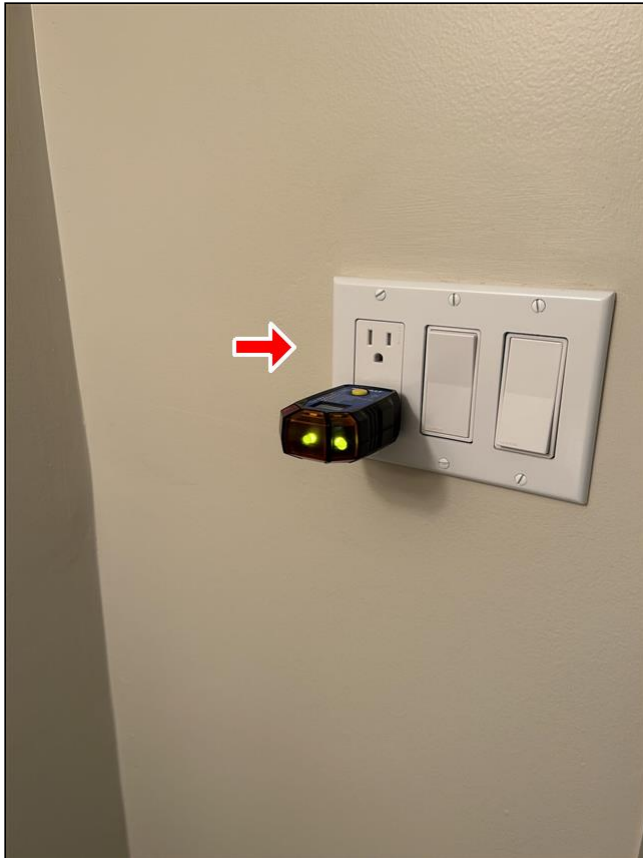
12.6 Item 1(Picture) standard outlet

A Ground Fault Circuit Interrupter (GFCI) is not present in the downstairs bathroom, suggest installing GFCI for safety.

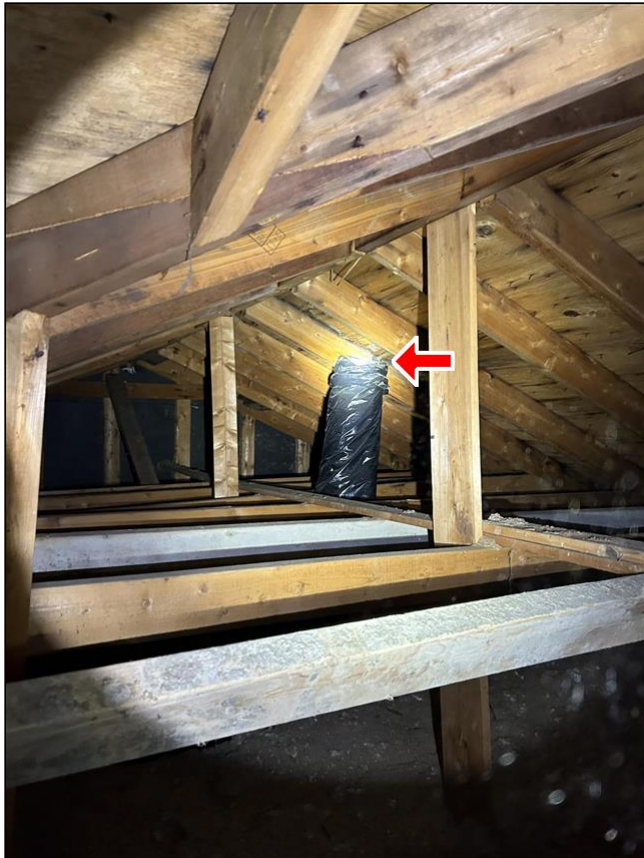
15.5 Item 1(Picture) bathroom vent

Bathroom fan is improperly venting into the attic. Recommend extending the venting to the exterior to prevent damage/deterioration in the attic from moisture/condensation.

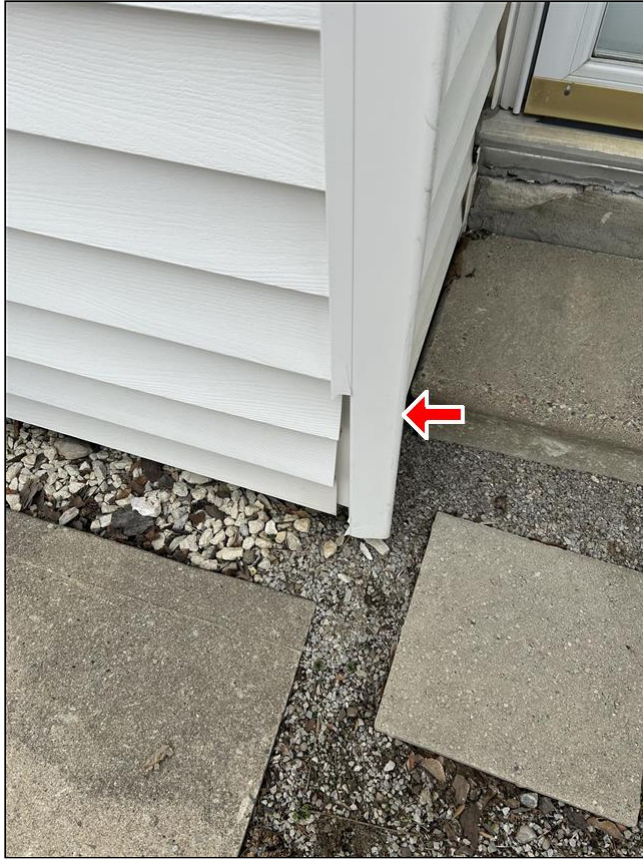
1.2 Item 1(Picture) damaged siding

Damaged vinyl corner siding noted at the rear. We recommend repair or replacement as required.

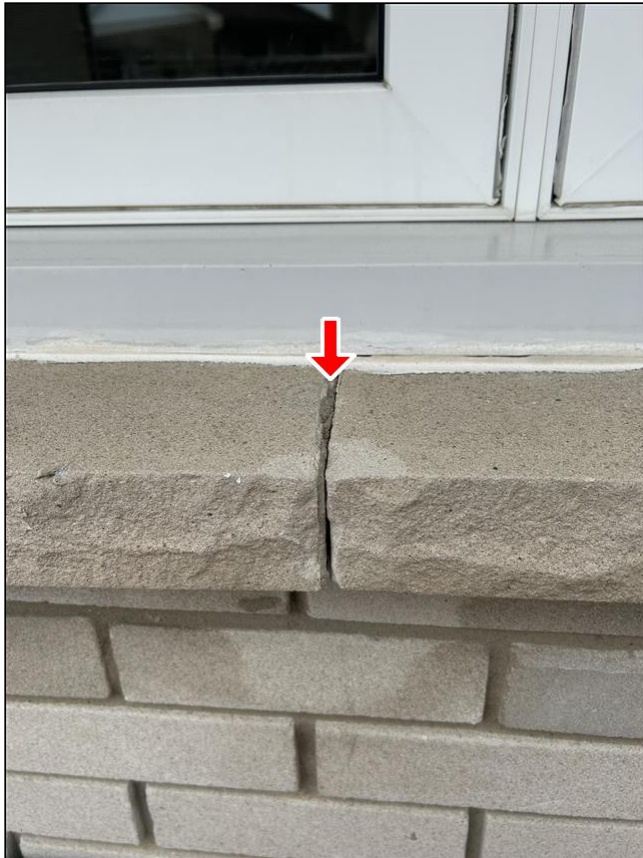
1.4 Item 1(Picture) sill joint

(1) Open sill joints noted. Caulking should be applied around all windows, doors, and any voids where necessary.

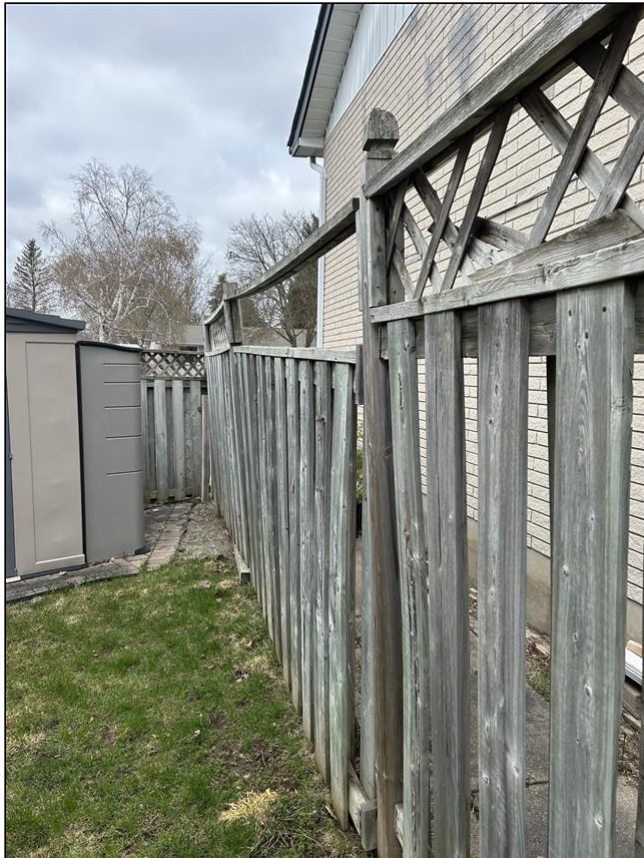
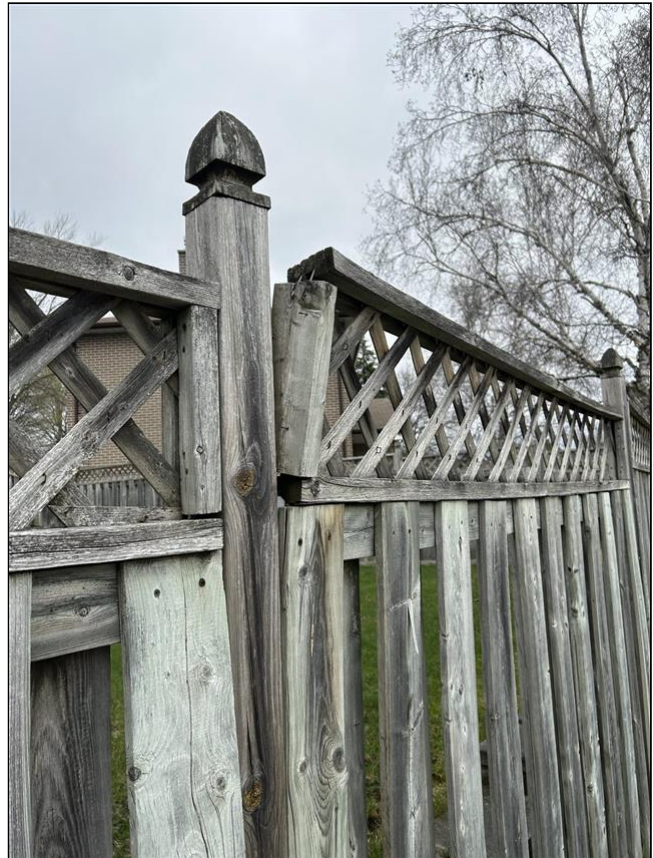
Damaged fencing and/or loose sections observed at various locations. Recommend review for repair or replacement as necessary.

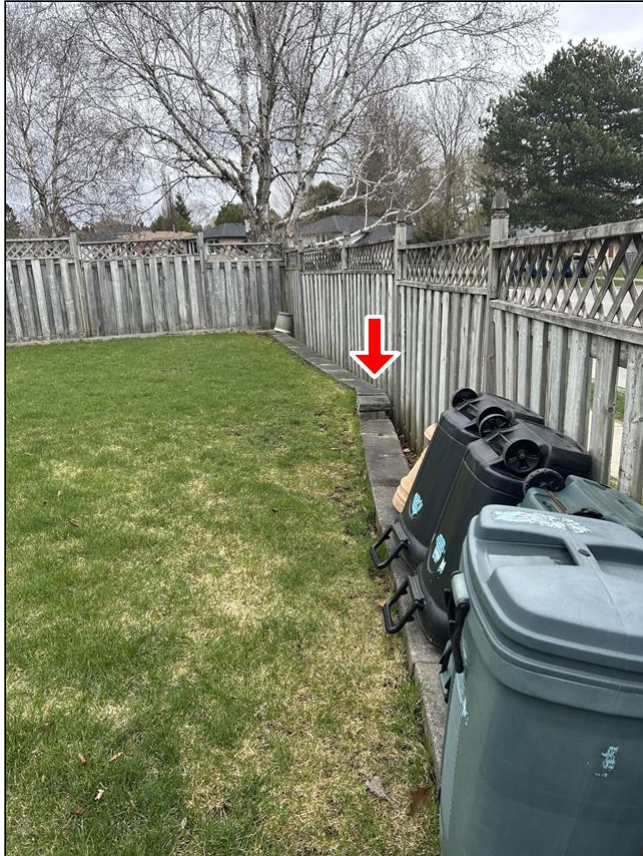
1.14 Item 1(Picture) retaining wall condition

The retaining wall at the right side adjoining the fencing is starting to lean. We recommend repairs as required to prevent further movement.

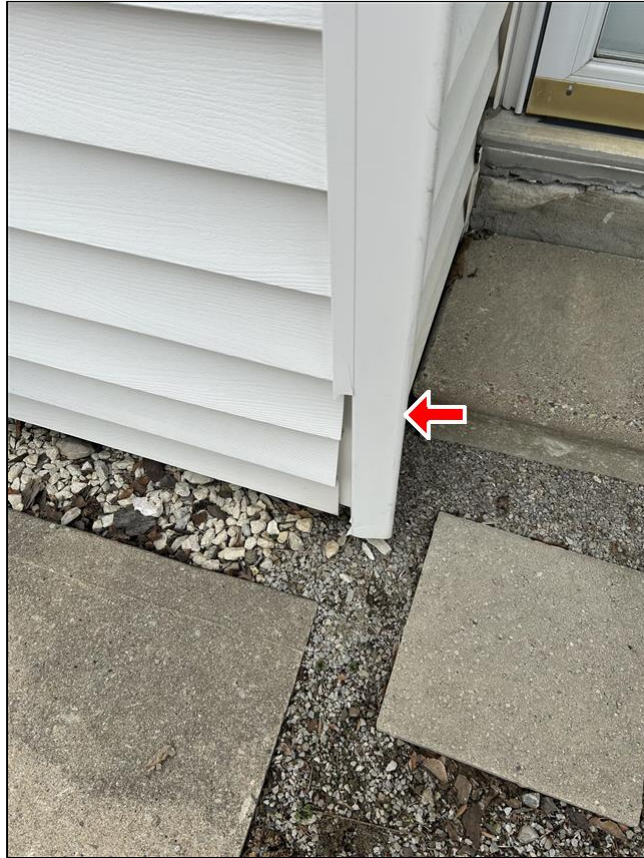
1.2 Item 1(Picture) damaged siding

1.2 Damaged vinyl corner siding noted at the rear. We recommend repair or replacement as required.

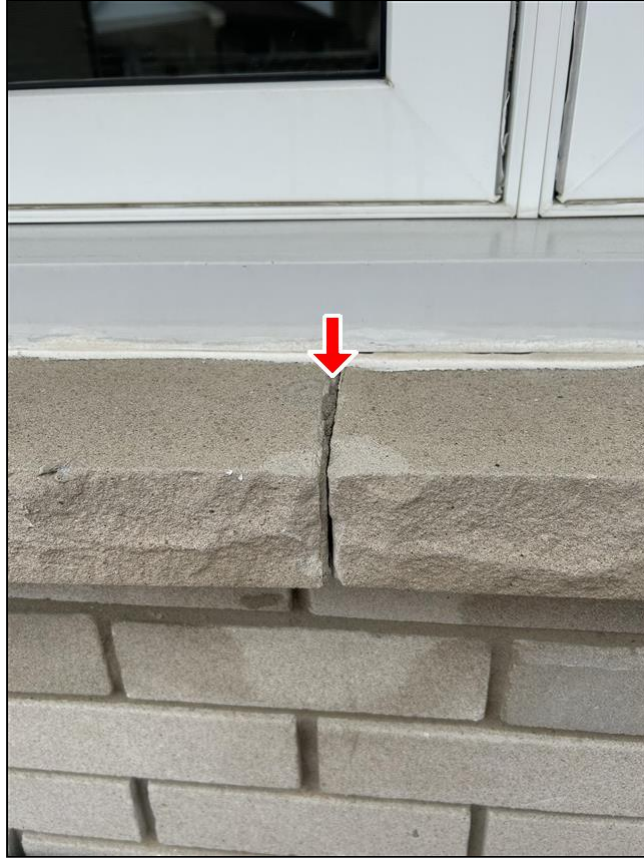
1.4 Item 1(Picture) sill joint

1.4 (1) Open sill joints noted. Caulking should be applied around all windows, doors, and any voids where necessary.

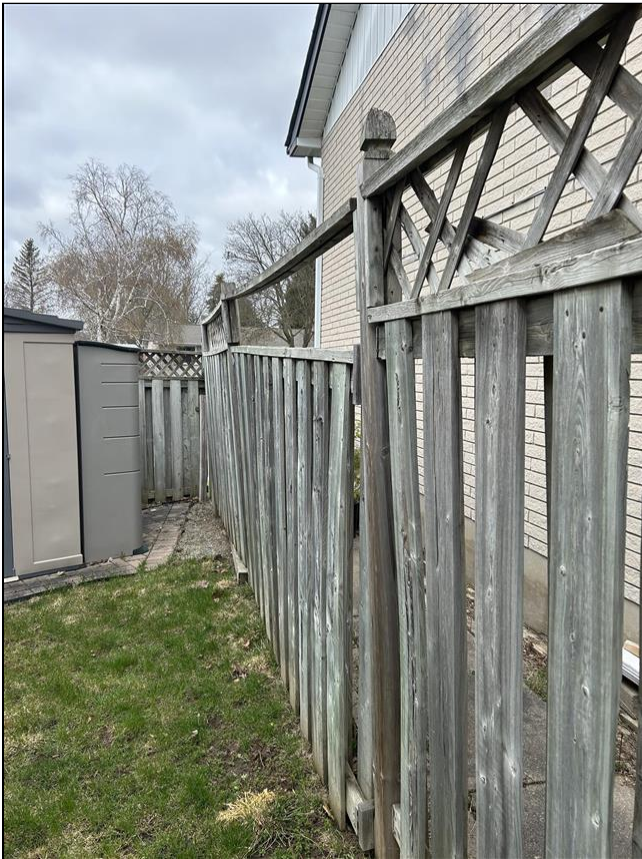
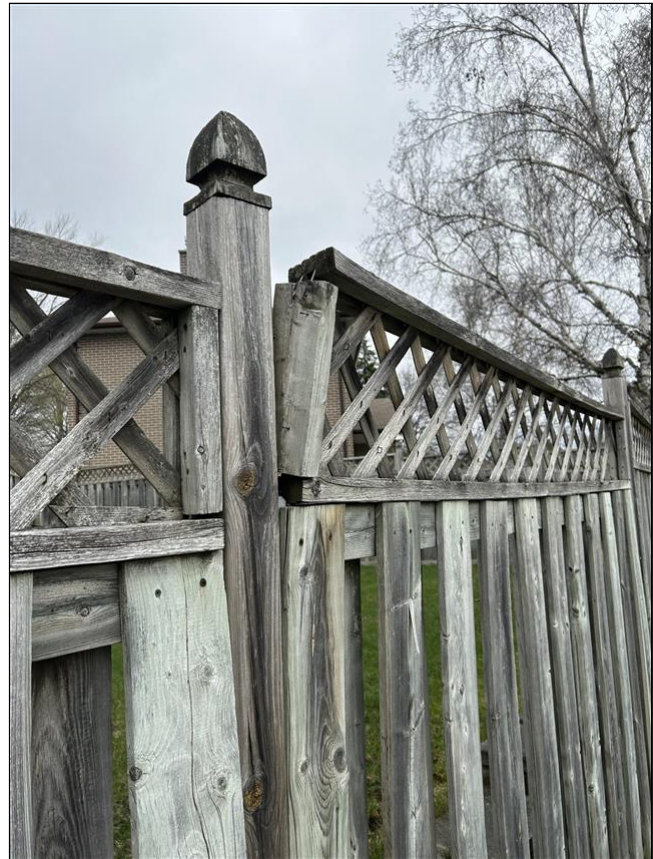
1.6 Damaged fencing and/or loose sections observed at various locations. Recommend review for repair or replacement as necessary.

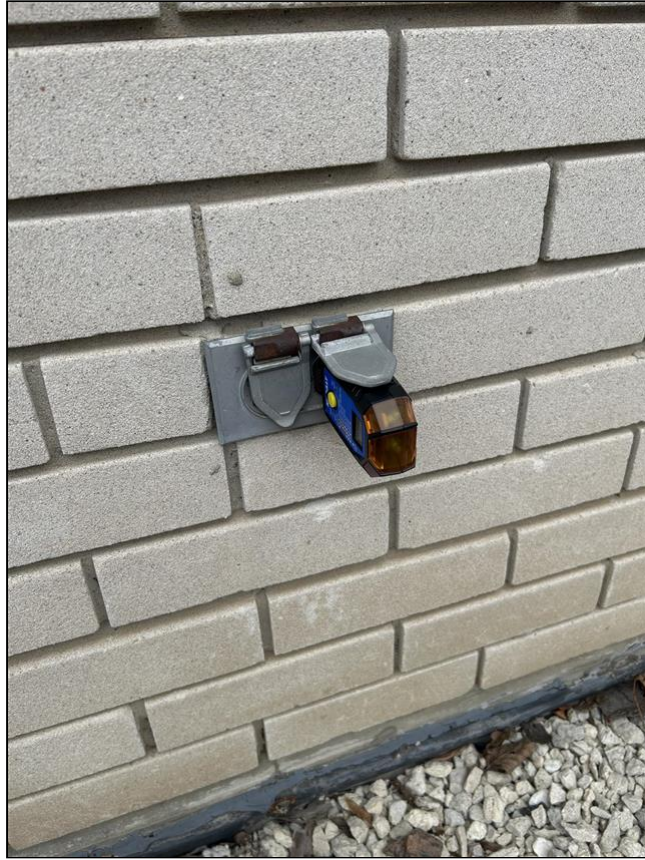
1.7 Item 1(Picture) standard outlet

1.7 Not all receptacles are ground fault circuit interrupter (GFCI) protected. This may not have been required when home was built; client is advised to install ground fault circuit interrupter outlets as a safety enhancement.

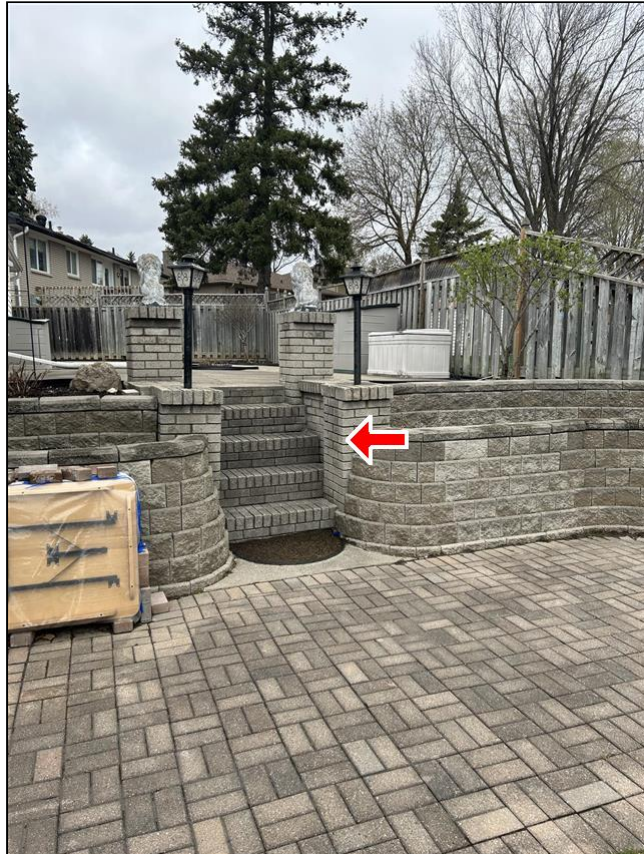
1.11 Item 1(Picture) missing railing

1.11 (2) No hand railings noted on steps at rear of home, recommend installing hand rail for safety. When ever four or more risers are present a handrail is usually required.

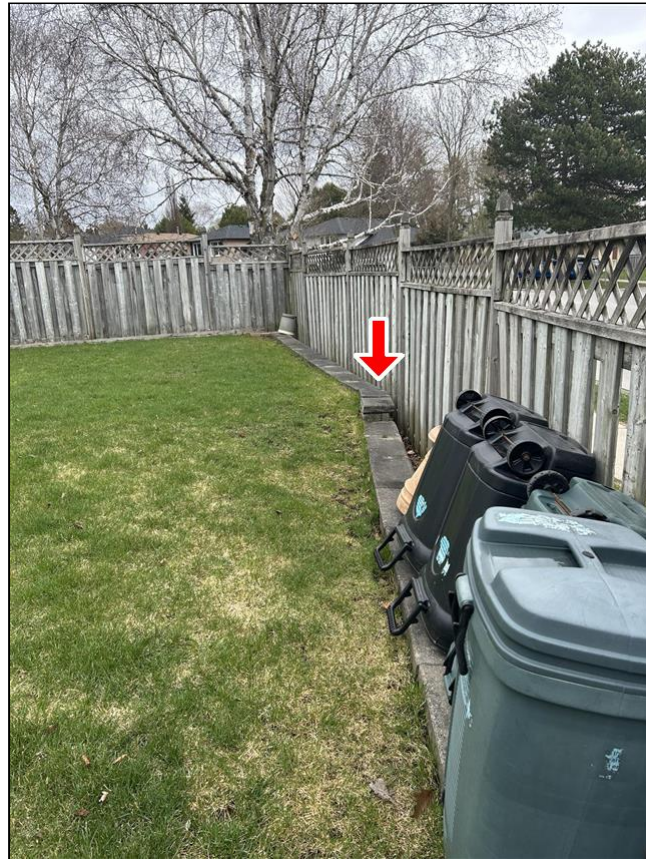
1.14 Item 1(Picture) retaining wall condition

1.14 The retaining wall at the right side adjoining the fencing is starting to lean. We recommend repairs as required to prevent further movement.

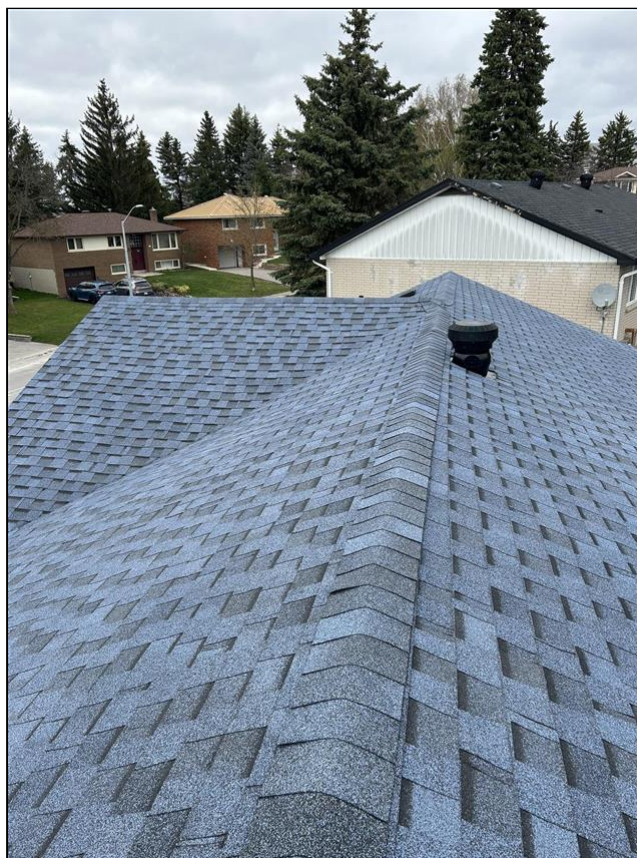
2.0 Item 1(Picture) roof conditions

2.0 Roof shows normal wear for its age and type. No damaged, deteriorated, or missing roofing materials were observed; it appears to be in serviceable condition at time of inspection.

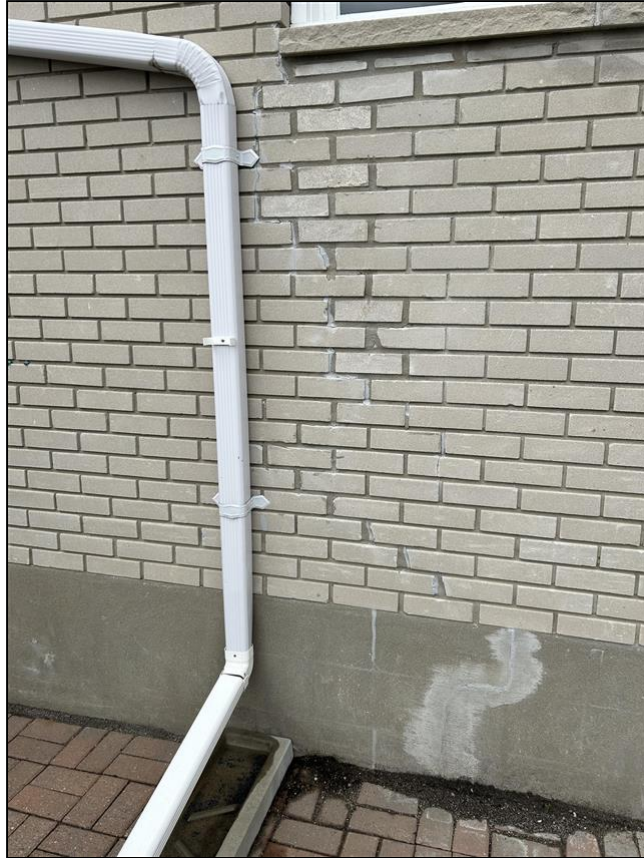
3.0 Item 1(Picture) step cracking

3.0 Step cracking in the brick is present at the right side of the garage. The step cracking in the brick veneer appears to be from normal settlement. We recommend sealing as required.

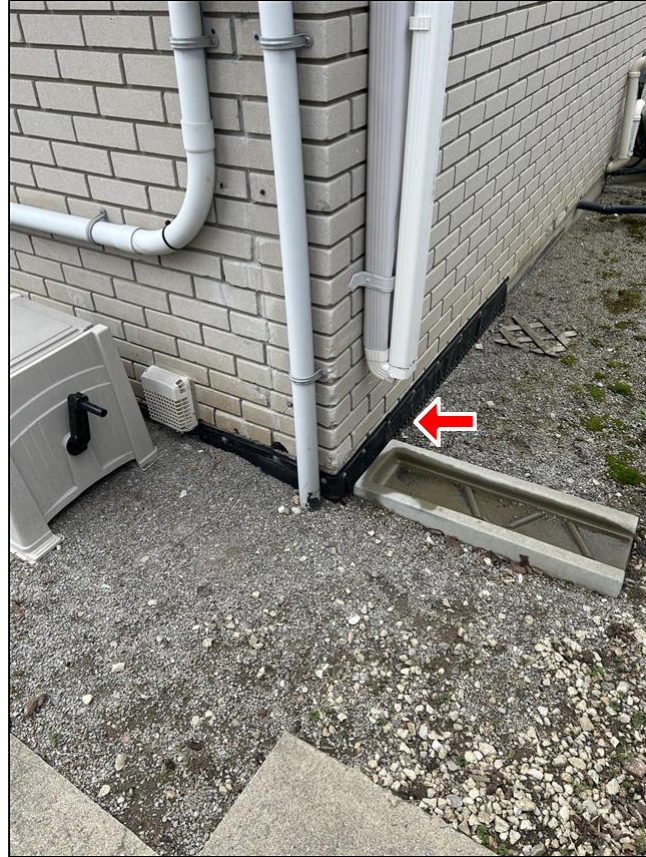
5.1 Item 1(Picture) waterproofing

5.1 Inspected. Exterior waterproofing noted along the rear left corner of the foundation. We recommend obtaining additional information from the seller.

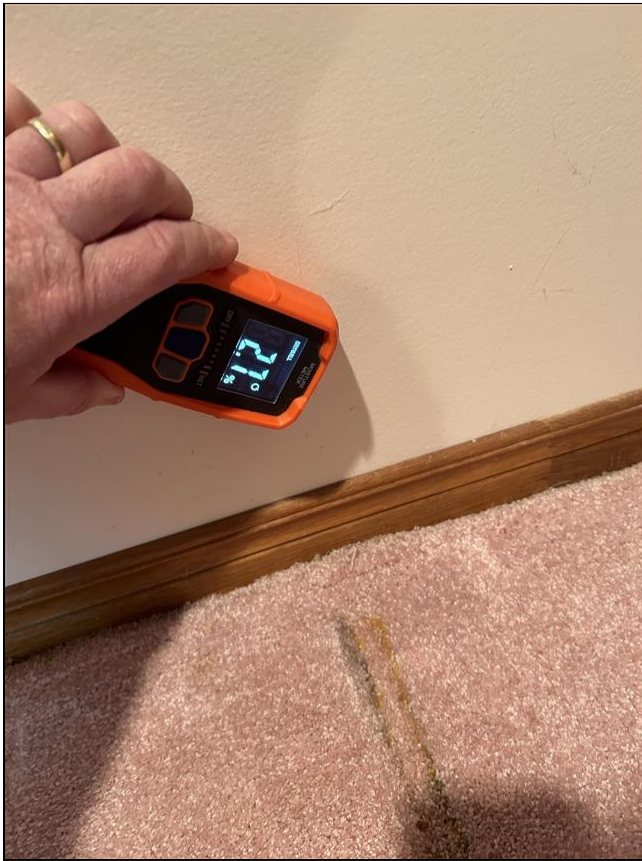
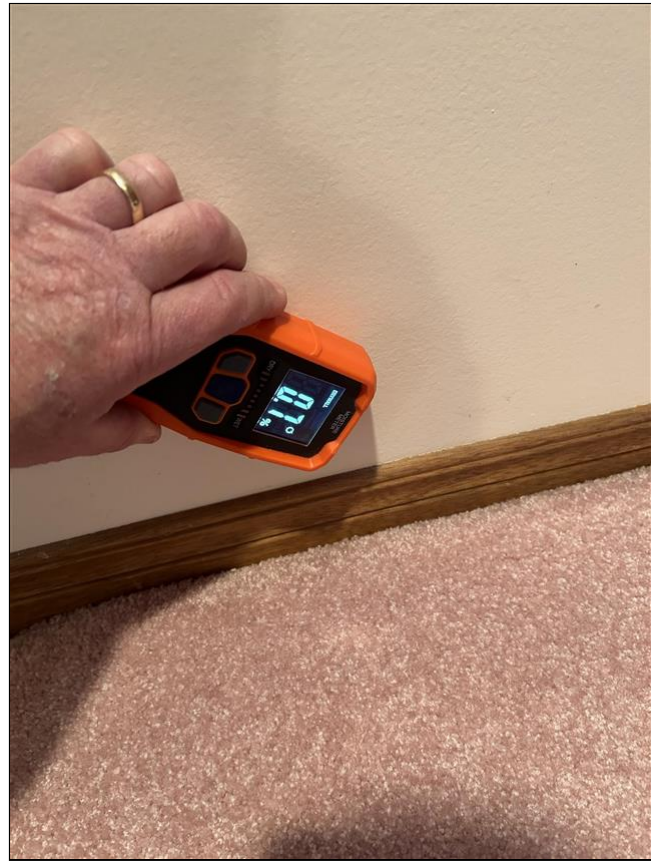
5.3 The basement walls were inspected for the presence of moisture at visibly accessible areas through non-intrusive means using thermal imaging, a moisture meter, touch, and visual inspection. No evidence of active moisture was noted in the visibly accessible areas of the basement walls.

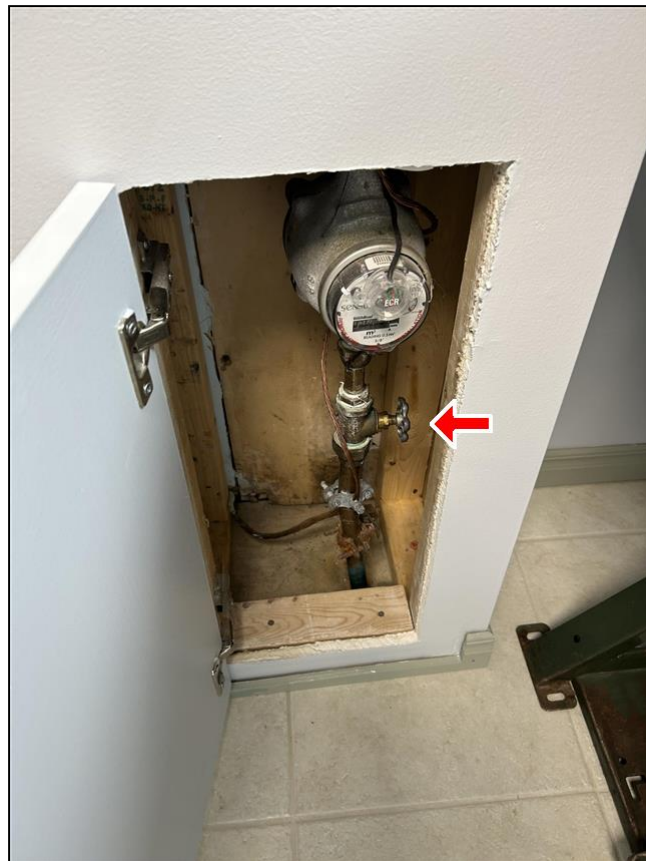
6.0 Item 1(Picture) main shut off

6.0 Gate-type valve observed. Since main shut-off valves are operated infrequently, it is not unusual for them to become frozen over time. They often leak or break when operated after a period of inactivity. For this reason main shut-off valves are not tested during a home inspection. We suggest caution when operating shut-offs that have not been turned for a long period of time. We recommend that the client consider upgrading the shut-off valve to a high quality ball-type valve which tend to be more reliable than gate valves.

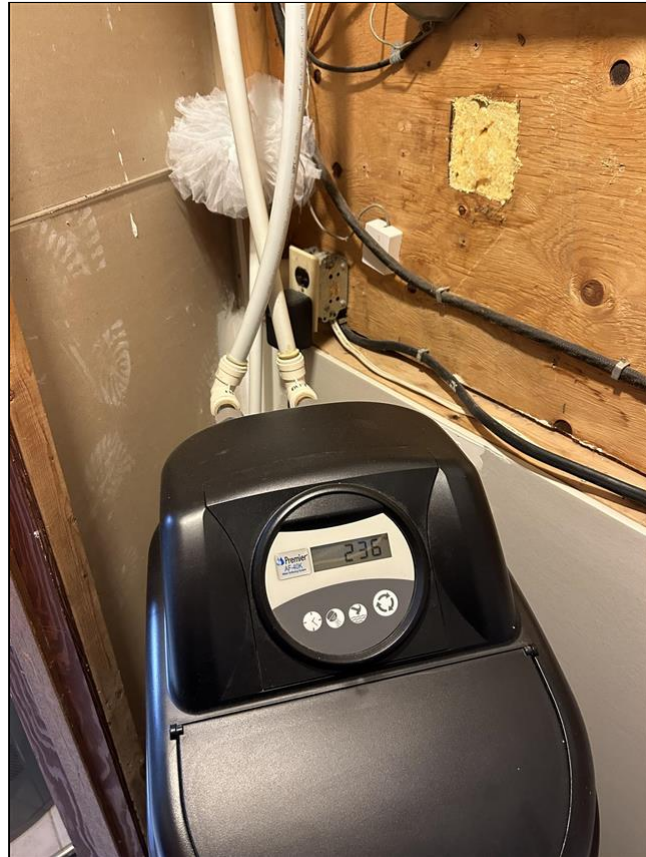
6.3 Item 1(Picture) water softener

6.3 (2) A water softening device was observed. This appliance was not inspected, as a water treatment device, controlled by an automatic timer, is beyond the scope of this inspection. We recommend referring to the Seller Disclosure Statement regarding the condition of this appliance. We further recommend confirming proper operation prior to close.

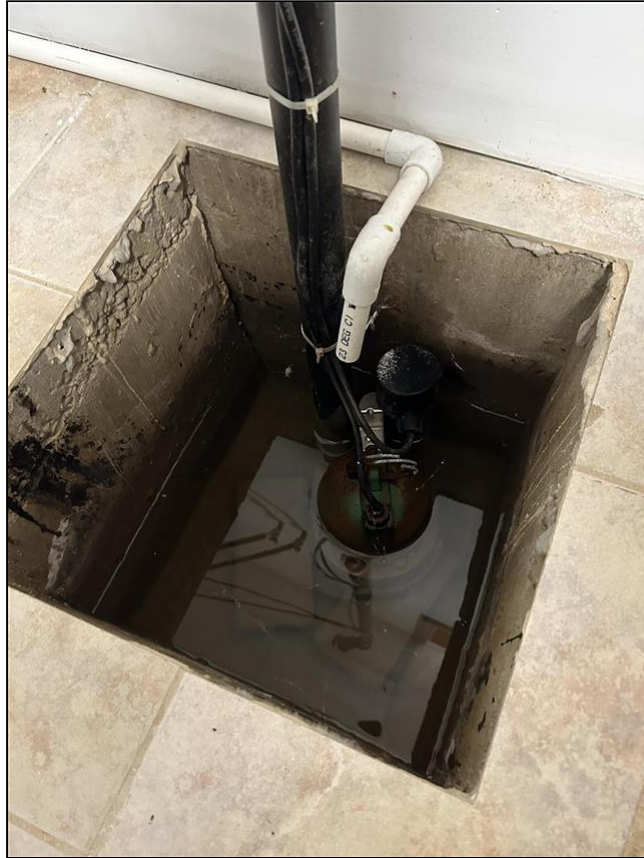
6.4 Item 1(Picture) sump

6.4 (2) Sump pumps should be tested on a regular basis. Installation of a backup pump and power supply is recommended.

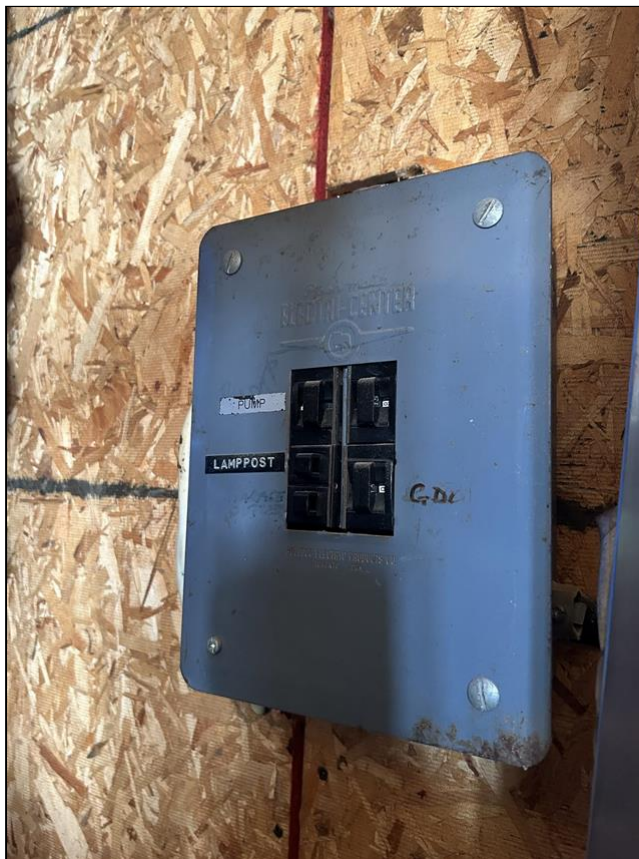
7.3 Item 1(Picture) panel conditions

7.3 Bulldog type panel observed in the garage. The cover was not removed as these covers are too close to the main service and have been known to arc. Most electrical experts believe that these panels are problematic and should be replaced. Recommend review by a licensed electrical contractor for replacement.

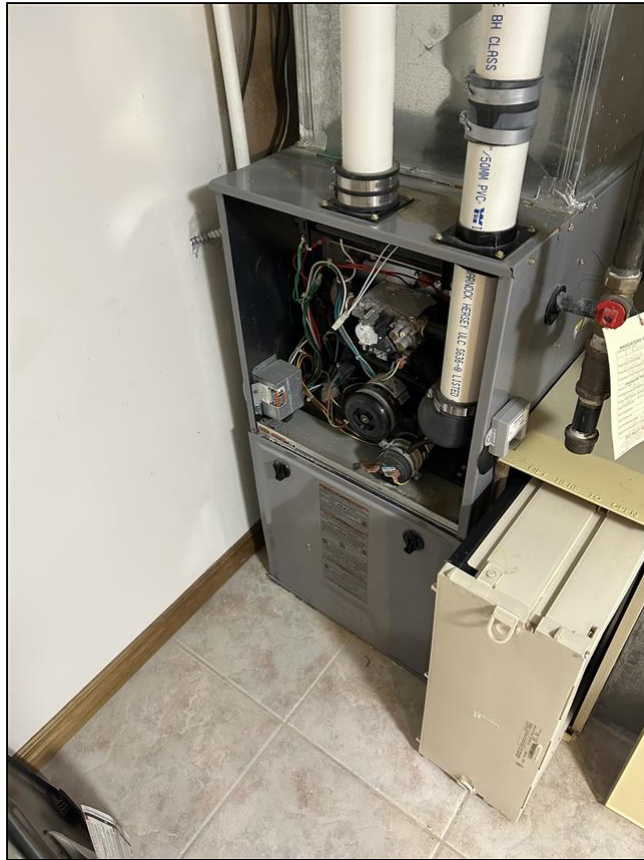
8.0 Item 1(Picture) furnace conditions

8.0 (1) The gas furnace was tested using normal operating controls and functioned properly at time of inspection. Rust was present in the unit from a previous condensate leak.

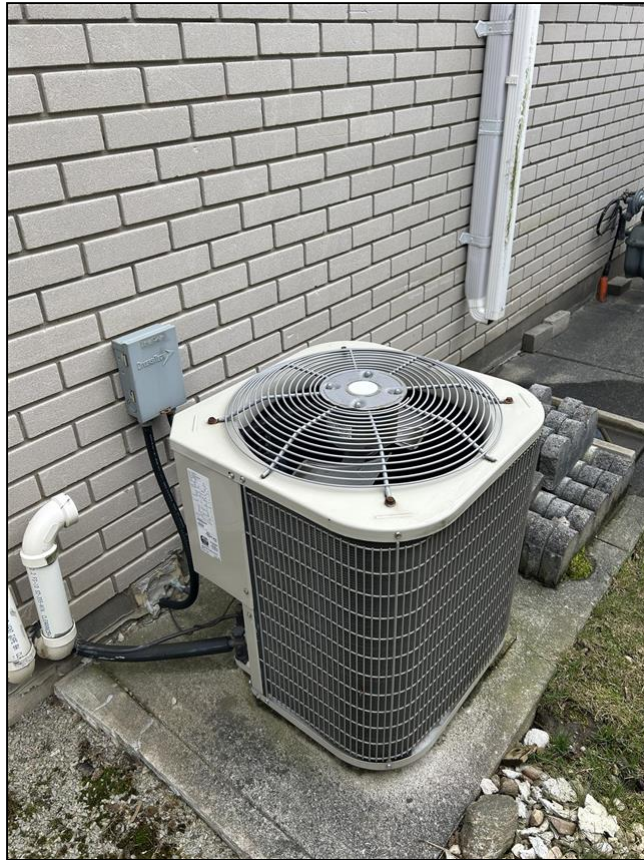
9.0 Item 1(Picture) air condenser

9.0 As most manufacturers warn against operating air conditioning units when the outside temperature is below 60 degrees, this unit was not tested. Recommend referring to the Sellers Disclosure Statement regarding the condition of this unit.

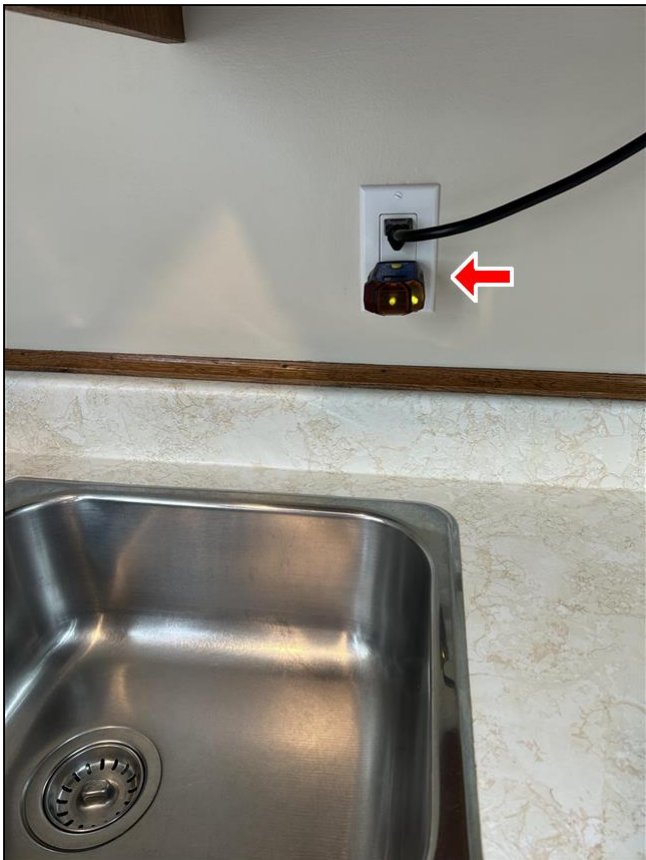
11.5 Item 1(Picture) standard outlet

11.5 Not all receptacles are ground fault circuit interrupter (GFCI) protected. This may not have been required when home was built; client is advised to install ground fault circuit interrupter outlets as a safety enhancement.

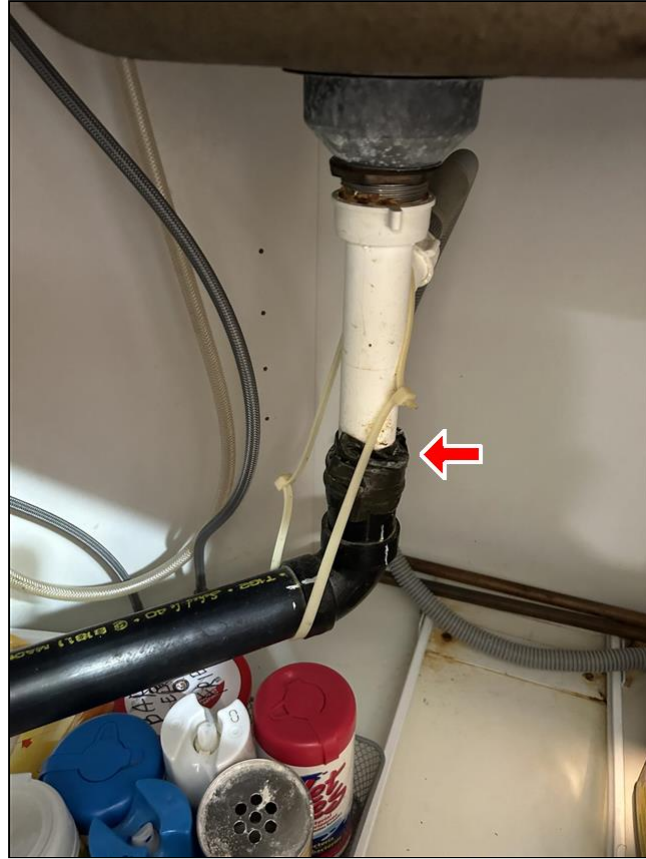
11.8 Item 1(Picture) drain repair

11.8 Although no leakage was detected, there are non-standard repairs at the drain line which are temporary in nature, permanent repairs are needed to ensure leak proof conditions.

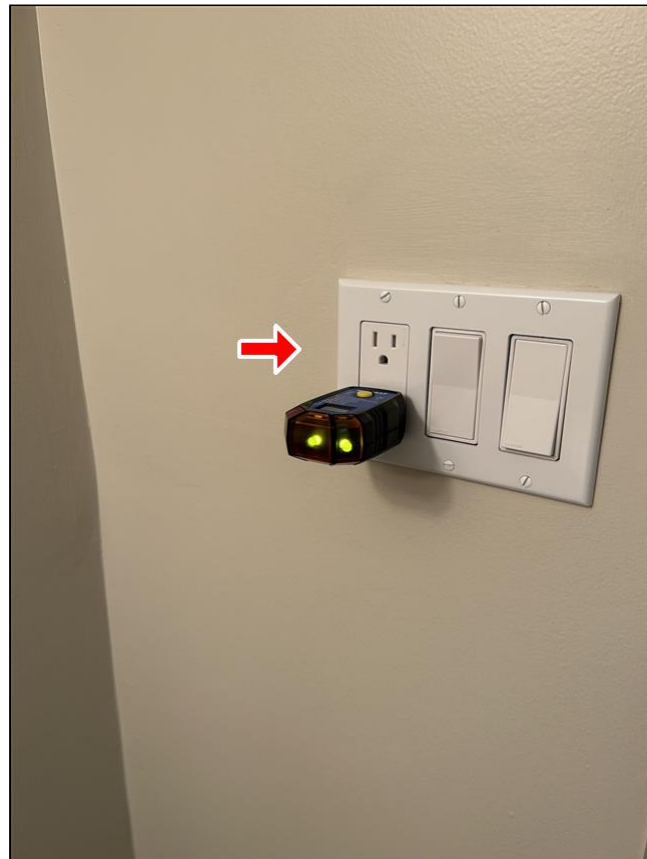
12.6 Item 1(Picture) standard outlet

12.6 A Ground Fault Circuit Interrupter (GFCI) is not present in the downstairs bathroom, suggest installing GFCI for safety.

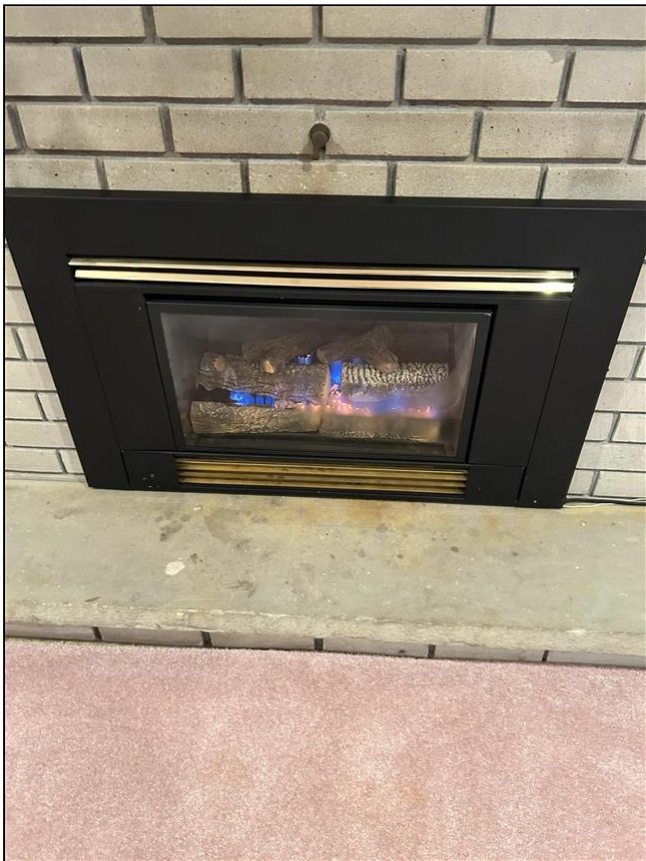
14.8 Item 1(Picture) gas fireplace condition

14.8 The gas fireplace tested operable using the normal operating controls.

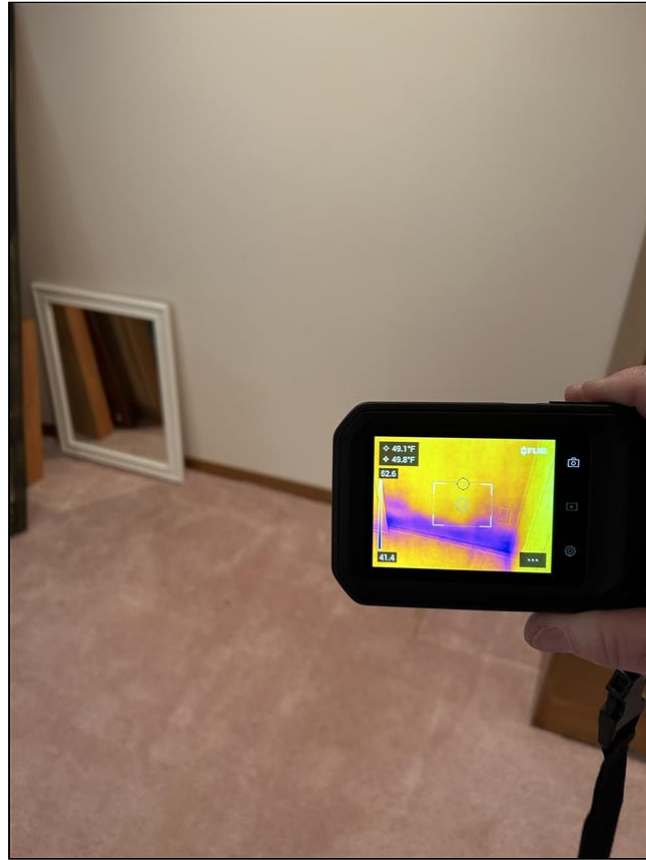
14.10 Item 1(Picture) thermal imaging

14.10 The interior rooms and areas were inspected for the presence of moisture at visibly accessible areas through non-intrusive means using thermal imaging, a moisture meter, touch, and visual inspection. No evidence of active moisture was noted in the visibly accessible areas of the walls and ceilings.

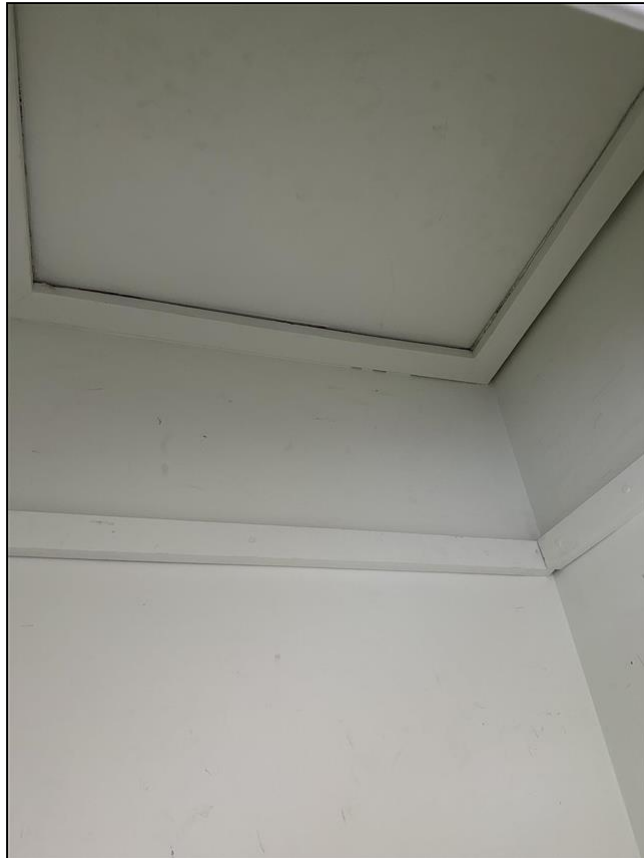
15.0 Item 1(Picture) attic hatch

- Did not enter, unable to access attic due to insulation, low clearance and/or personal storage. Entering attics that are heavily insulated can cause damage to the insulation and attic framing. Attics with deep insulation cannot be safely inspected due to limited visibility of the framing members upon which the inspector must walk. In such cases, the attic is only partially accessed, thereby limiting the review of the attic area from the hatch area only. Inspectors will not crawl the attic area when they believe it is a danger to them or that they might damage the attic insulation or framing. This is a limited review of the attic area viewed from the hatch only; recommend consulting sellers for any additional information.

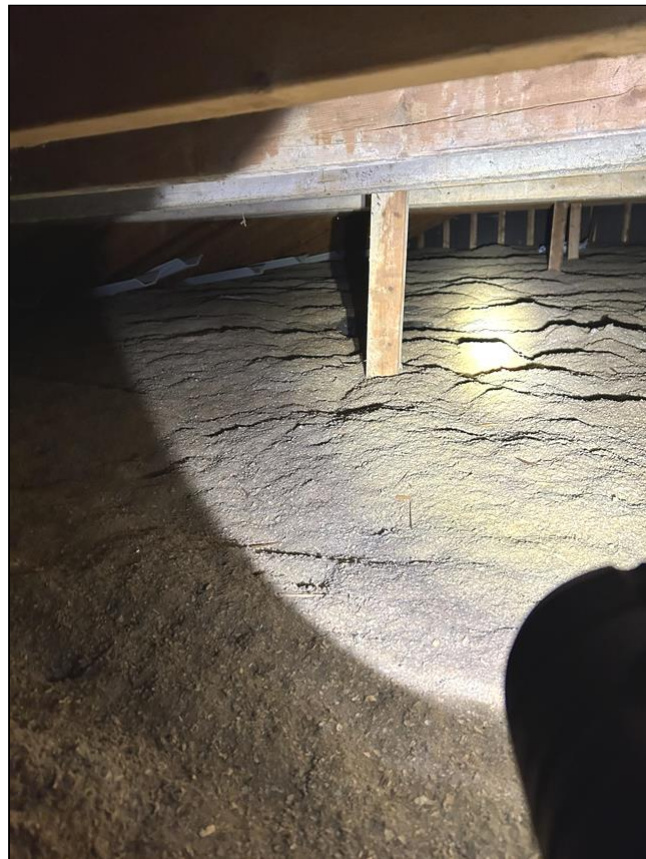
15.3 Item 1(Picture) insulation conditions

15.3 We recommend increasing the amount of insulation to current standards as an energy conservation measure.

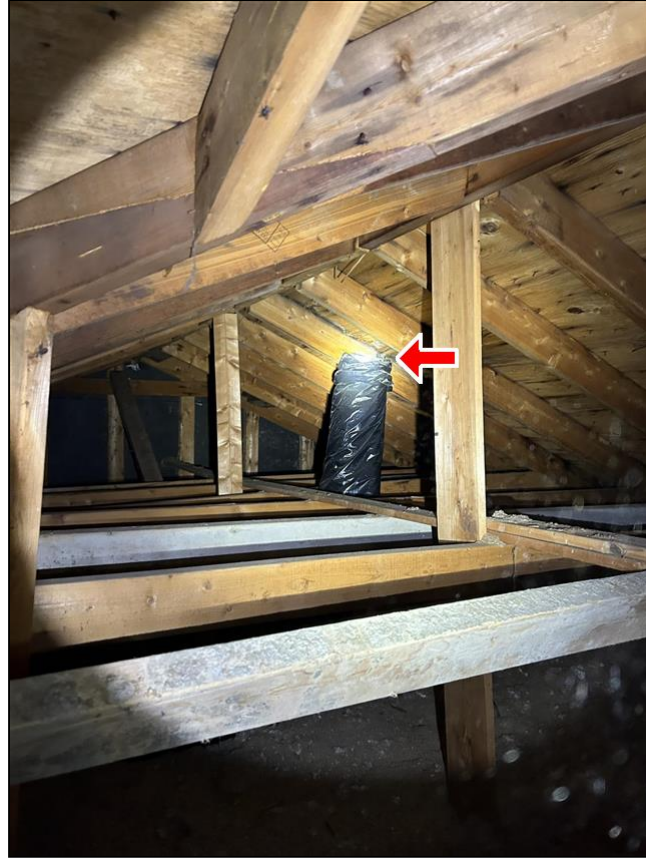
15.5 Item 1(Picture) bathroom vent

15.5 Bathroom fan is improperly venting into the attic. Recommend extending the venting to the exterior to prevent damage/deterioration in the attic from moisture/condensation.
