Doc #:	AB-210730	Inspector:	Andrew LaRoche
Date:	2021-07-22		
Dwelling Address:	1 Main Street Any City Ontario A1A 2B2		
Client Name:	ABC Company		
Client's Agent:		Real Estate Company:

This is a Property Condition Report "PCR" using the ASTM E2018 as a standard guideline to describe the condition of building or buildings for the property inspected. This process involves observation of the property by a person or entity. It can include interviews of sources, and reviews of available documentation for the purpose of developing an opinion and preparing a PCR of a commercial real estate's current physical condition. At the option of the user, a PCA may include a higher level of inquiry and due diligence than the baseline scope described within this guide or, at the user's option, it may include a lower level of inquiry or due diligence than the baseline scope described in this guide. If there are such deviations from this guide's scope it should be disclosed here on this page. A PCR is a written report, prepared in accordance with the recommendations contained in this guide, that outlines the consultant's observations, opinions as to the subject property's condition, and opinions of

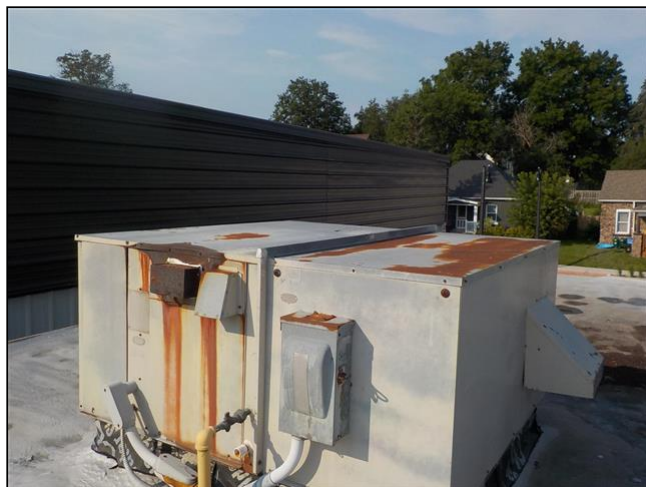
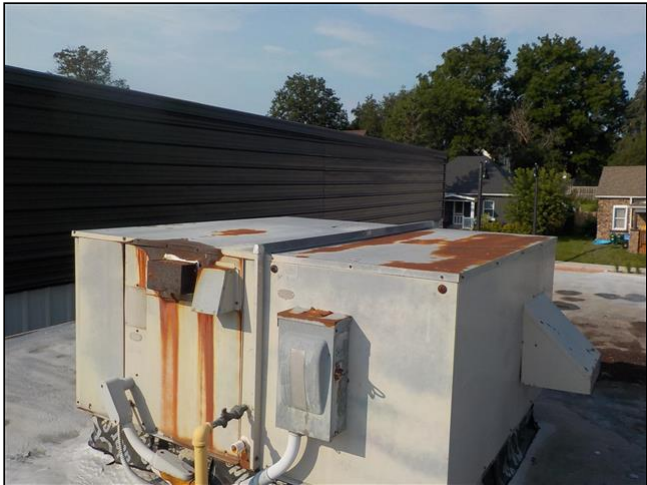
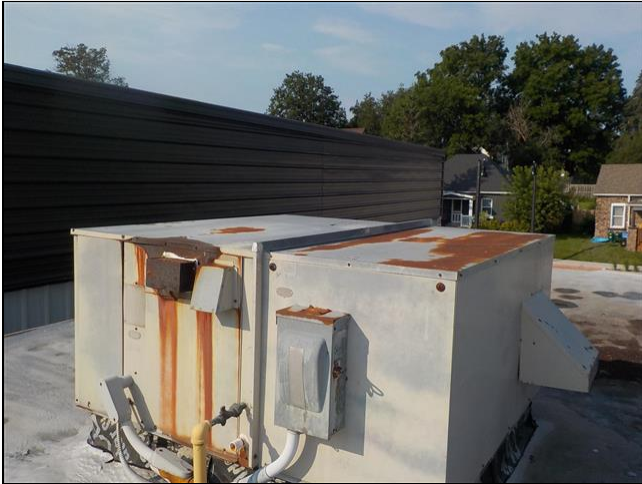
D. (1) The building is heated and cooled by two rooftop package units. The LENNOX unit is original to the building construction (1974) and has reached its typical life expectancy. We recommend budgeting for replacement. Rust and corrosion and a missing condensate trap was noted. We recommend the unit be inspected and serviced by a licensed HVAC contractor to ensure proper operation. Regular servicing and maintenance should be completed.

D. Item 1(Picture) Original LENNOX unit

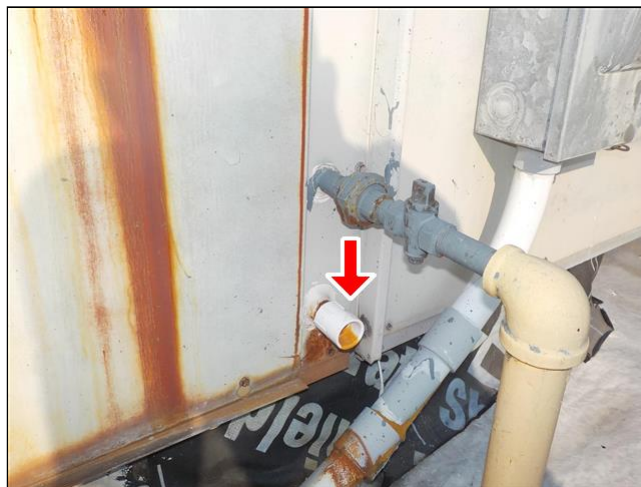
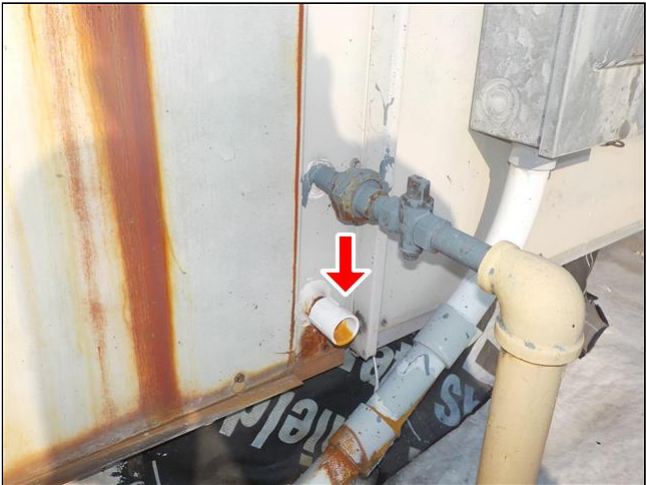
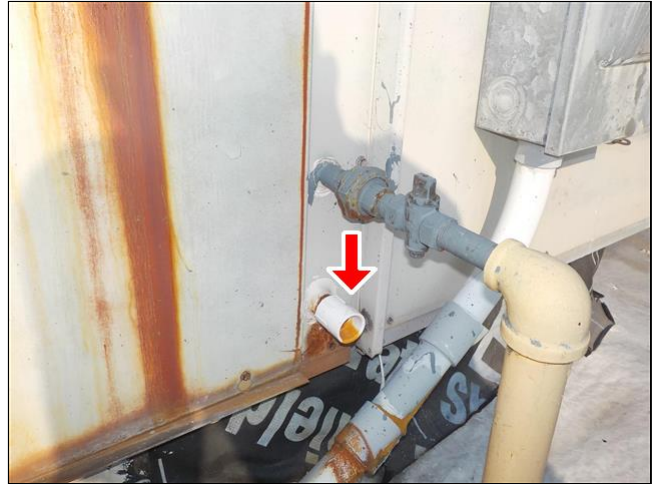
D. Item 2(Picture) Missing condensate trap

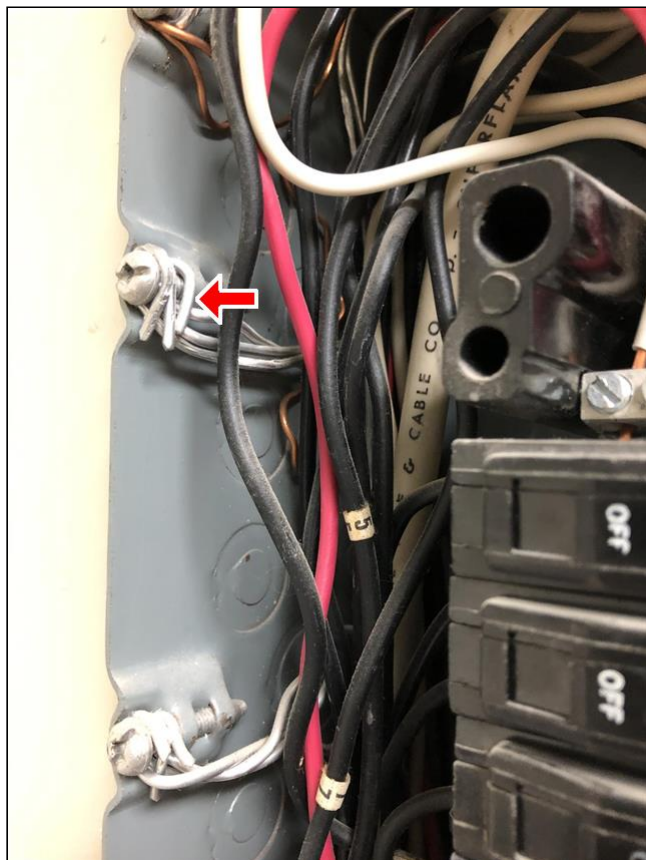
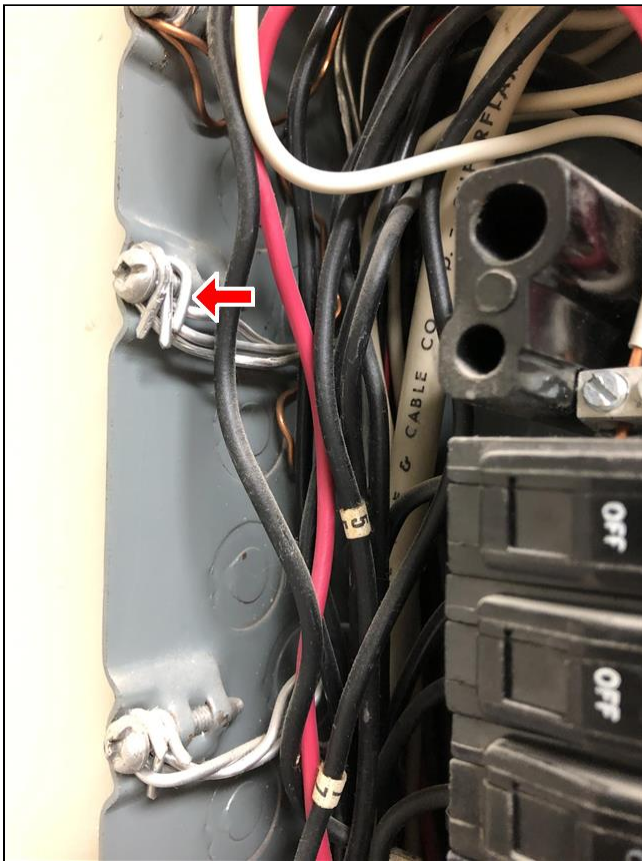
G. (1) Aluminum wire is installed on a portion of the 120 VAC branch electrical circuits in the building. This wiring was used widely during the mid 1960s and 1970s. Problems due to expansion can cause overheating at connections between the wire and devices (switches and outlets) or at splices. Properly rated (CO/ALR) electrical switches and outlets for aluminum wiring connections is required. It is recommended that the electrical system be evaluated by a licensed electrician.

G. Item 1(Picture) Aluminum wire

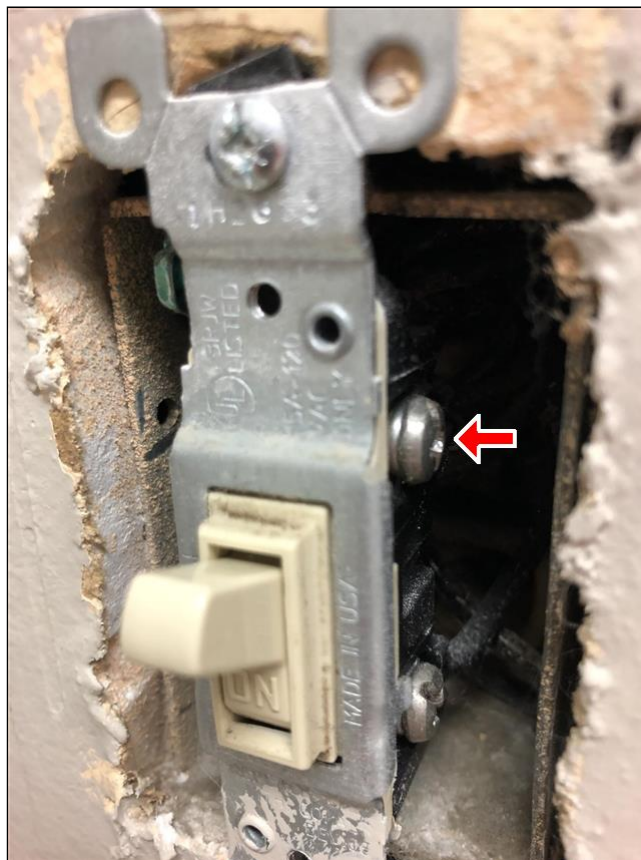
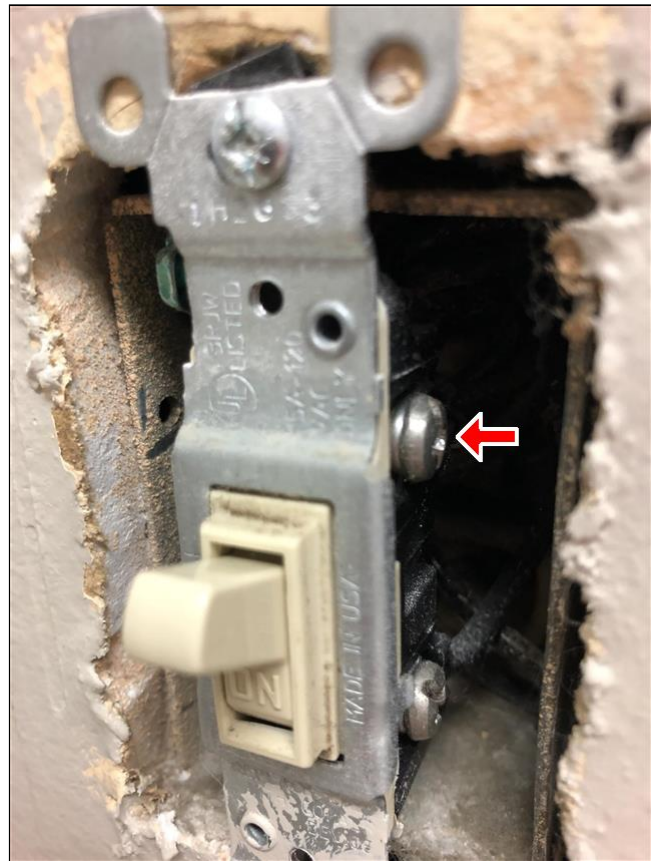
G. Item 2(Picture) Rated switch

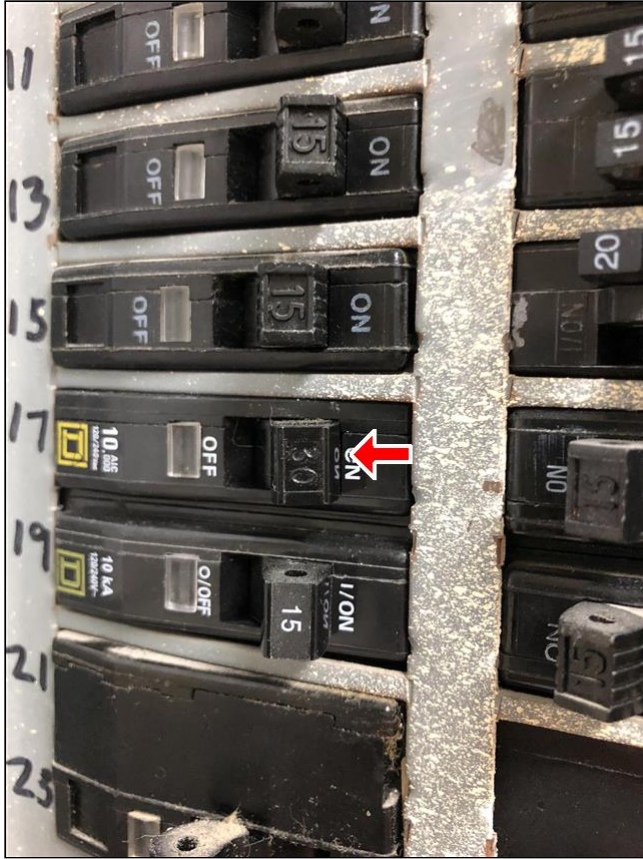
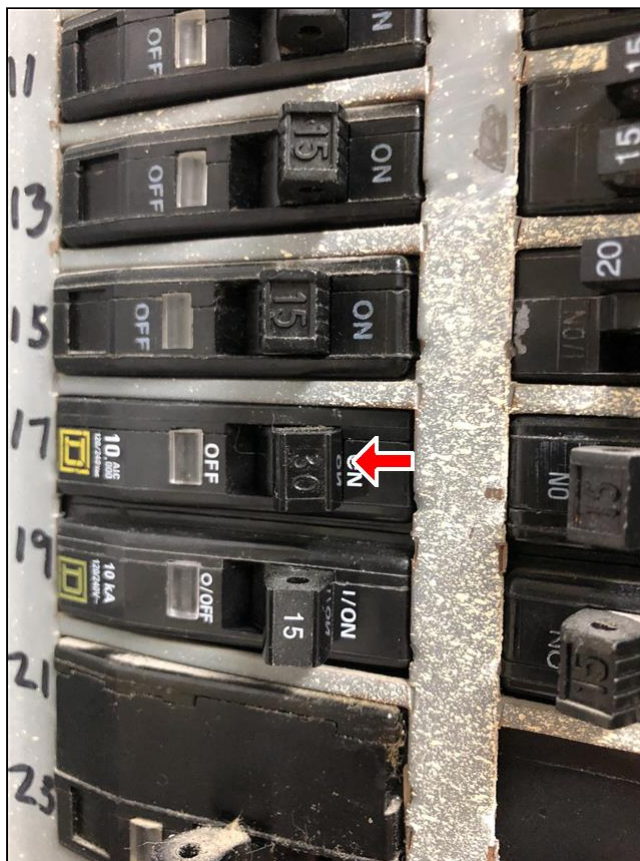
G. (2) The wiring to the 30 amp single pole breaker in the main floor sub panel appears undersized. We recommend further review to ensure the properly sized circuit breaker and wiring is installed for safety.

G. Item 3(Picture) Oversized breaker

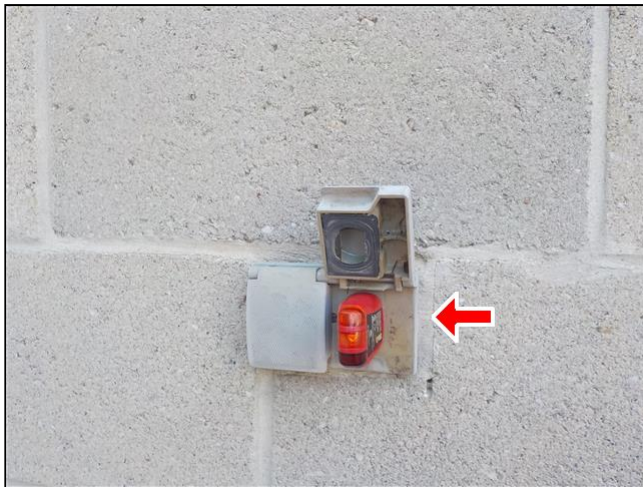
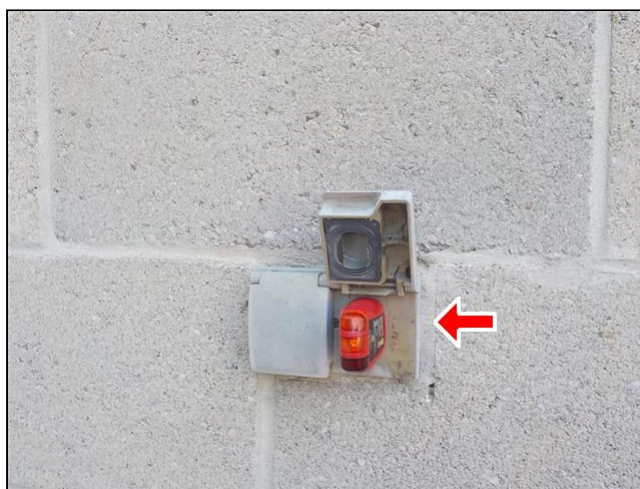
G. (3) No GFCI protection was noted on the left side exterior outlet. We recommend upgrading with a GFCI protected outlet in a weathertight cover to enhance safety.

G. Item 4(Picture) Standard outlet

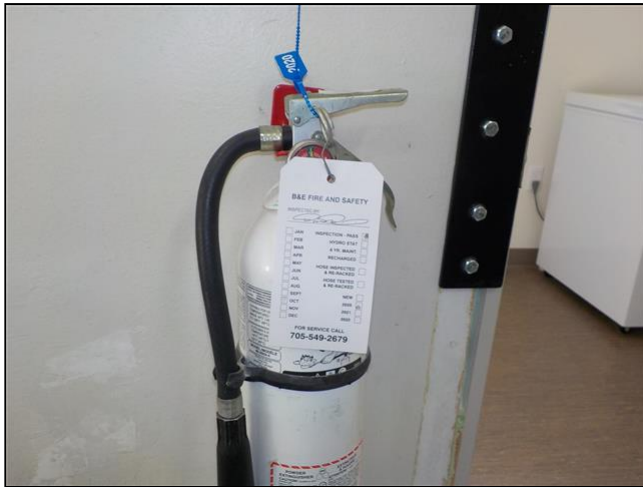
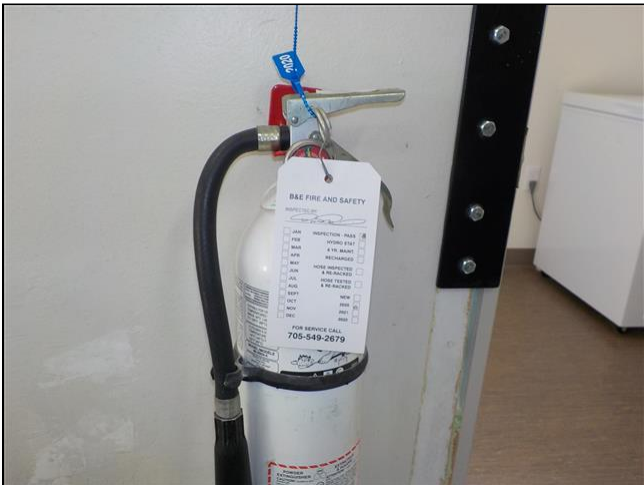
A. Exit signs and emergency lighting with battery backup and fire extinguishers with out of date inspection tags were noted in the building. Fire safety plans are posted. Smoke detectors are present. We recommend the existing fire systems be reviewed and regular inspections be completed by a fire safety company.

A. Item 3(Picture) Fire extinguisher inspection tag

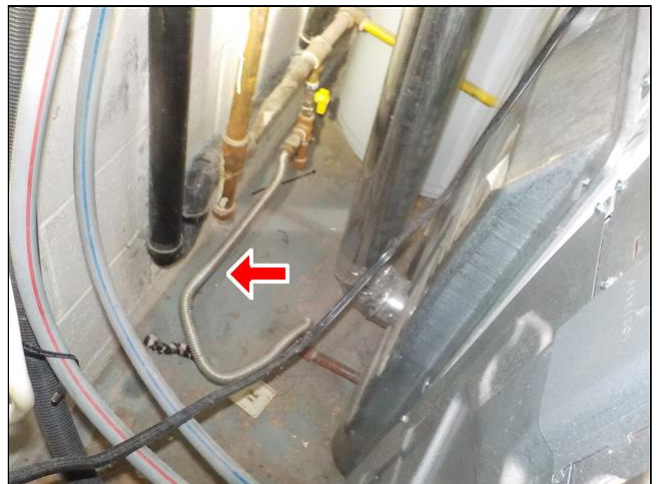
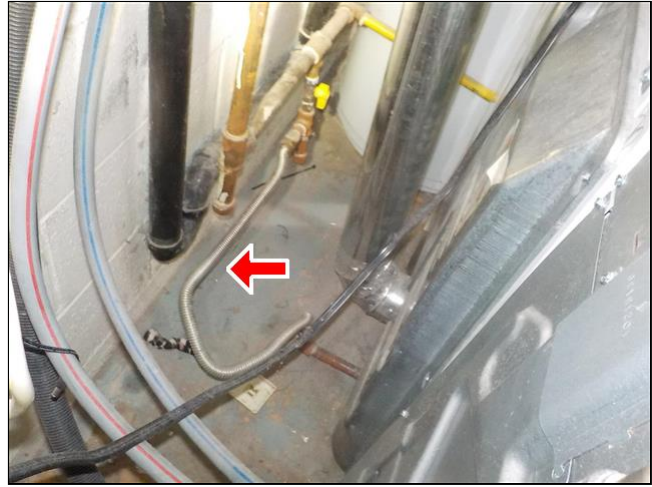
C. A MAYTAG washer and KENMORE gas dryer are present in the basement. We recommend the flexible gas line to the dryer be upgraded to enhance safety.

C. Item 2(Picture) Older gas connection

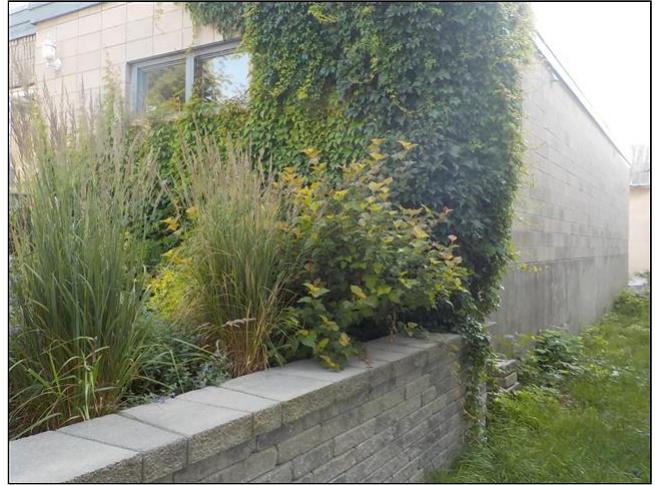
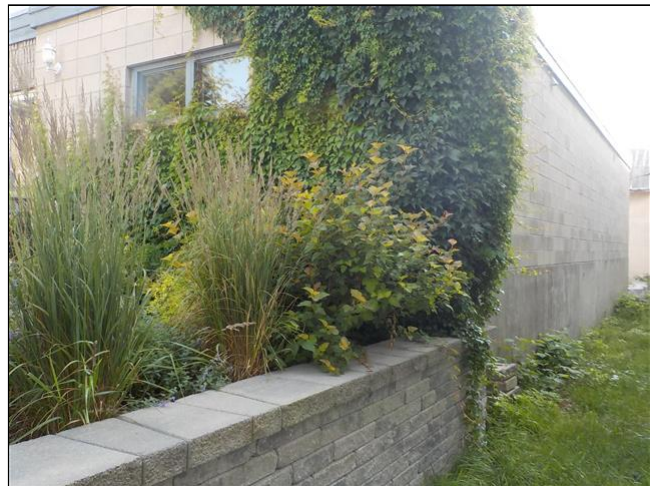
E. Raised flower beds are present along the right side of the parking area and front of the building. Vegetation overgrowth noted on the front siding. We recommend removal as required.

E. Item 2(Picture) Overgrowth

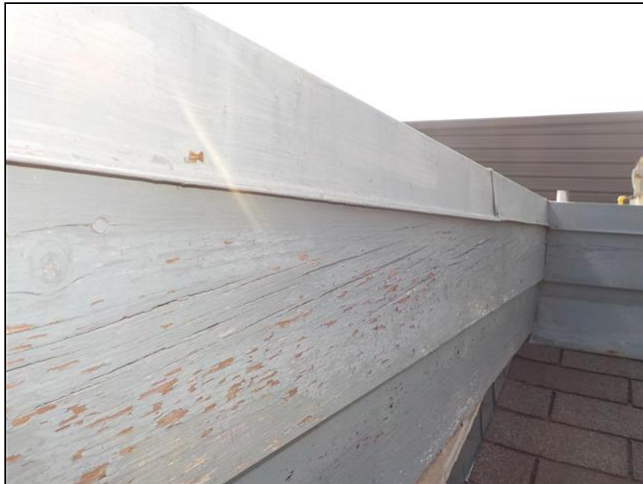
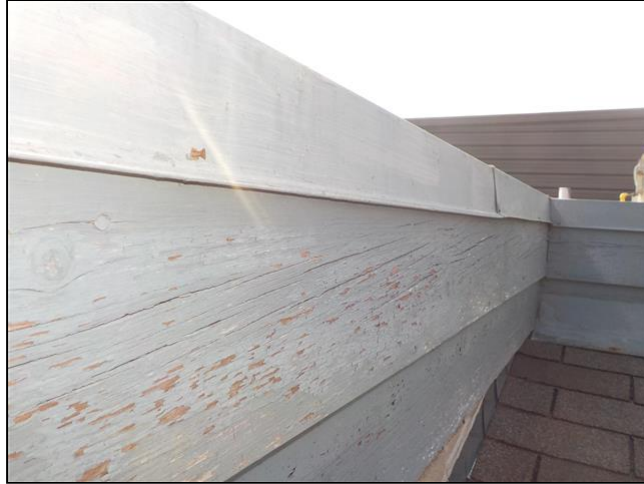
C. Weathered wood trim noted. We recommend wood maintenance be completed to prevent further deterioration. Metal capping or cladding should be considered to reduce maintenance requirements.

C. Item 1(Picture) Wood trim conditions

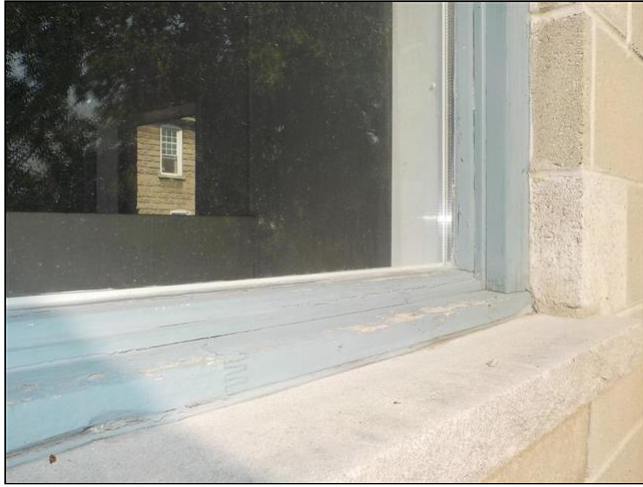
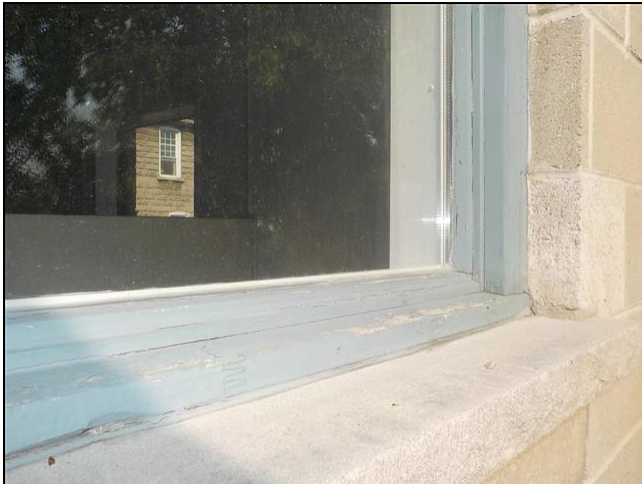
D. (1) Wood frame windows are present. Weathered wood conditions were noted. A cracked window pane was present on a left side window. We recommend wood maintenance and repairs be completed as required. Budgeting for future window replacement should be undertaken.

D. Item 1(Picture) Wood frame conditions

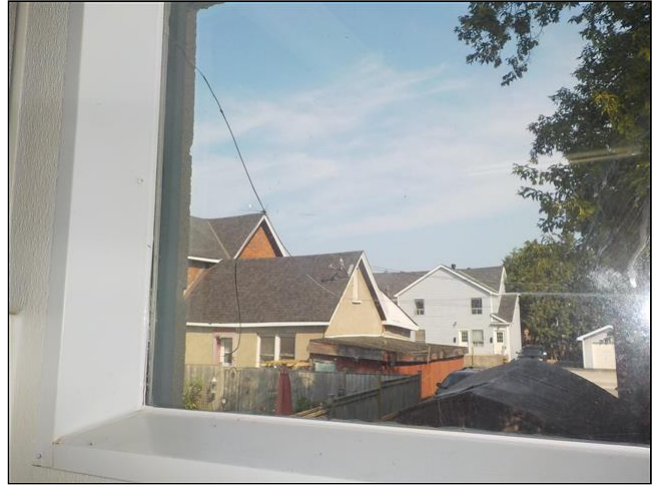
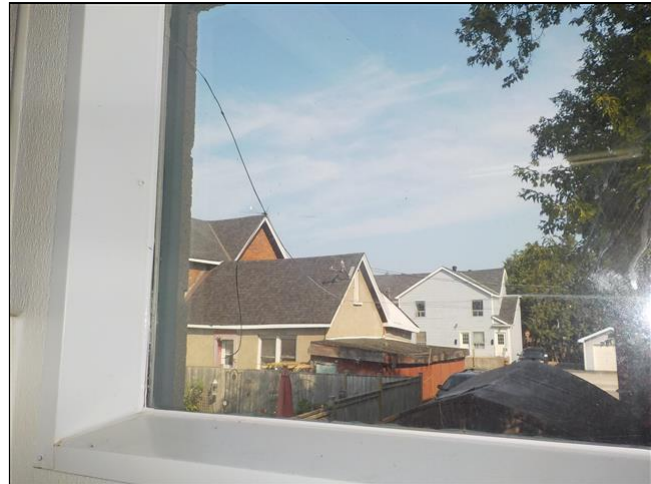
D. Item 2(Picture) Cracked window pane

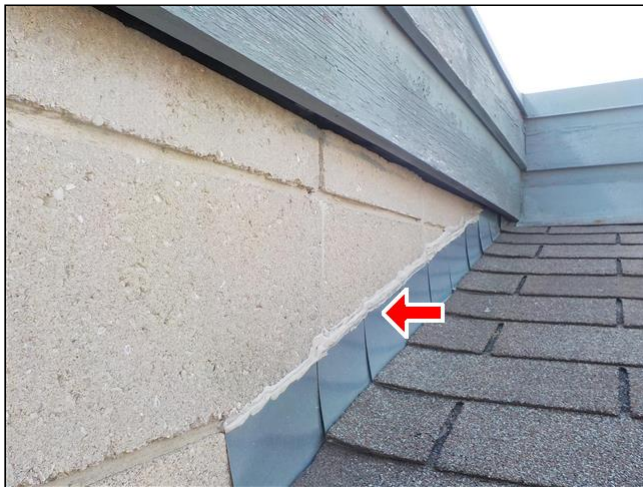
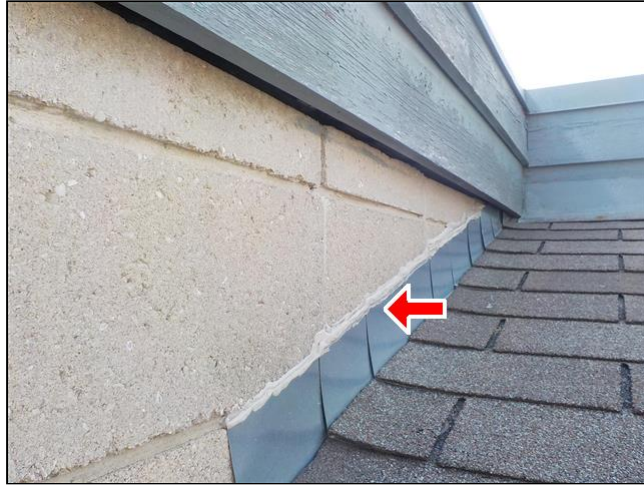
E. (2) The step flashing adjoining the block siding and the asphalt composite roofing materials on the entry cover is not properly capped/sealed. We recommend flashing repairs as required to ensure leak proof conditions.

E. Item 4(Picture) Step flashing

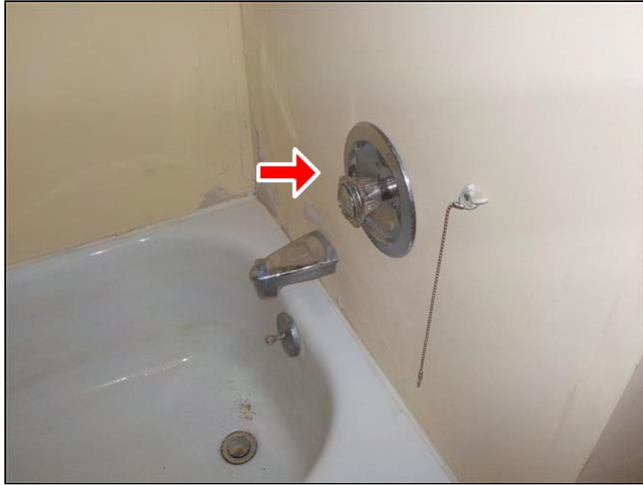
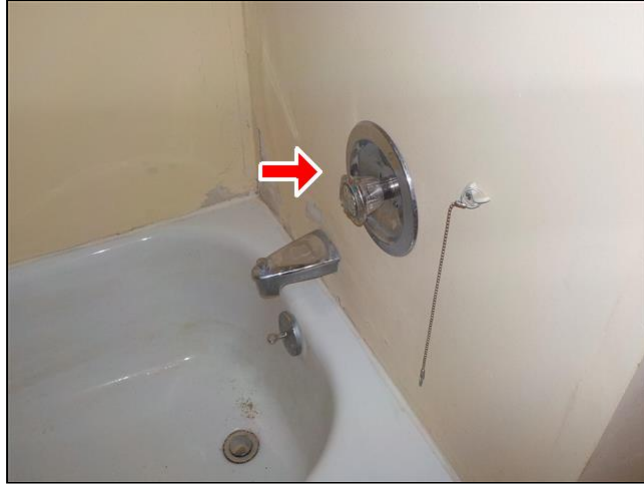
A. (2) The tub fixture in the basement bathroom was inoperable at the time of the inspection. We recommend plumbing repairs as required.

A. Item 1(Picture) Inoperable fixture

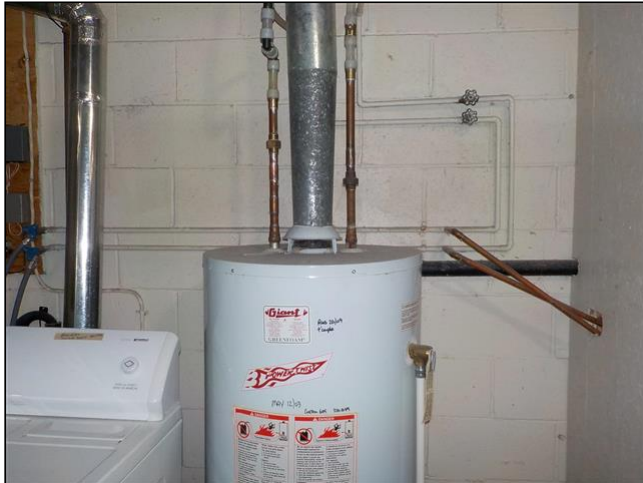
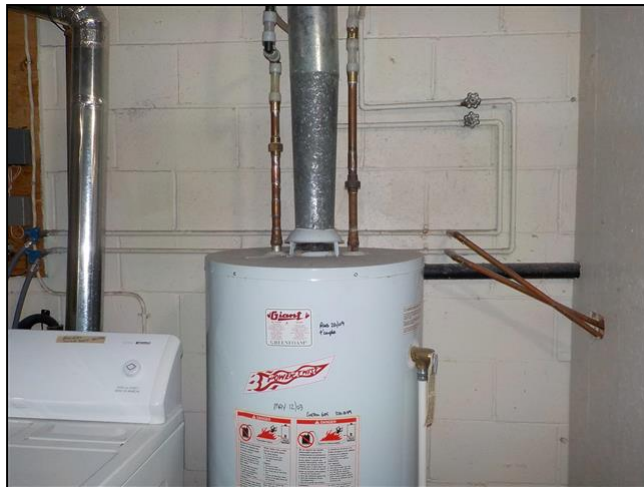
C. The water heater was manufactured in 2002. We recommend budgeting for replacement due to its age. Upgrading to a power vented water heater is recommended.

C. Item 1(Picture) Water heater

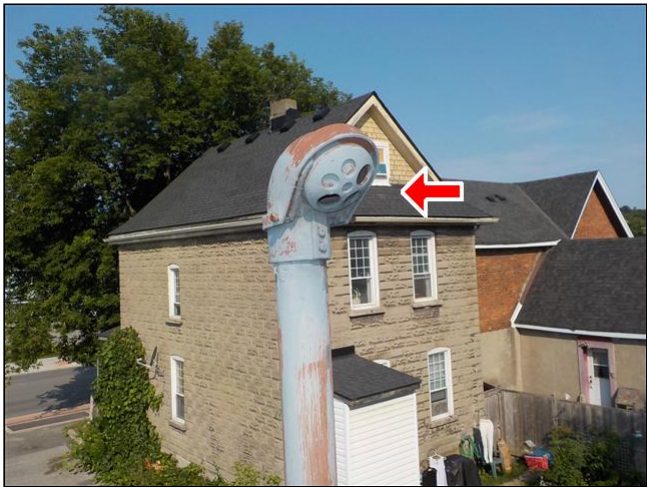
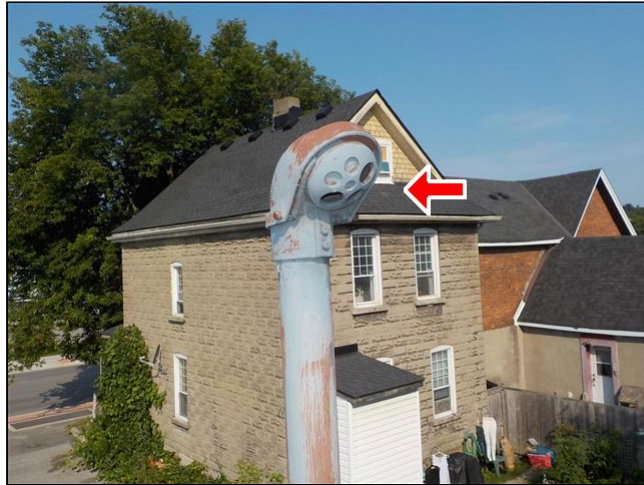
F. (2) An obsolete overhead service mast was present. We recommend removal and capping as required.

F. Item 3(Picture) Obsolete service mast

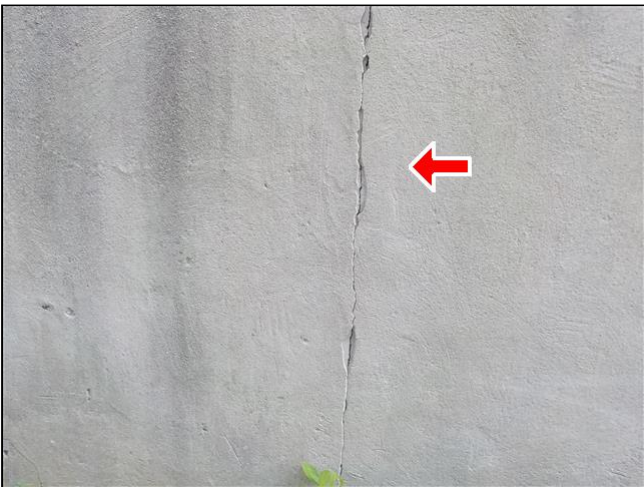
A. The building is constructed on a block foundation. The rear extension is a poured concrete foundation. A vertical crack(s) was observed in the foundation wall at the right side (facing front). No repairs are needed or foreseen at this time. Should the drainage or landscape change, erosion may occur causing further settlement. I recommend you monitor periodically. No active leaks were visible or detected at the time of the inspection.

A. Item 1(Picture) Vertical crack

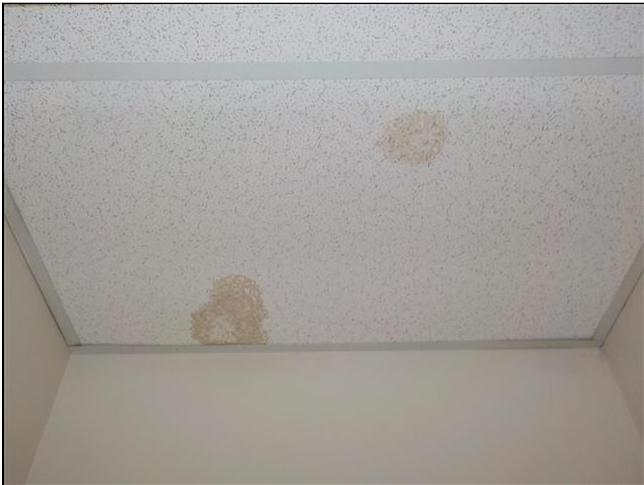
A. The main floor rooms consist of vinyl and tile flooring with drywall and panelled walls and drywall and suspended tile ceilings. The interiors were in overall good condition. Stains from previous roof seepage were noted on the ceiling tiles below the older rooftop package unit. No active leaks were noted at the time of the inspection. The basement rooms were partially finished. Unfinished floors and ceilings were present.

A. Item 1(Picture) Staining from previous seepage

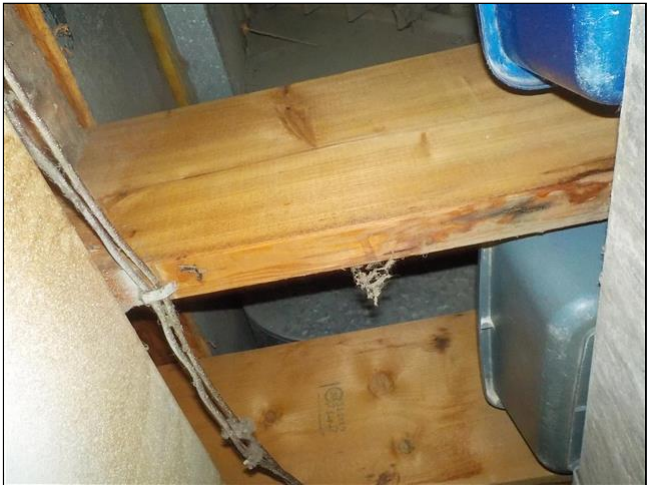
A. Item 2(Picture) Previous seepage below rooftop unit
