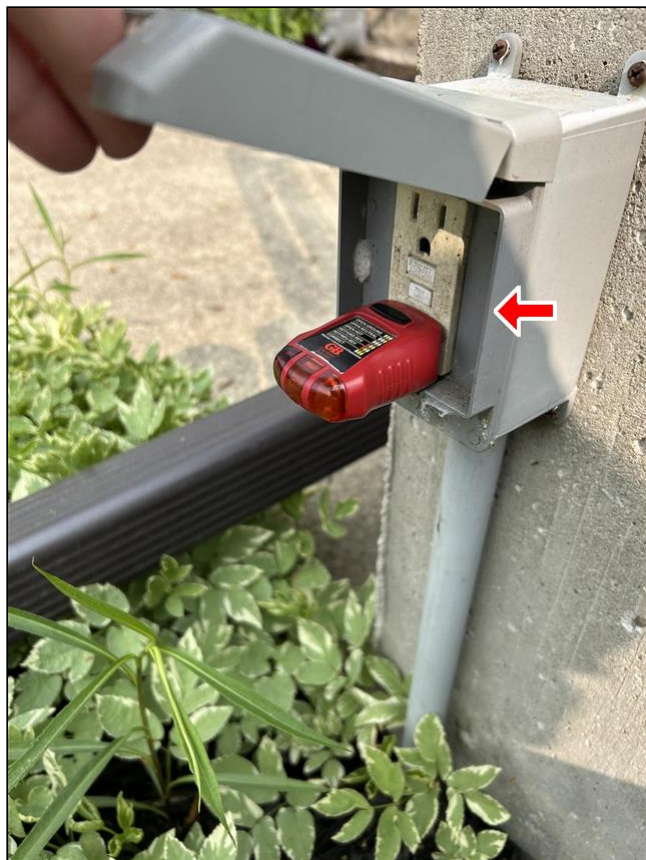
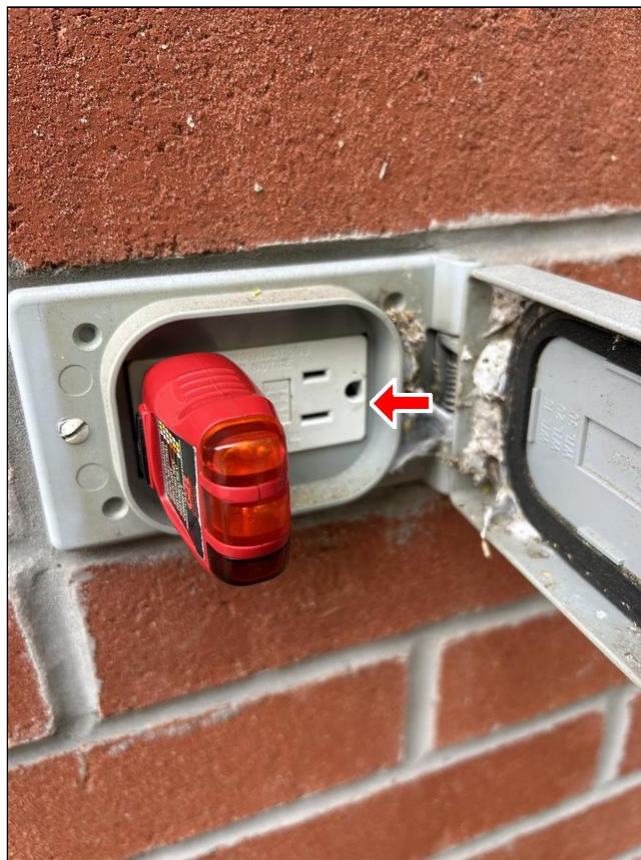
(2) GFCI located at the front porch of the home and the balcony did not respond to test; suggest review by licensed electrician for repairs/replacement as needed for safety.

1.7 Item 1(Picture) inoperable GFCI

1.7 Item 2(Picture) defective GFCI

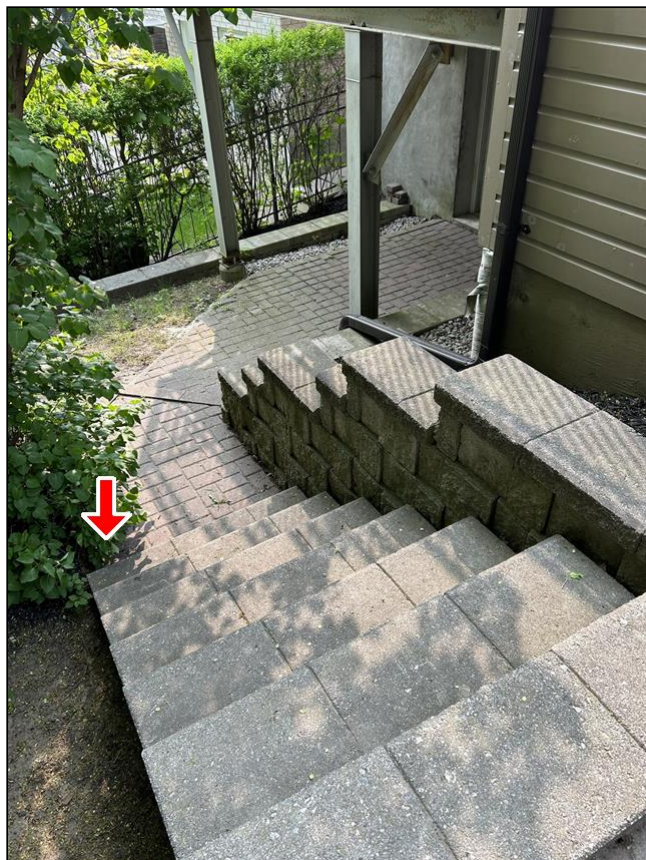
No hand railings noted on steps at rear of home, recommend installing hand rail for safety. When ever four or more risers are present a handrail is usually required.

1.11 Item 1(Picture) missing railing

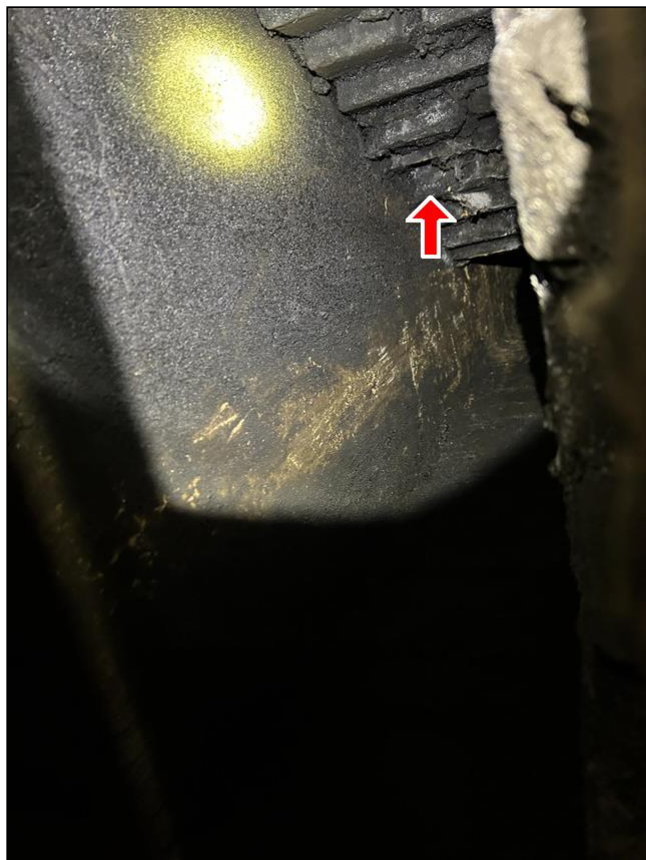
The chimney has an unlined flue for the wood burning fireplace. While this may have been acceptable at the time of construction, flue liners are a fire safety feature which the client should consider installing to enhance safety. Regular cleaning of the chimney is recommended to ensure safe and efficient operation.

3.1 Item 1(Picture) flue conditions

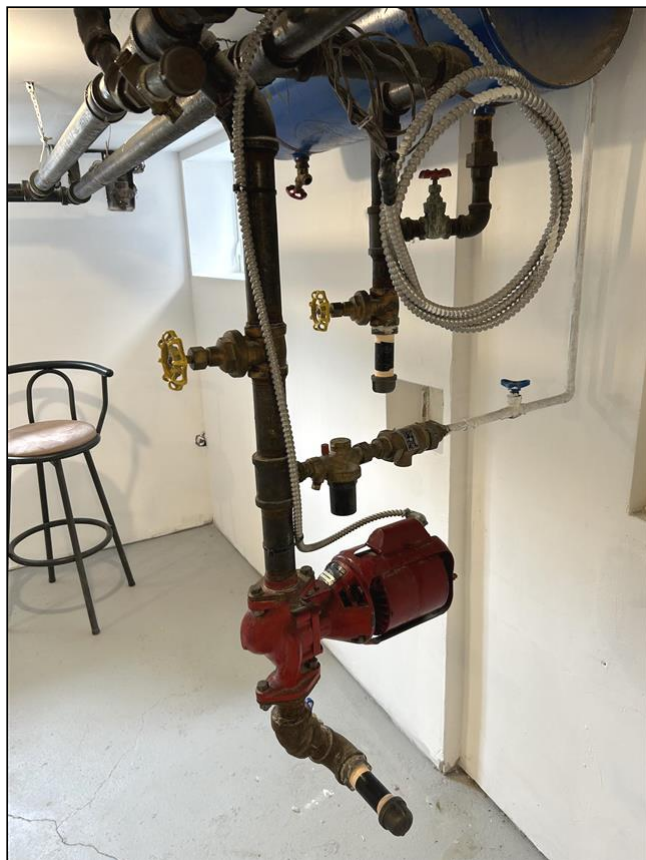
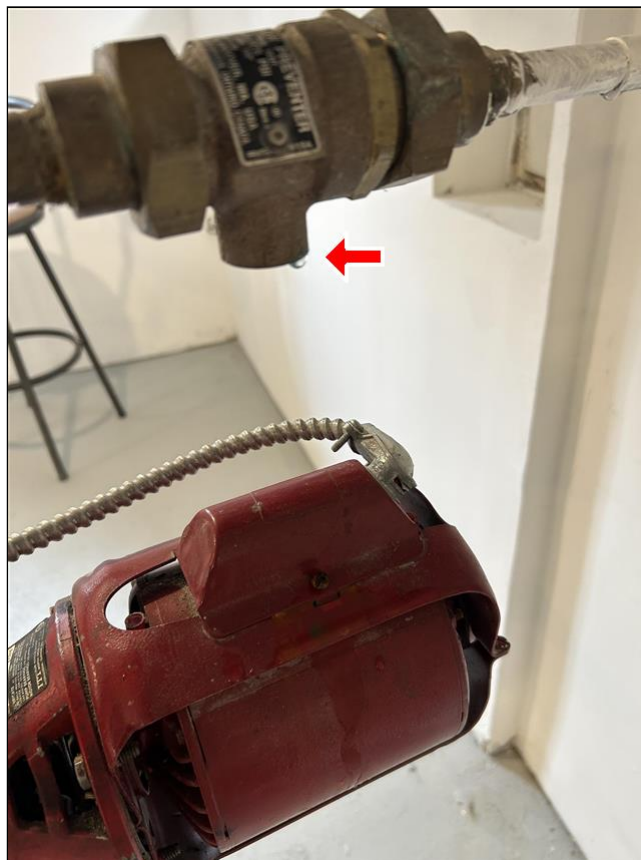
(2) Obsolete circulating radiator system present. A leak was noted from the backflow preventer. We recommend plumbing repairs be completed. Full removal of the piping system and radiators may be considered.

7.5 Item 2(Picture) obsolete boiler system

7.5 Item 3(Picture) leaking valve

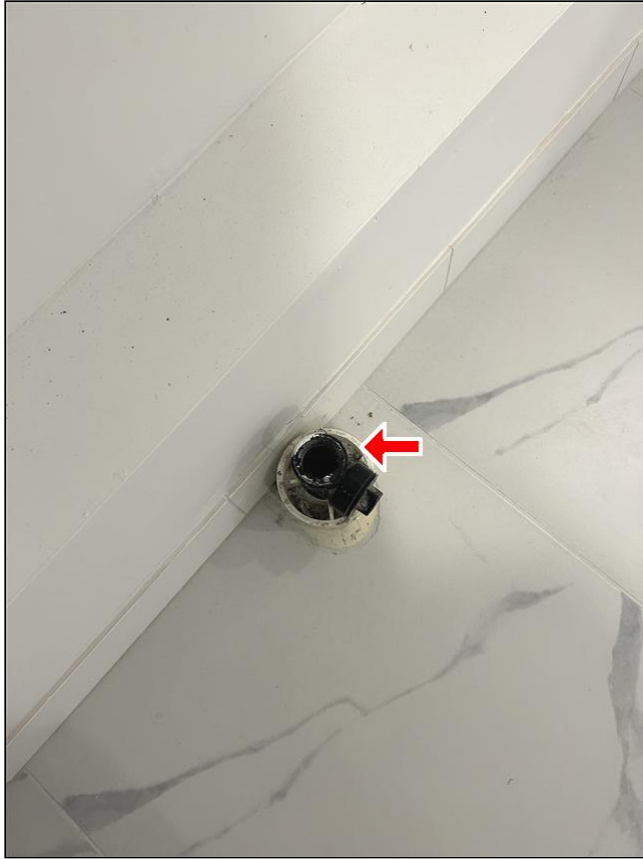
Laundry tub removed. We recommend the drain pipe be capped to prevent the entry of sewer gasses.

12.4 Item 1(Picture) open drain

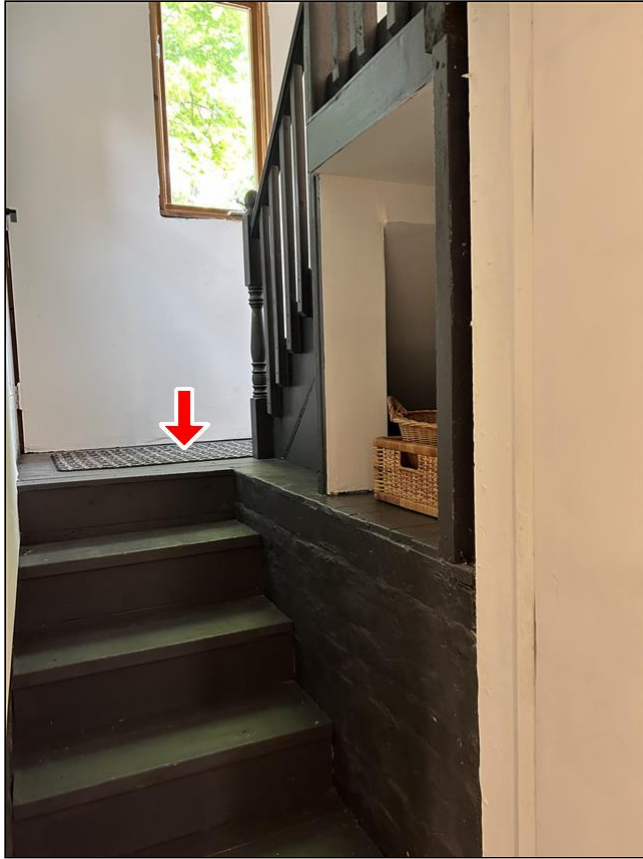
No railings noted on the rear basement stairs, recommend installing handrails for safety.

13.9 Item 1(Picture) missing railing

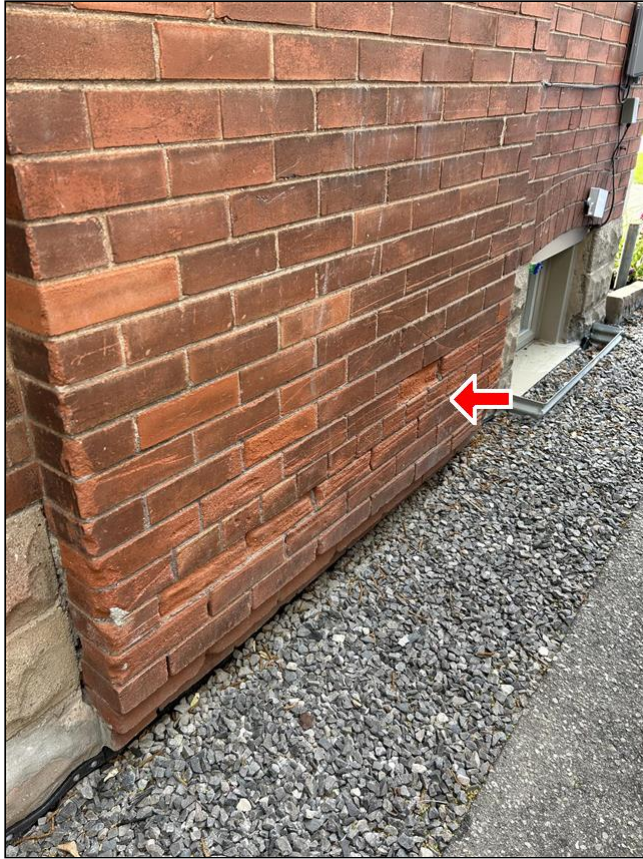
Spalling brick observed at the left side. Recommend review for repair or replacement as necessary.

1.2 Item 1(Picture) spalling brick

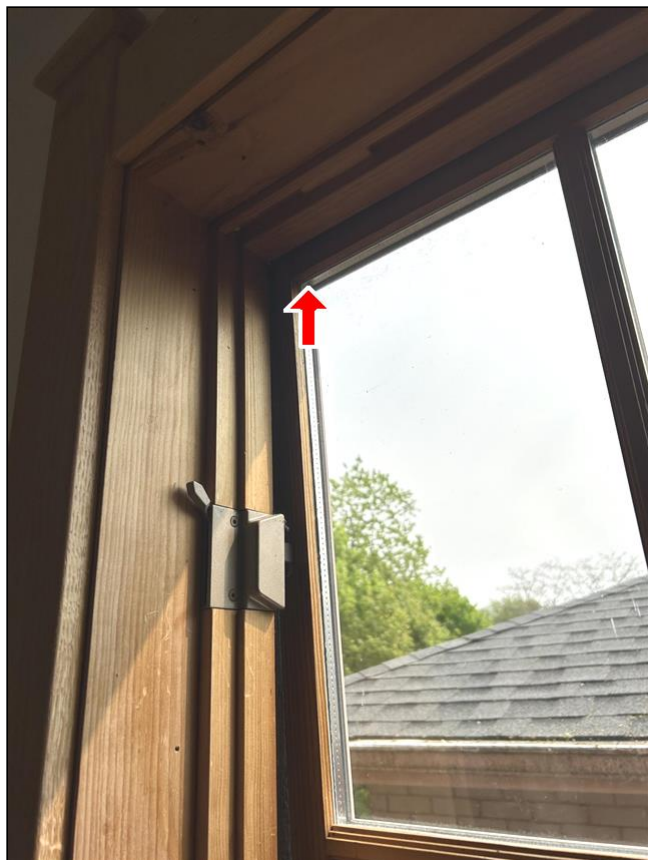
The window in the main floor family room does not open without restriction in the family room. Recommend adjustments to ensure proper operation.

13.5 Item 1(Picture) binding window

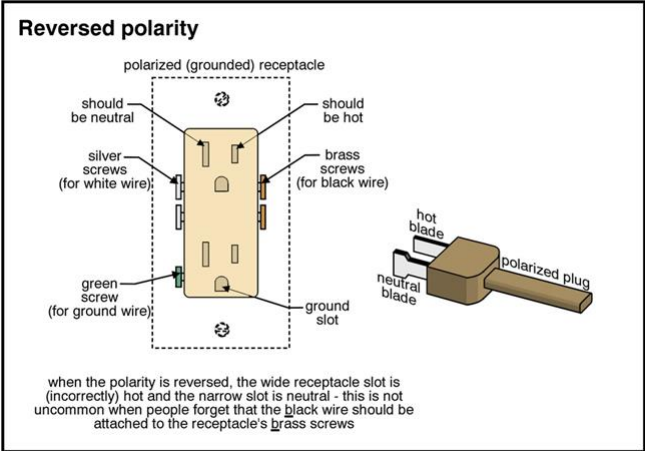
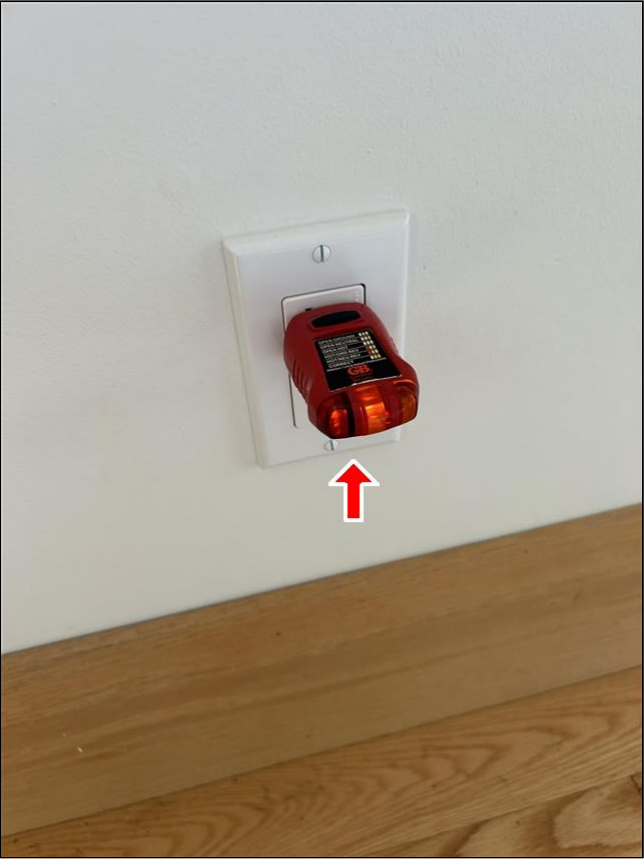
Reversed polarity receptacle detected in the family room. Reversed polarity, hot and neutral wires reversed, is usually easily corrected by minor wiring adjustments at the affected outlet(s). When this condition is observed, a qualified electrical contractor is needed for repairs/corrections.

13.7 Item 1(Picture) reversed polarity

13.7 Item 2(Picture) reverse polarity

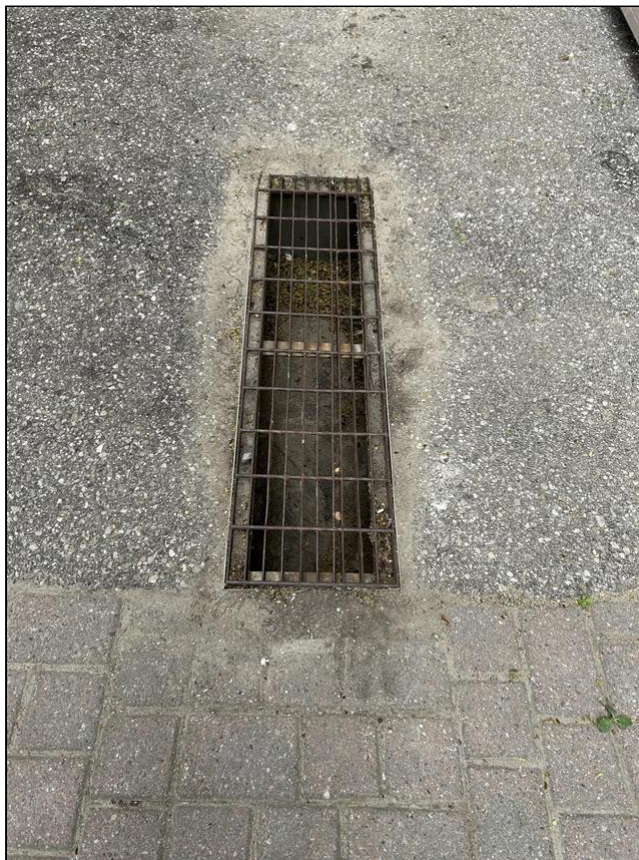
1.0 (2) Surface drains were noted. It is beyond the scope of our visual inspection to verify drainage systems. If such a review is desired, we recommend consulting a specialist.

1.0 Item 1(Picture) surface drain

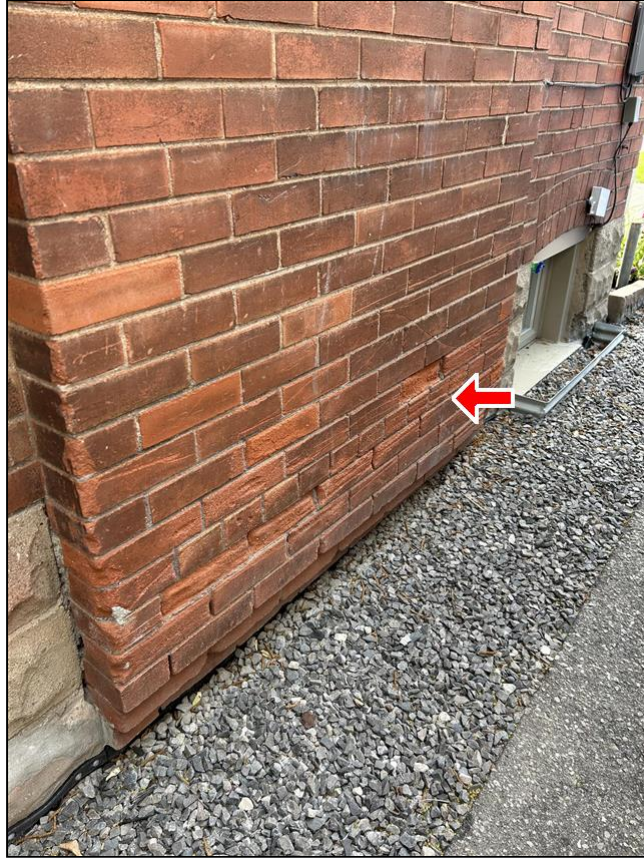
1.2 Spalling brick observed at the left side. Recommend review for repair or replacement as necessary.

1.2 Item 1(Picture) spalling brick

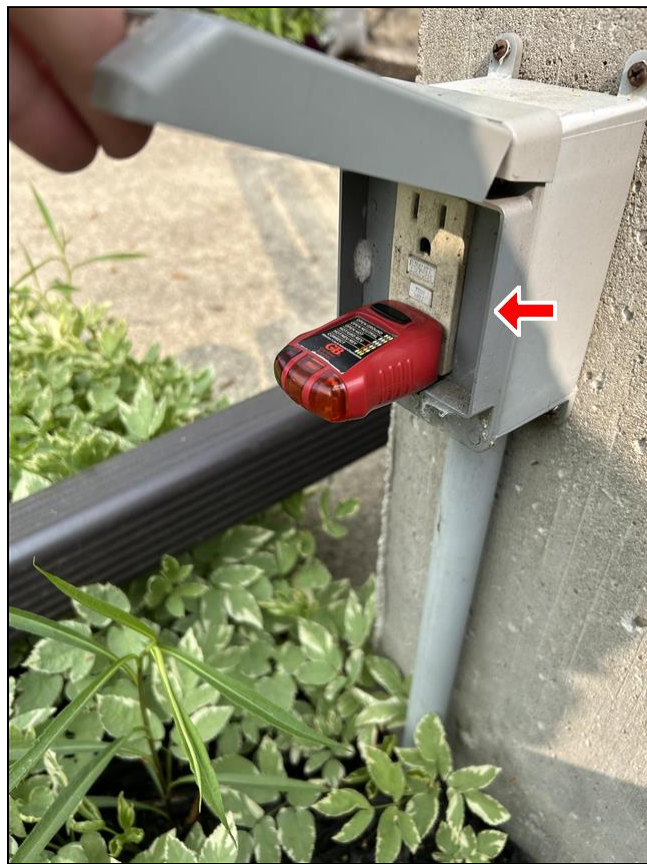
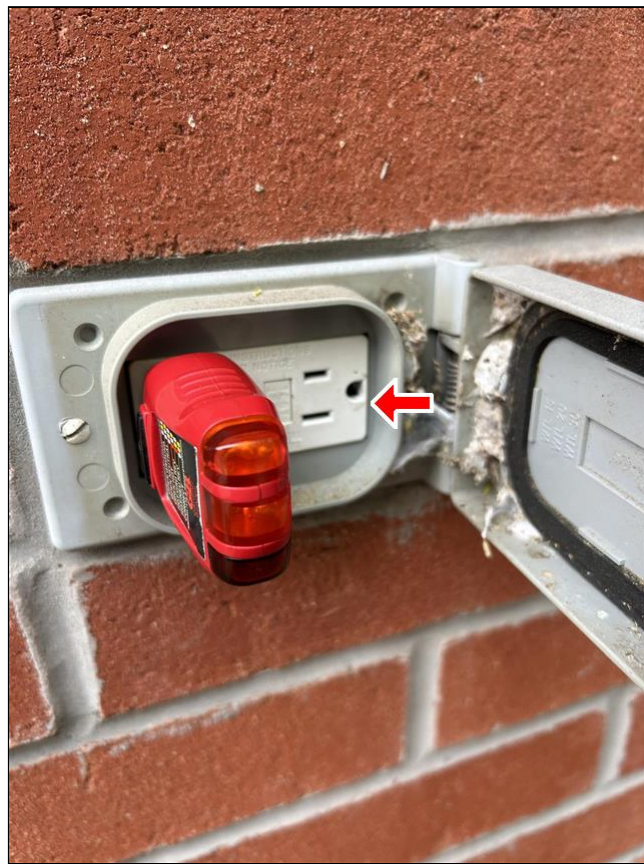
1.7 (2) GFCI located at the front porch of the home and the balcony did not respond to test; suggest review by licensed electrician for repairs/replacement as needed for safety.

1.7 Item 1(Picture) inoperable GFCI

1.7 Item 2(Picture) defective GFCI

6.3 GFCI located at the front porch of the home and the balcony did not respond to test; suggest review by licensed electrician for repairs/replacement as needed for safety.

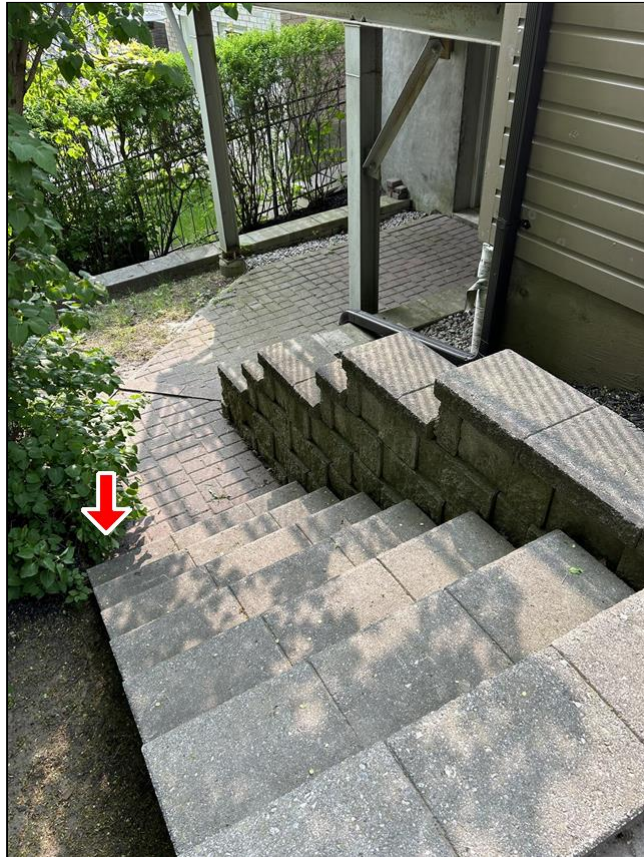
1.11 No hand railings noted on steps at rear of home, recommend installing hand rail for safety. When ever four or more risers are present a handrail is usually required.

1.11 Item 1(Picture) missing railing

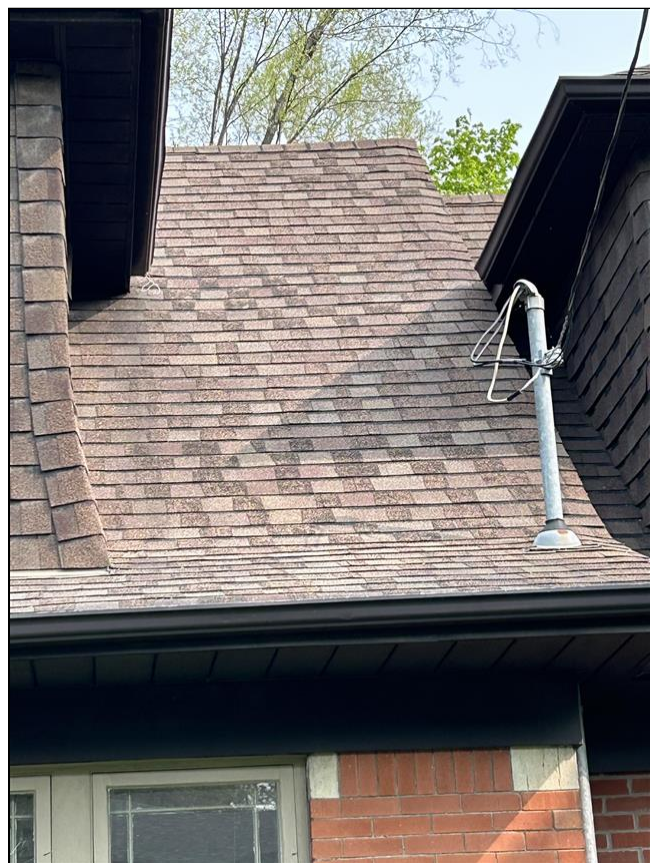
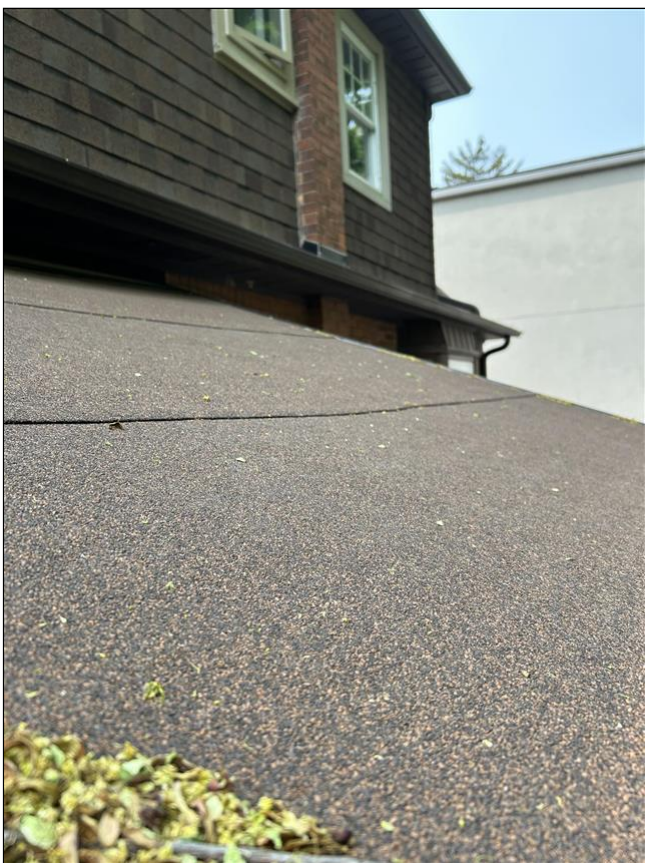
2.0 The roof was inspected from the ground only due to the roof height and pitch. Our roofing review is limited to visible accessible components as viewed from these areas. Roof shows normal wear for its age and type. No damaged, deteriorated, or missing roofing materials were observed; it appears to be in serviceable condition at time of inspection.

2.0 Item 1(Picture) roof conditions

2.0 Item 2(Picture) rear porch roof

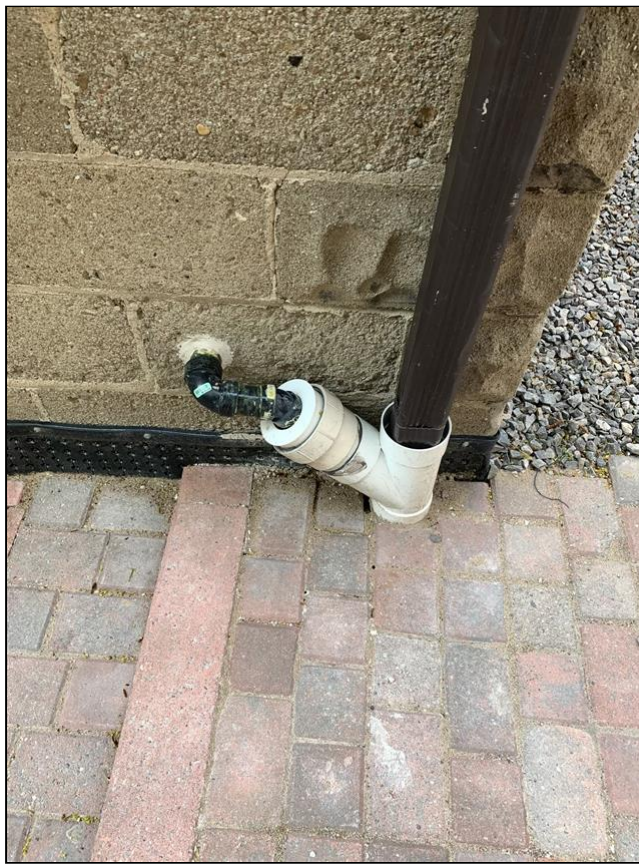
2.2 Downspouts exit into an underground drainage system. Underground drainage systems are not within the scope of this inspection and a functional water flow test is not performed. Drains to underground drain piping which was not tested.

2.2 Item 1(Picture) underground drains

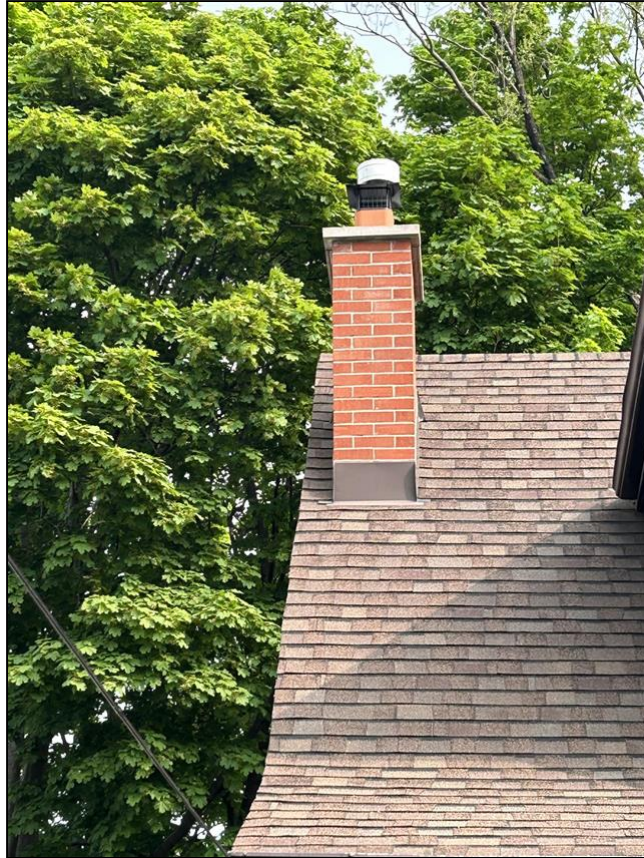
3.0 (1) Flue, crown, and flashing inspected from the ground only due to roof not being mounted. Our chimney inspection is limited to visible accessible components only.

3.0 Item 1(Picture) chimney conditions

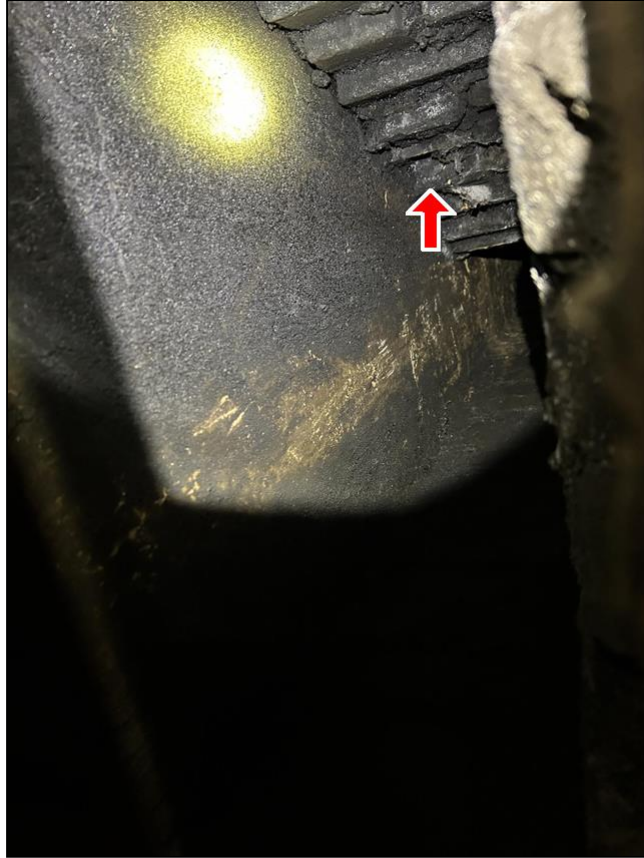
3.1 The chimney has an unlined flue for the wood burning fireplace. While this may have been acceptable at the time of construction, flue liners are a fire safety feature which the client should consider installing to enhance safety. Regular cleaning of the chimney is recommended to ensure safe and efficient operation.

3.1 Item 1(Picture) flue conditions

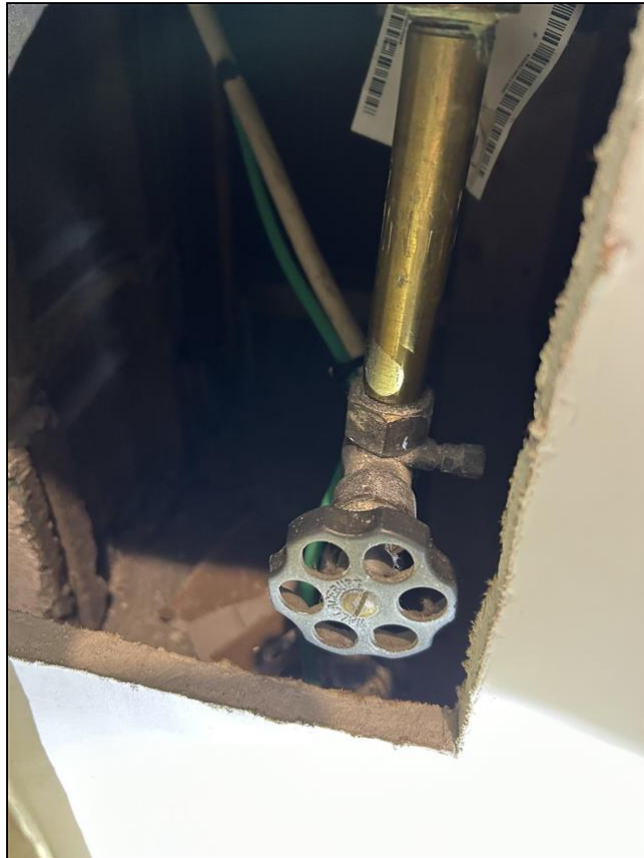
5.0 Gate-type valve observed. Since main shut-off valves are operated infrequently, it is not unusual for them to become frozen over time. They often leak or break when operated after a period of inactivity. For this reason main shut-off valves are not tested during a home inspection. We suggest caution when operating shut-offs that have not been turned for a long period of time. We recommend that the client consider upgrading the shut-off valve to a high quality ball-type valve which tend to be more reliable than gate valves.

5.0 Item 1(Picture) main shut off

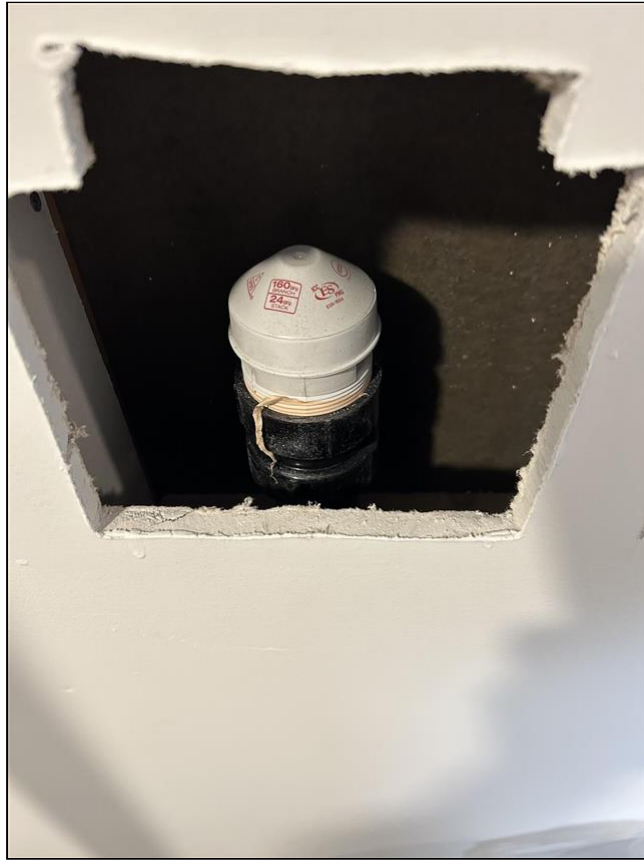
5.1 (2) Air admittance valve(s) were noted in the basement and kitchen. These one-way devices prevent sewer gases from escaping into the home. Because air admittance valves and automatic air vents do not allow air to be pushed out through the vent, they don't perform all of the functions of a venting system.

5.1 Item 1(Picture) air admittance valve

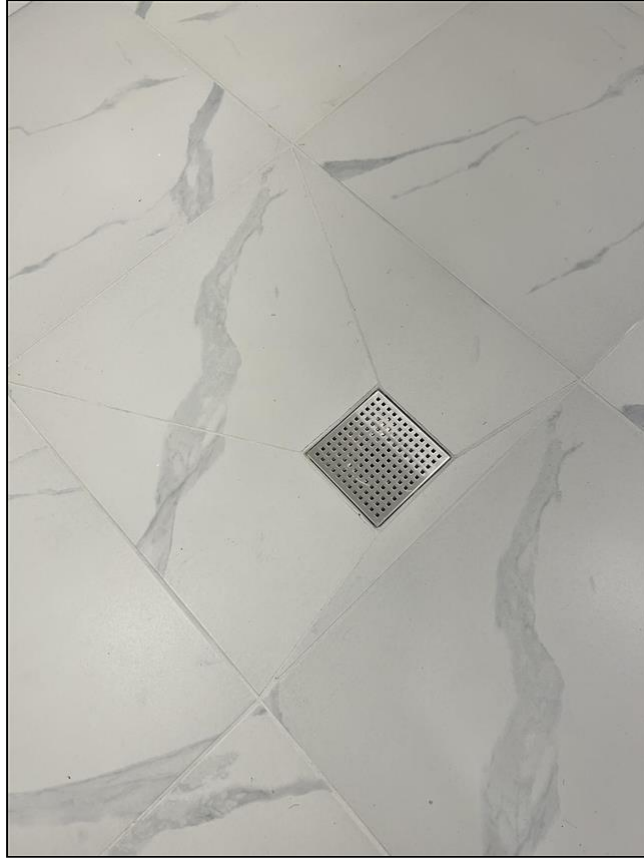
5.3 Floor drain noted. We recommend ensuring that the floor drain is accessible and clear of debris or blockages.

5.3 Item 1(Picture) floor drain

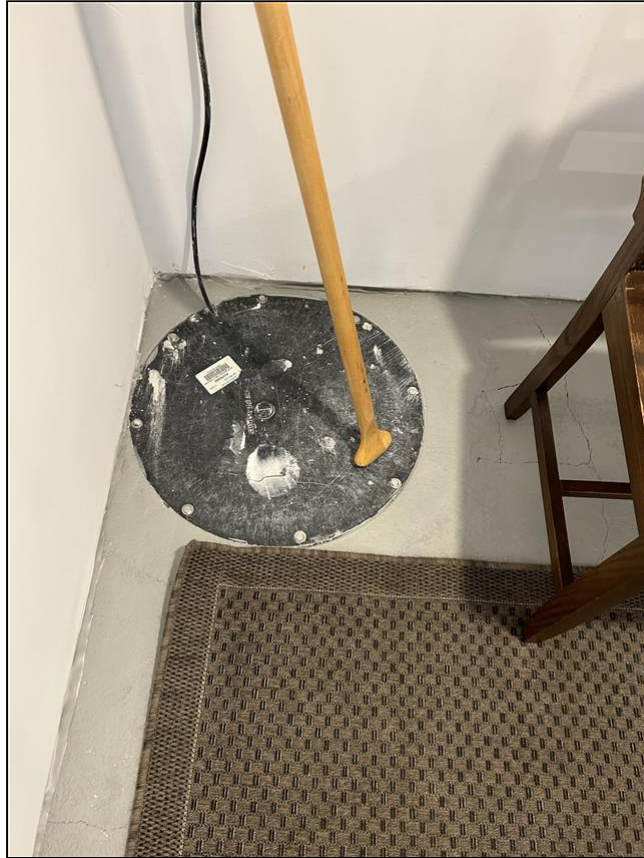
5.4 (1) Sealed pit lid noted. Unable to test sump pump. The sump pump was installed with the exterior waterproofing.

5.4 Item 1(Picture) sump

5.4 (2) Sump pumps should be tested on a regular basis. Installation of a backup pump and power supply is recommended.

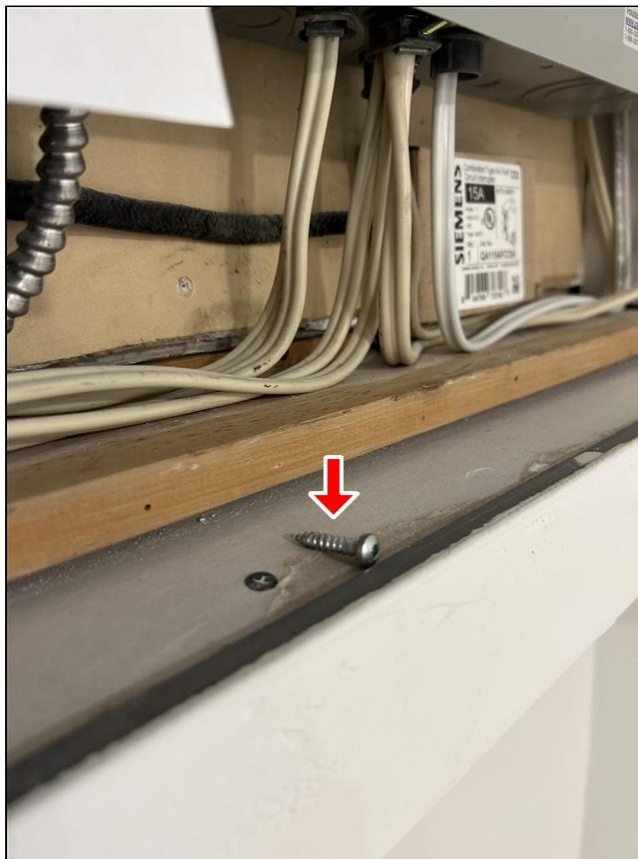
6.2 (3) Pointed sheet metal screws have been used to secure the dead front cover to the front of the main panel. Blunt screws should be used to prevent the wire insulation from being cut by the screws.

6.2 Item 2(Picture) panel screw

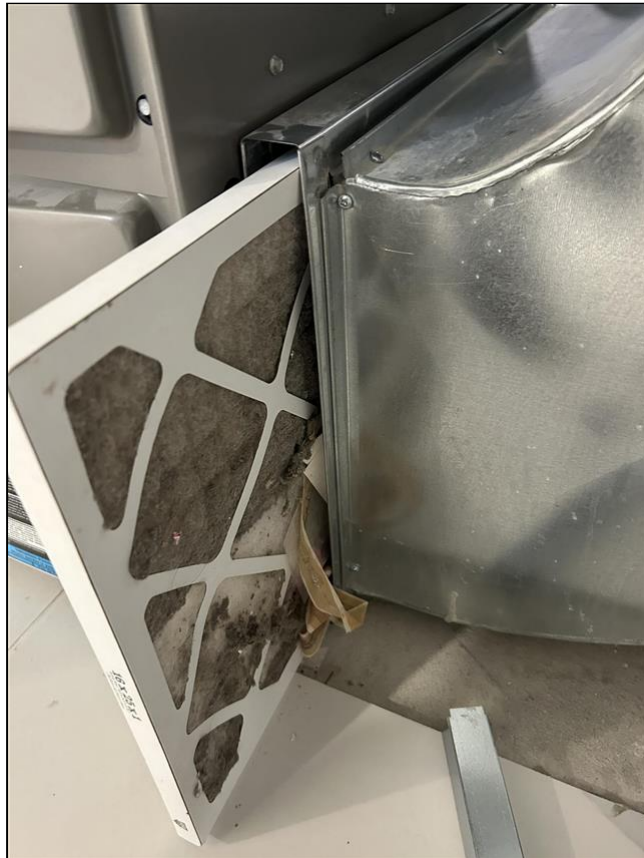
7.4 Filter is dirty; recommend replacement for proper operation of the system. Recommend servicing/cleaning filters on a regular basis to ensure proper operation and air flow.

7.4 Item 1(Picture) filter condition

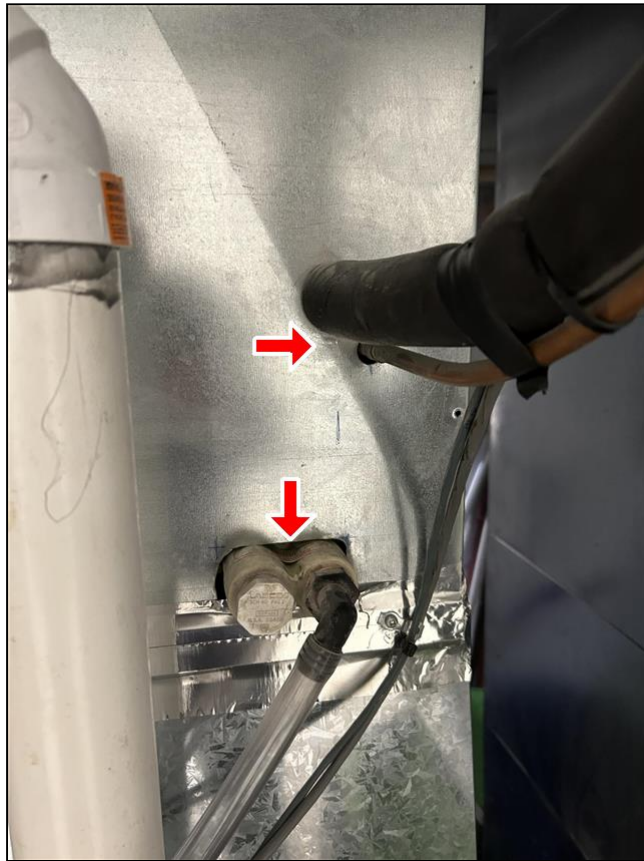
7.5 (1) Openings noted around the air conditioning lines entering the furnace plenum. We recommend sealing to prevent air leakage.

7.5 Item 1(Picture) openings

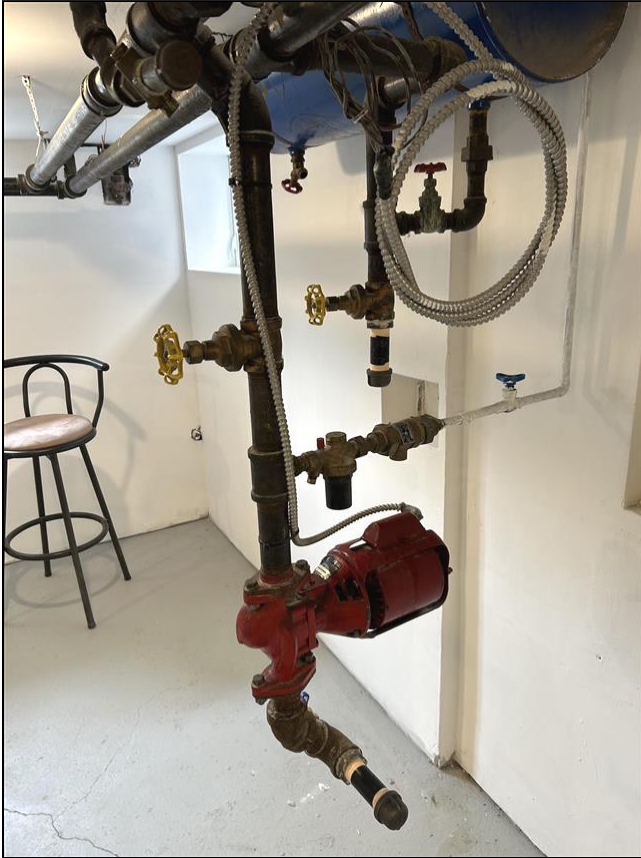
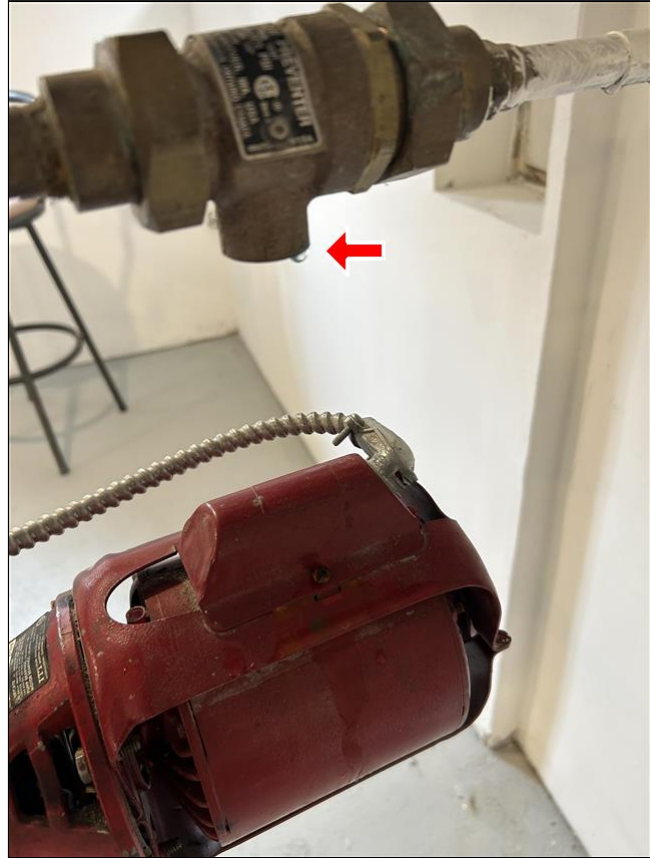
7.5 (2) Obsolete circulating radiator system present. A leak was noted from the backflow preventer. We recommend plumbing repairs be completed. Full removal of the piping system and radiators may be considered.

7.5 Item 2(Picture) obsolete boiler system

7.5 Item 3(Picture) leaking valve

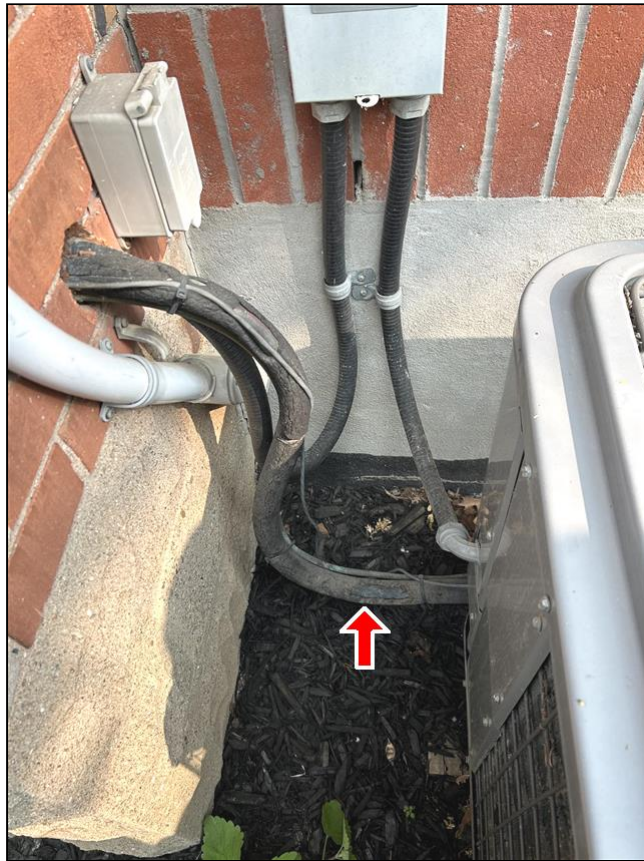
8.0 (2) Refrigerant suction line insulation is deteriorated; recommend replacing insulation for improved performance.

8.0 Item 2(Picture) deteriorated insulation

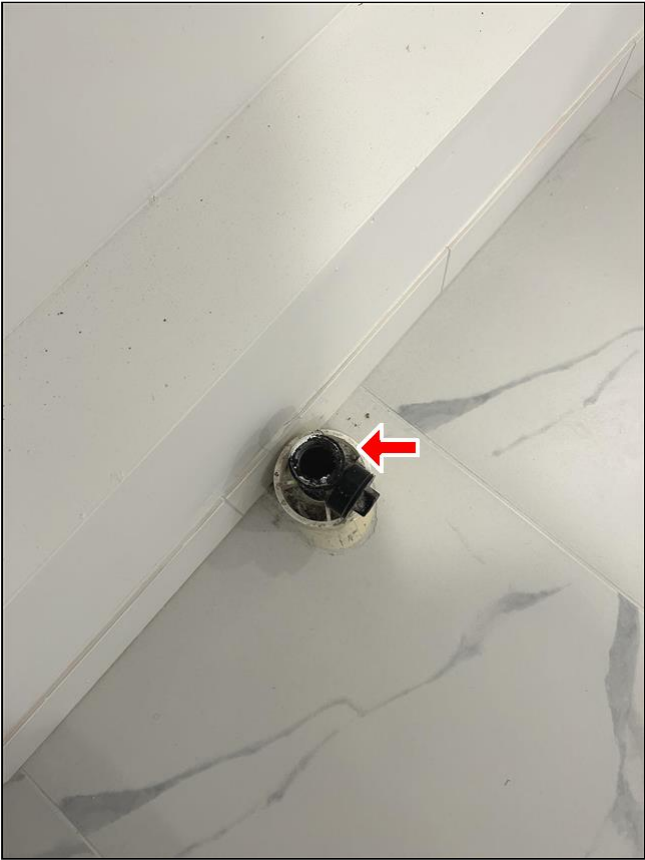
12.4 Laundry tub removed. We recommend the drain pipe be capped to prevent the entry of sewer gasses.

12.4 Item 1(Picture) open drain

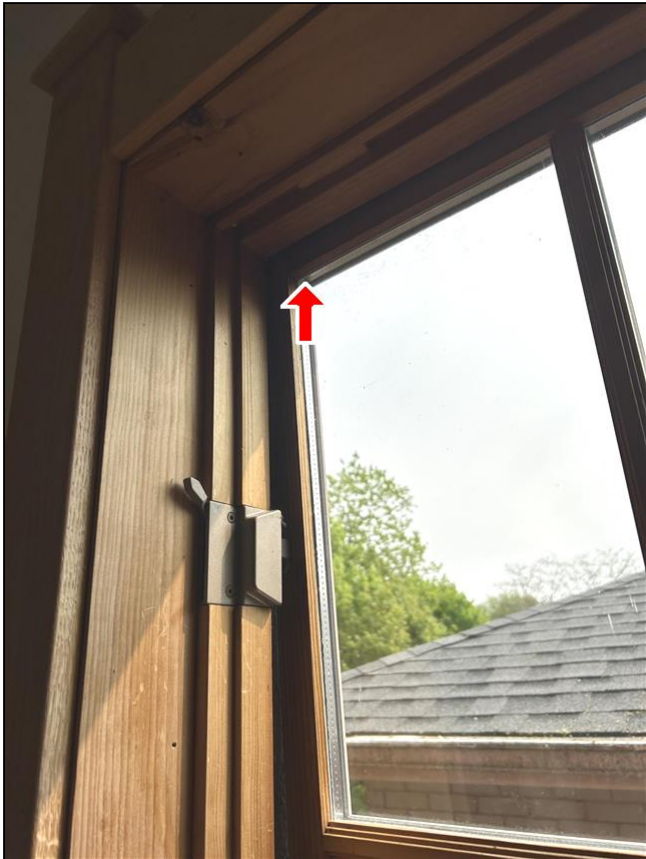
13.5 The window in the main floor family room does not open without restriction in the family room. Recommend adjustments to ensure proper operation.

13.5 Item 1(Picture) binding window

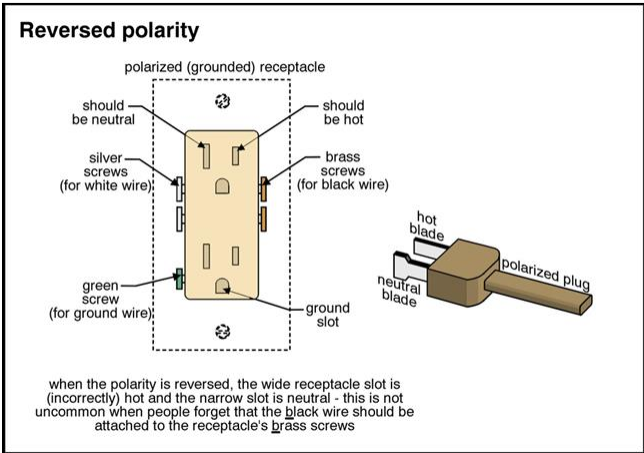
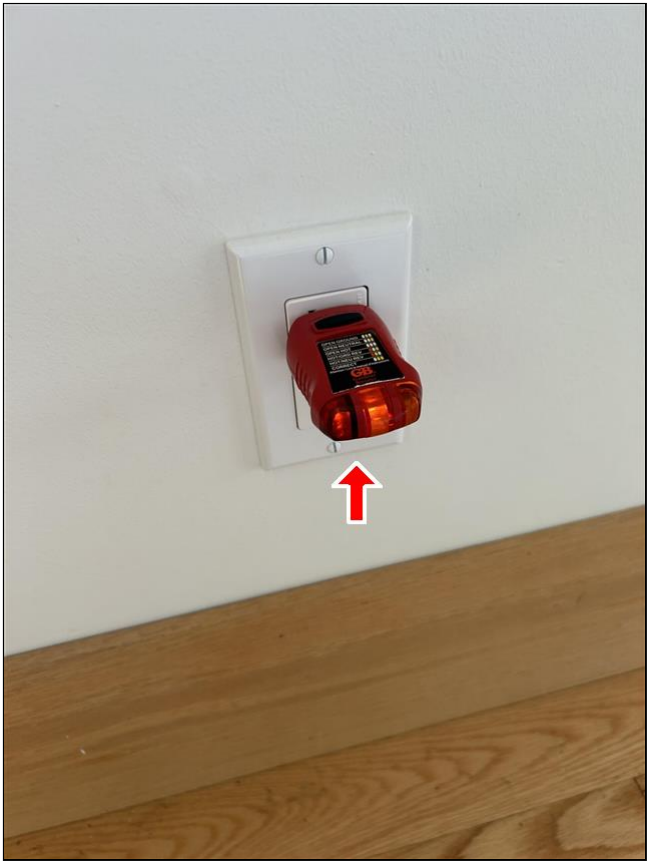
13.7 Reversed polarity receptacle detected in the family room. Reversed polarity, hot and neutral wires reversed, is usually easily corrected by minor wiring adjustments at the affected outlet(s). When this condition is observed, a qualified electrical contractor is needed for repairs/corrections.

13.7 Item 1(Picture) reversed polarity

13.7 Item 2(Picture) reverse polarity

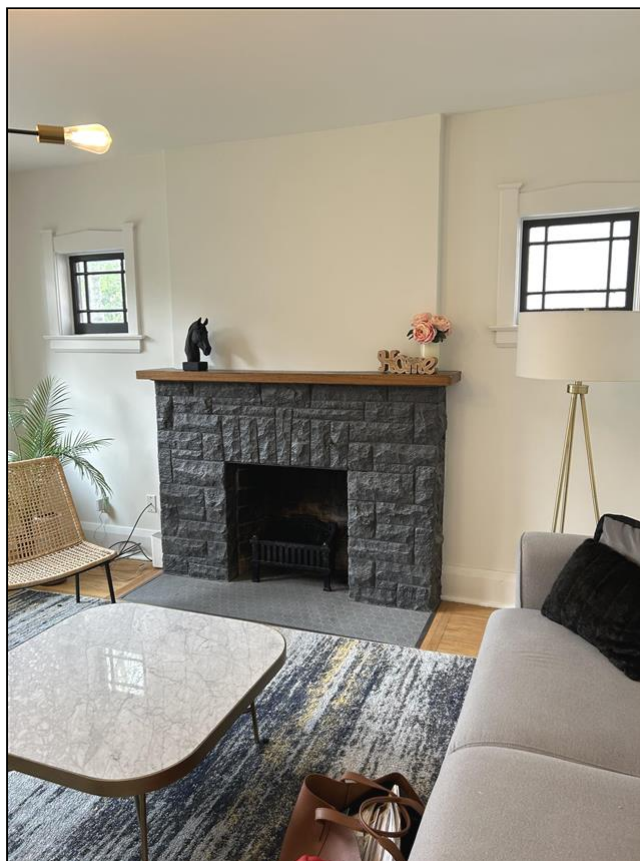
13.8 The wood burning fireplace is not to current standards. Please refer to the Chimney section for additional information.

13.8 Item 1(Picture) wood burning fireplace

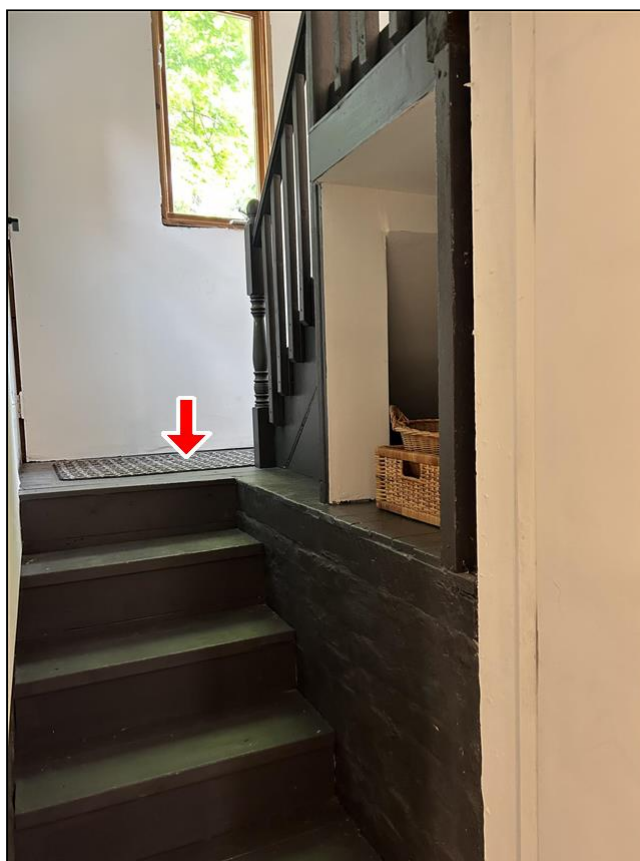
13.9 No railings noted on the rear basement stairs, recommend installing handrails for safety.

13.9 Item 1(Picture) missing railing
