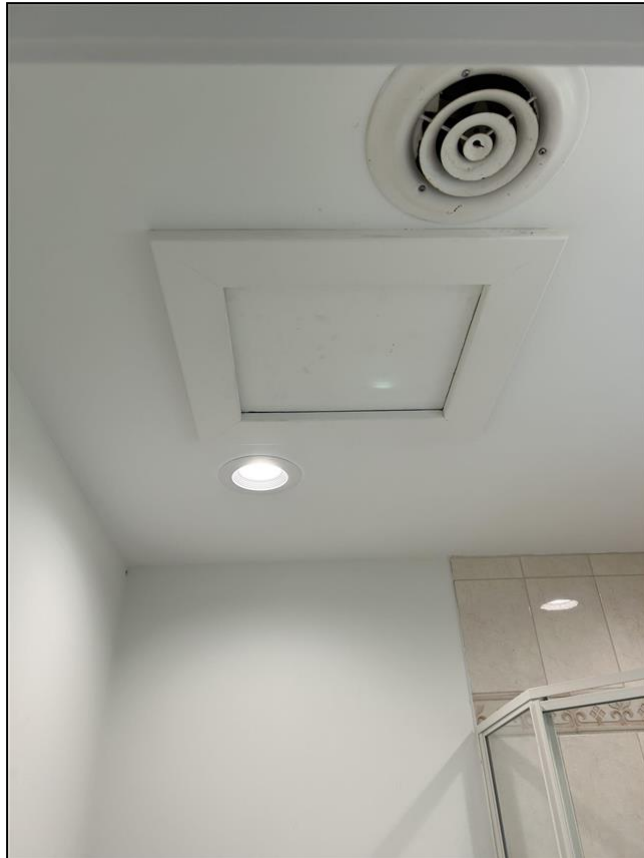
14.0 (1) We recommend insulating and weather-stripping the attic hatch to reduce heat loss and air leakage.

14.0 Item 1(Picture) main attic access

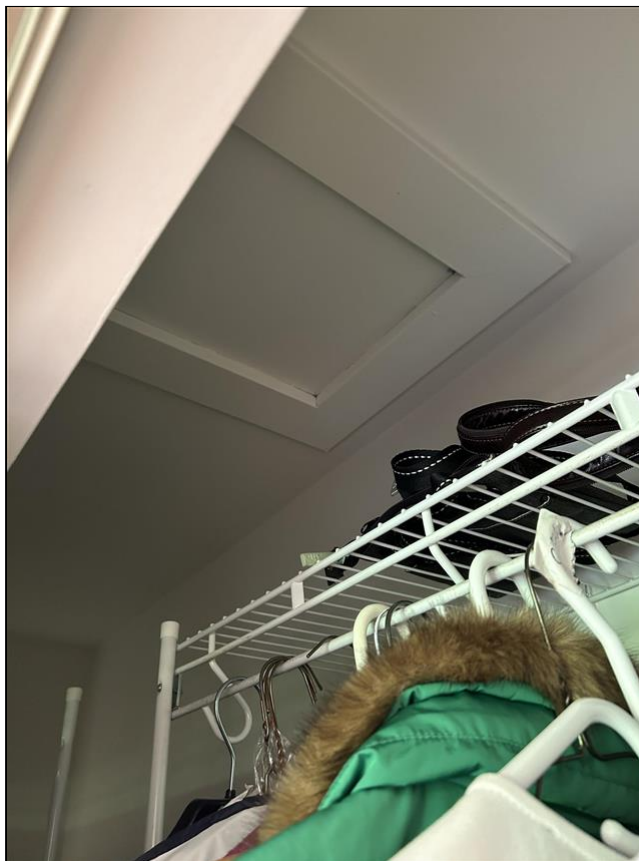
14.0 (3) Access to the addition attic was blocked. We were unable to view the Attic to note possible evidence of leaking, the amount and type of insulation, the condition of the components, etc. We recommend arranging access and fully inspecting this area, making any repairs necessary to assure safety and serviceability.

14.0 Item 2(Picture) closet access hatch
