Inspection Report

Property Address:
123 Main Street
Anytown ON ABC 123

Amerispec Waterloo Region/Guelph/Brampton and Orangeville

Date: 2018-05-04	Time: 08:20 AM	Report ID: 123456789
Property: 123 Main Street Anytown ON ABC 123	Customer: John Smith	Real Estate Professional:

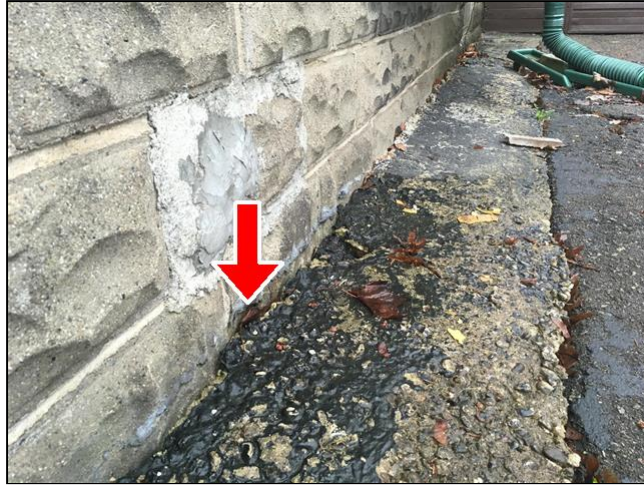
1.0 Item 1(Picture)

1.0 (1) We recommend that the client seals/caulks the opening between the foundation and the driveway with an elastic sealant and seal the driveway in accordance to manufacturer's directions for further protection.

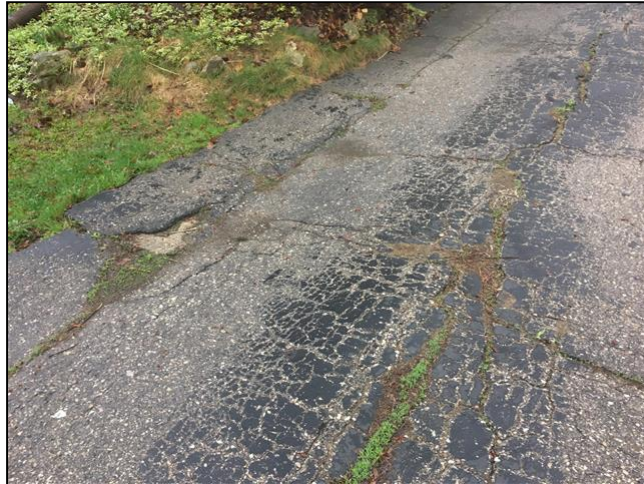
1.0 Item 2(Picture)

1.0 (2) Cracking and surface deterioration observed, recommend regular maintenance and repairs to prolong the useful life of the surface.

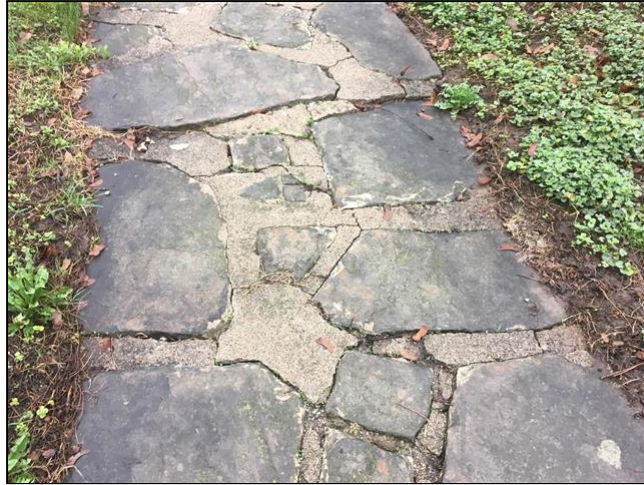
1.1 Item 1(Picture)

1.1 As a result of uneven settlement, heaving or cracking, a trip hazard was observed front. We recommend review and repair for safety reasons.

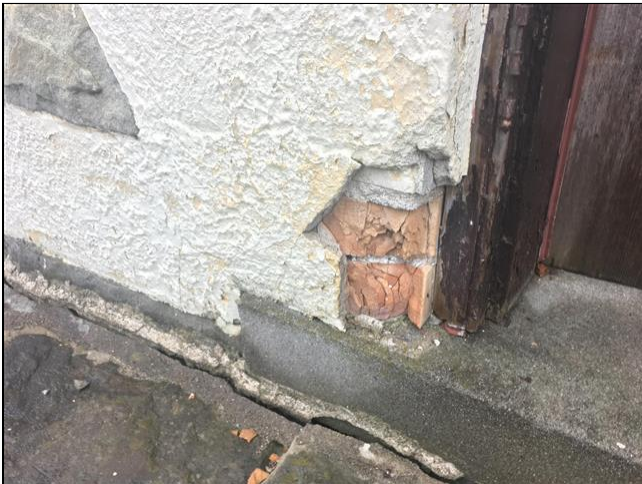
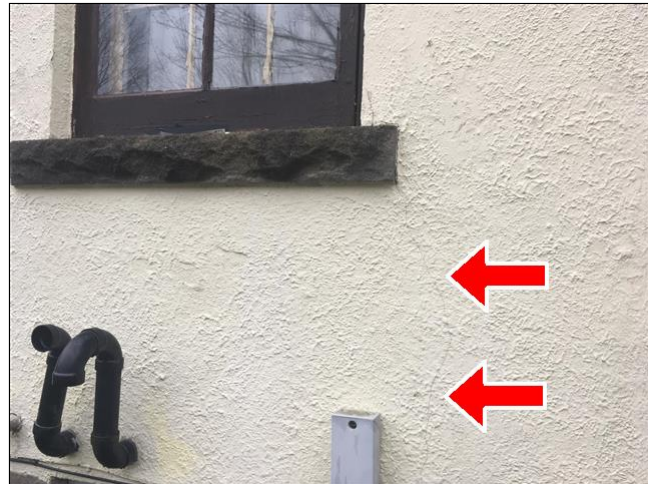
1.2 (1) Cracking observed in wall located at right side. This is an indication that previous settlement has occurred at this location. Inspector is unable to determine when settlement occurred or if additional settlement is likely. Suggest consulting the seller for additional information or a qualified contractor if a more detailed report is desired.

Damage observed to the stucco application at the front of the property, recommend corrections to deter the potential for water related damage to the interior.

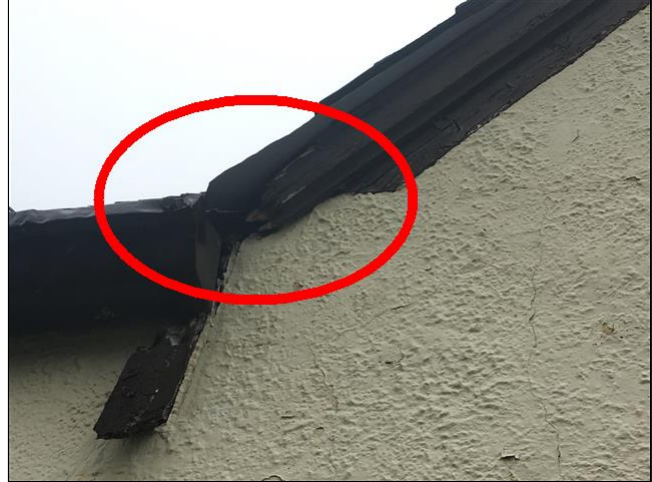
1.2 Item 4(Picture)

1.2 (3) Openings/breaches were noted around the exterior of the home. We recommend sealing any openings to prevent potential moisture damage to exterior/interior walls and pest incursion. Should water seepage into the home occur, it may not always be visible to the inspector (dry conditions, for example), however the Client should be aware that water entry into the home can lead to deterioration of the structure over time, mold growth and other issues. If

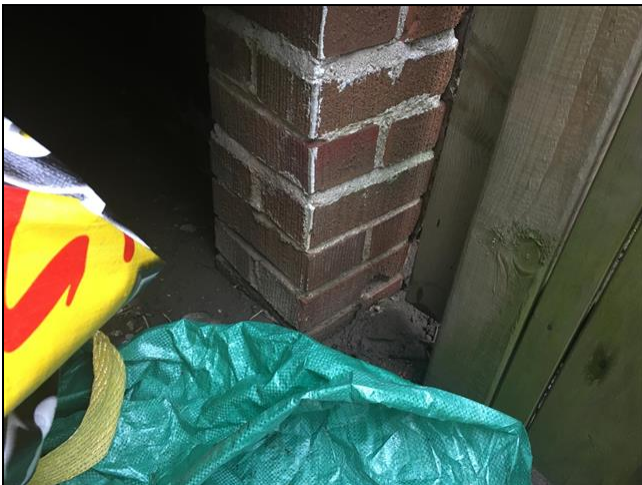
1.2 Item 5(Picture)

1.2 (4) Earth to brick contact observed at the rear. We recommend breaking the contact to prevent moisture damage and pest intrusion.

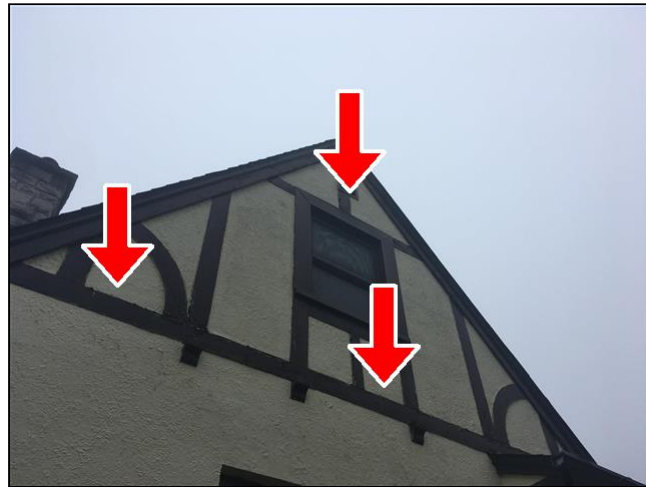
1.2 Item 7(Picture)

1.2 (5) The exterior is covered with a hard coat stucco, or a hybrid of systems. Few installations of these materials meet all of the manufacturers' recommendations, but the system may perform well. Most residential stucco systems must be kept well sealed to prevent moisture penetration and subsequent damage to the underlying wall. The deterioration, which can be caused by water penetration, is most often not apparent to a visual review of the surface. Underlying rot, moisture in construction materials and flashing integrity are therefore outside the scope of our visual review. If such a review is desired, we recommend consulting a siding expert who is trained and equipped for invasive inspection and testing.

Vulnerable areas in regards to moisture related issues were observed at the stucco/wood member intersections.

The wood sections may create ledges enabling water to collect, if moisture is allowed to get in behind the stucco surface it will cause damage quickly.

We recommend monitoring these areas for localized deterioration, and performing regular maintenance, as required.

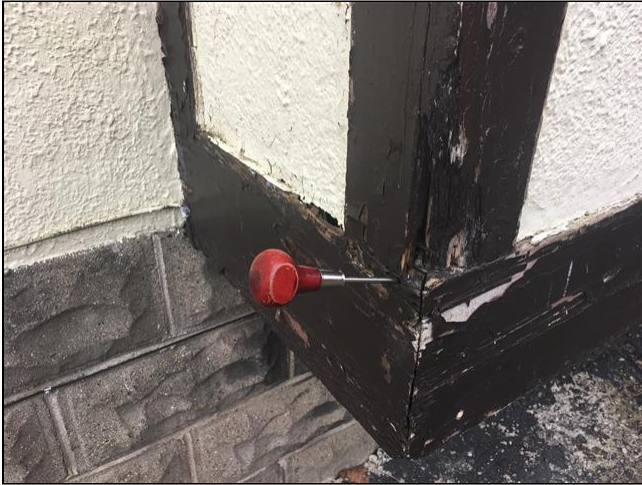
1.3 Item 1(Picture)

1.3 (2) Moisture damaged trim observed at various areas. The extent of damage could not be determined without destructive analysis (maintenance and/or repairs should be performed).

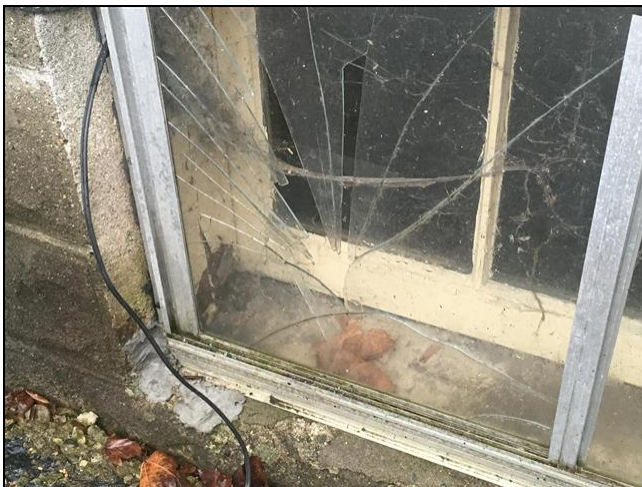
1.4 Item 1(Picture)

1.4 (3) Broken/damaged windows(s) observed at the several locations. Recommend review for repair or replacement as necessary.

Some of the window sills did not appear to have a capillary break on the underside of the sill. Ideally, a groove is cut on the bottom of the sill roughly 1" from the outer edge, and well away from the exterior wall. This detail will prevent water from running along the underside of the sill back to the wall surface. We recommend applying a bead of caulking on the underside of the sill as preventative maintenance to help deter water infiltration behind the sill/siding materials and the resultant concealed damage that may occur.

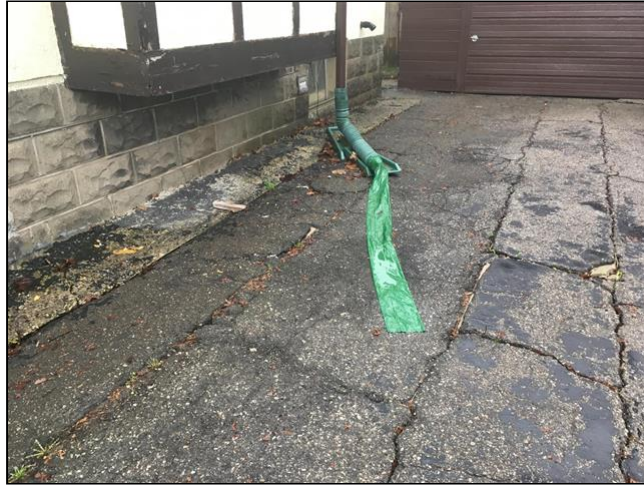
1.6 Item 1(Picture)

1.6 (2) Downspout(s) discharge to the driveway/walkway at right side. Recommend redirecting to prevent icing conditions.

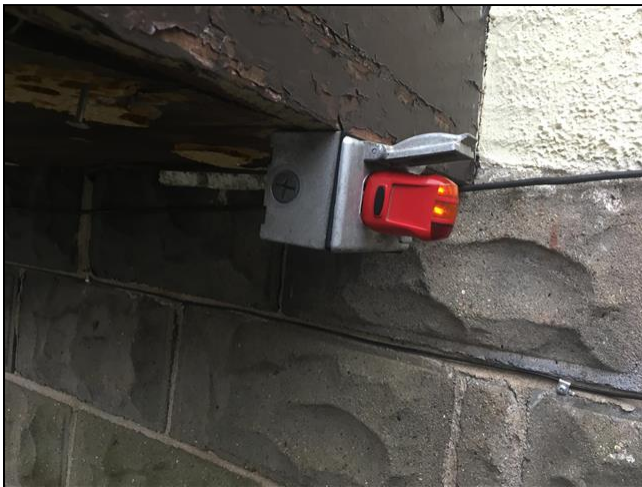
1.8 Item 1(Picture)

Loose conduit observed at the rear of the home, suggest having properly secured to enhance safety,

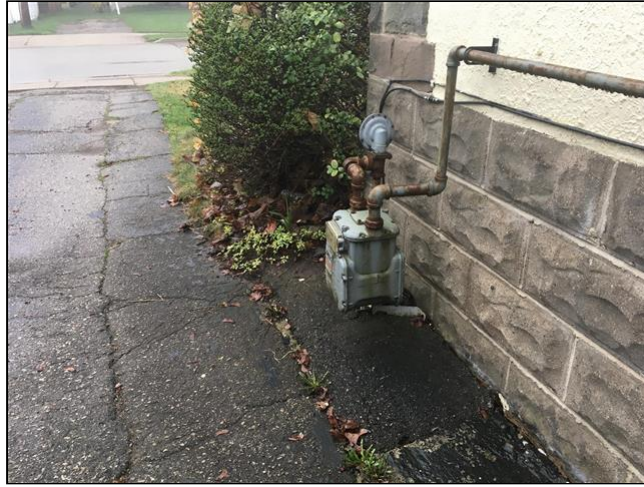
1.10 Item 1(Picture)

1.10 The gas meter is installed in the driveway adjacent to the home and may be susceptible to physical contact damage in its current location. Based on the conditions observed, we recommend consulting with the local utility company responsible for the gas meter to determine options for the installation of protective bollard(s) to enhance safety. In addition, we recommend taking caution in this area with vehicles to reduce the potential for physical contact and to ensure safety.

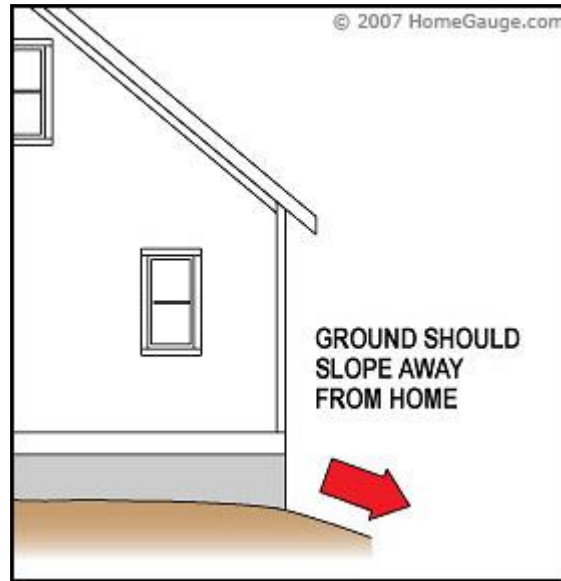
1.14 Item 1(Picture)

1.14 (2) We suggest regrading and maintaining a positive grade away from the foundation walls around the entire house wherever possible to further channel water away from the foundation walls and to reduce the potential for possible water infiltration into the home.

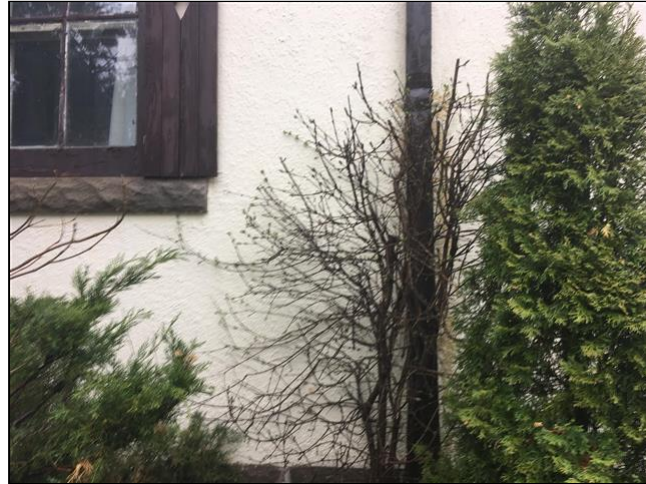
1.15 Item 1(Picture)

1.15 (3) Trees/shrubs present in close proximity to foundation. Removal of tree may be needed in future should damage become apparent. Suggest client monitor foundation/wall/roof to ensure damage free conditions.

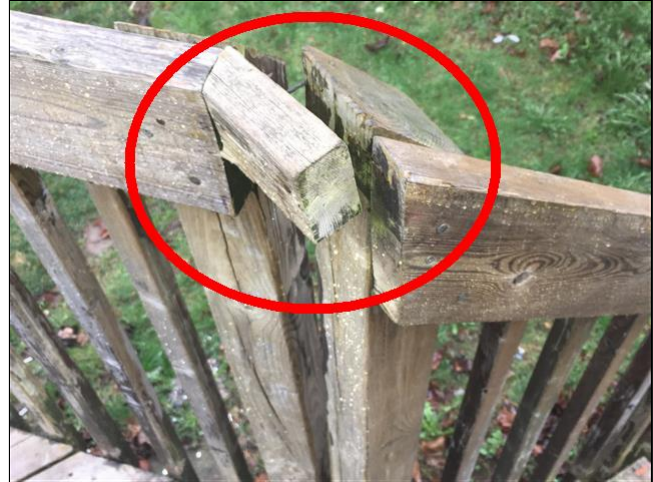
1.18 Item 2(Picture)

1.18 (1) Missing/loose guardrails observed. This is a "Safety Concern". Although guardrails may not have been required when the home was built, we recommend client consider installing guardrails as a safety enhancement.

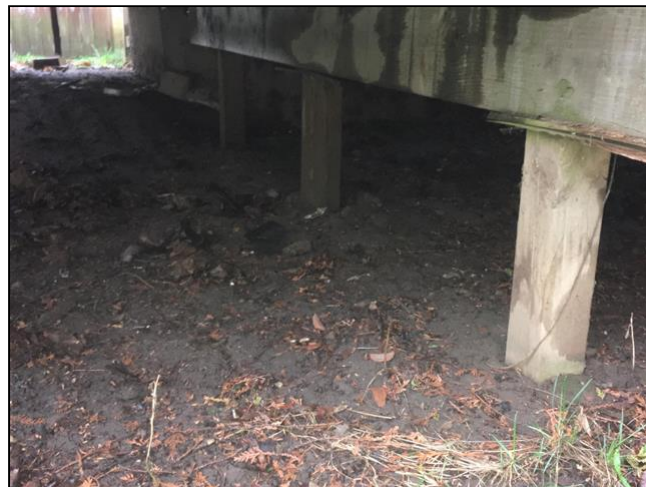
1.18 Item 3(Picture)

1.18 (2) The deck does not appear to be installed on proper footings. Accordingly, the deck may be subject to heaving and other movement. We recommend further review to determine if proper footings are required.

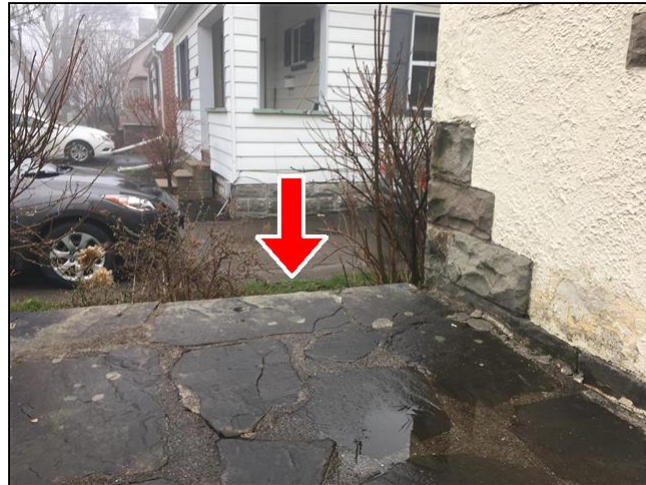
1.20 Item 1(Picture)

1.20 (2) Missing guardrails observed. This is a "Safety Concern". Although guardrails may not have been required when the home was built, we recommend client consider installing guardrails as a safety enhancement.

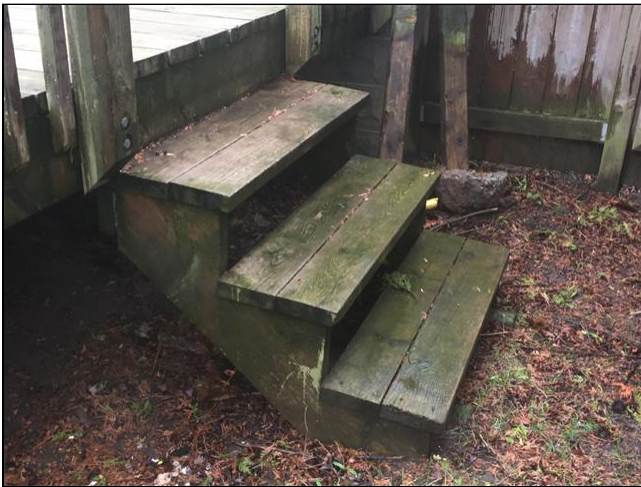
1.21 Item 1(Picture)

1.21 (1) No handrailings noted, recommend installing handrails for safety.

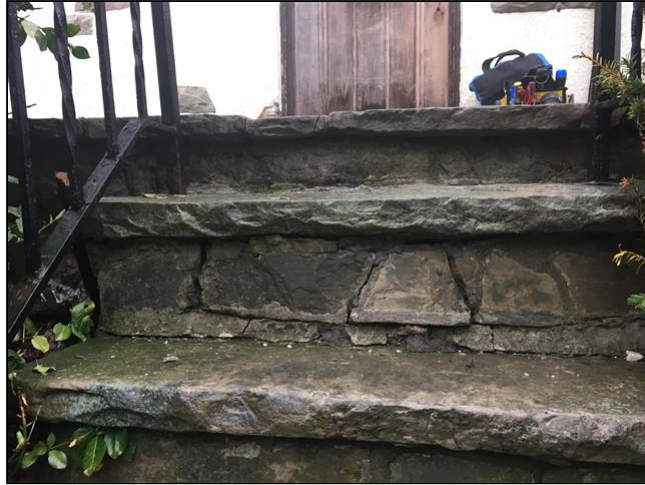
1.21 Item 3(Picture)

1.21 (3) Risers are of an uneven height. This could be a trip hazard. We recommend further review.

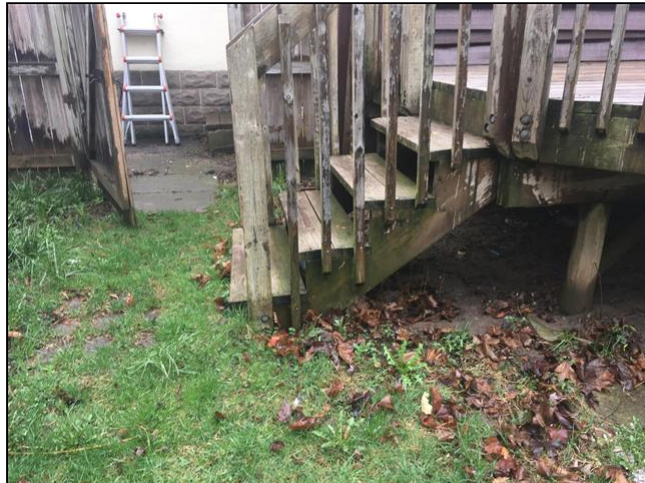
1.21 Item 4(Picture)

1.21 (4) Missing footing/solid base noted under the deck steps. We recommend installing a proper support under the steps to reduce the potential for displacement and enhance safety

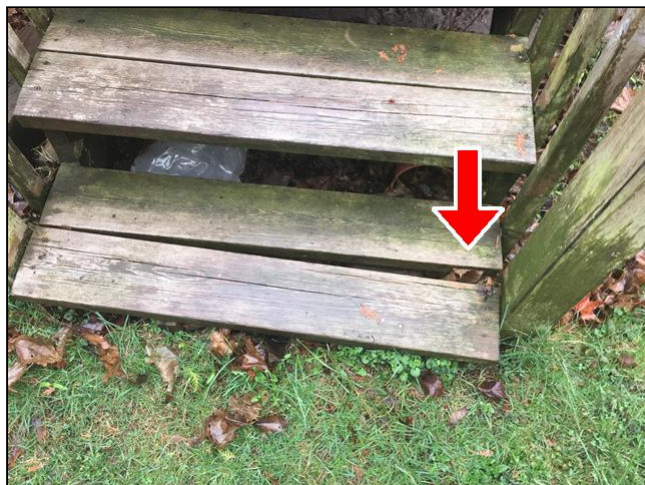
1.21 Item 5(Picture)

1.21 (5) Stair treads are damaged/ loose. Corrections are needed to ensure safety.

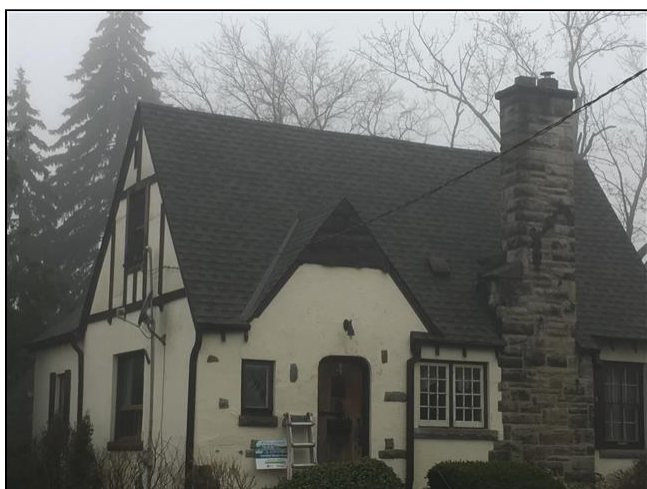
2.0 Item 1(Picture)

2.0 Roof shows normal wear for its age and type. No damaged, deteriorated, or missing roofing materials were observed; it appears to be in serviceable condition.

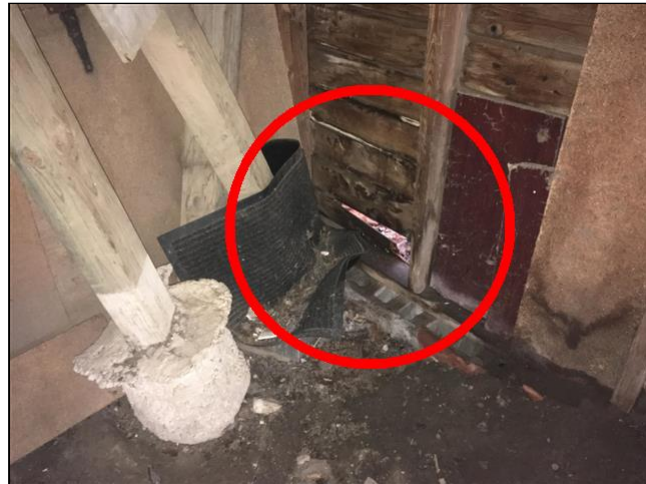
3.11 Item 1(Picture)

3.11 Deterioration/damage observed. Recommend review by a qualified professional for repair or replacement, as necessary.

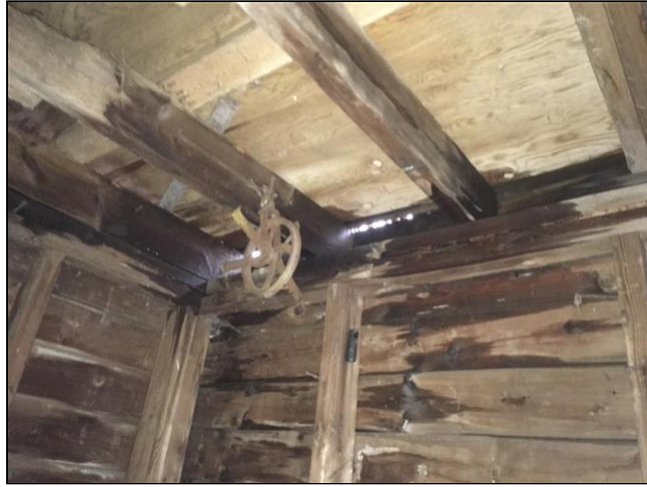
3.13 Item 1(Picture)

3.13 Stains observed on ceiling/wall. An elevated level of moisture was detected using an electronic moisture meter. A qualified contractor is needed for further review and to perform necessary corrections prior to close.

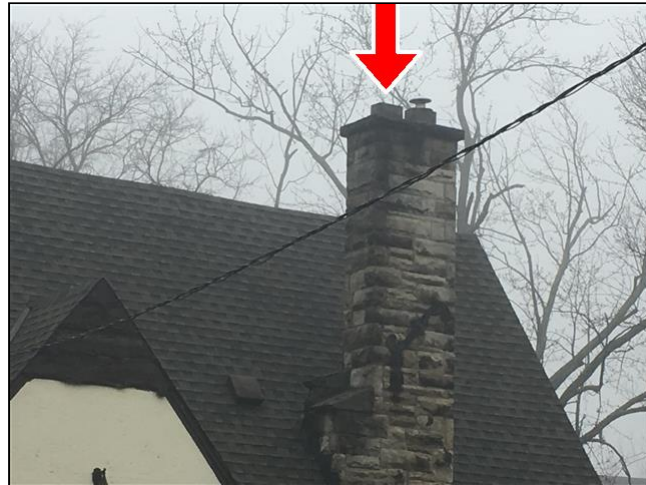
4.3 Item 1(Picture)

The chimney has no spark arrester/ rain cap installed at the left chimney flue. We suggest installing as a safety measure and to reduce the possibility for pest intrusion and water infiltration into the chimney.

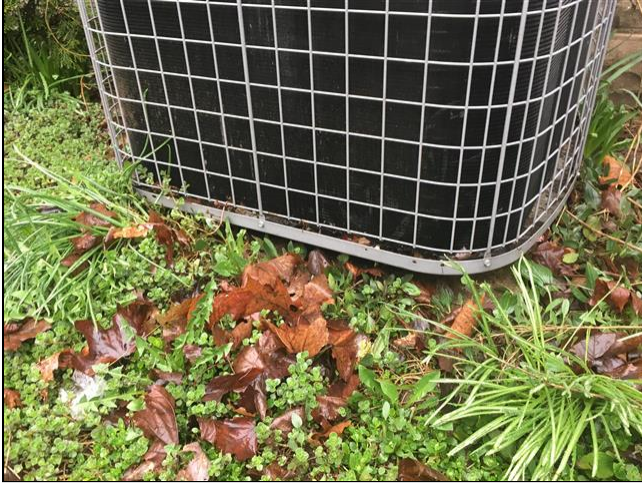
5.2 Item 3(Picture)

5.2 (2) Pad that condenser sits on appears too small for unit, corrections are needed. Recommend review by a licensed HVAC contractor for repair or replacement, as necessary, prior to close.

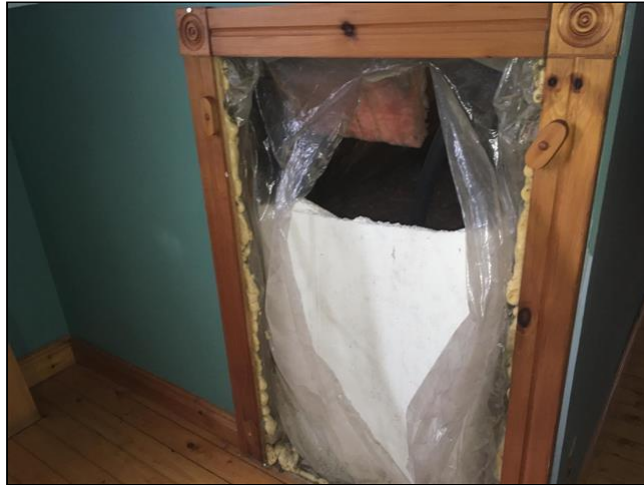
7.0 Item 1(Picture)

7.0 (2) Missing or low levels of insulation on attic hatch. Recommend properly insulating and weather-stripping the hatch.

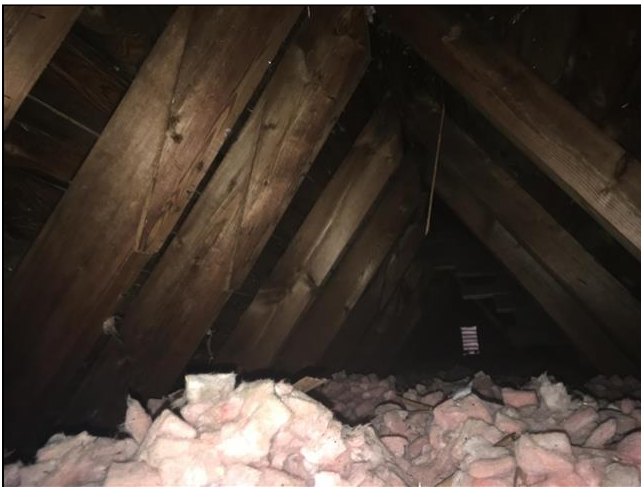
7.2 Item 1(Picture)

7.2 10-15" of insulation present, equivalent to approximately R32-R40. Recommend adding additional insulation to at least R50, in low areas.

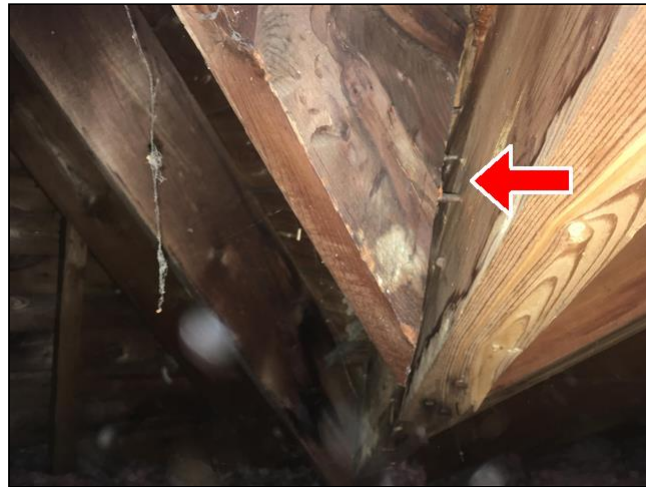
7.4 Item 1(Picture)

7.4 Framing is poorly braced at the left knee-wall area. Review by qualified contractor is needed for corrections as needed.

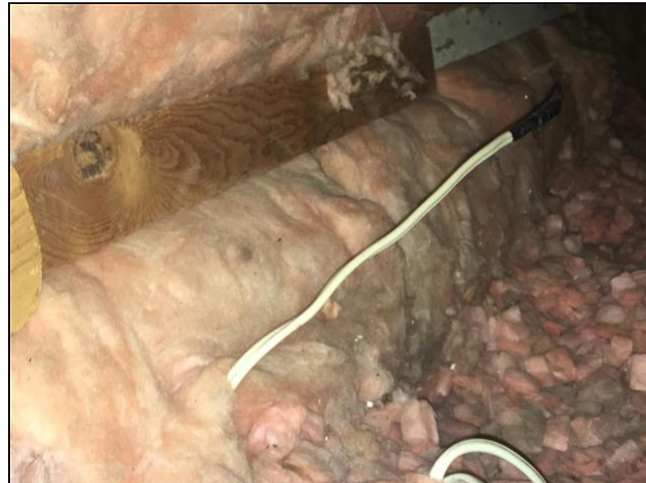
7.7 Item 1(Picture)

7.7 Exposed electrical wiring observed at front knee-wall area. This is a safety concern if used where it could be subject to "Physical Damage". It is recommended that all exposed electrical wires be encased in conduit to ensure safety. Client should consult with a licensed electrician prior to closing for repairs/replacement as needed to ensure safety.

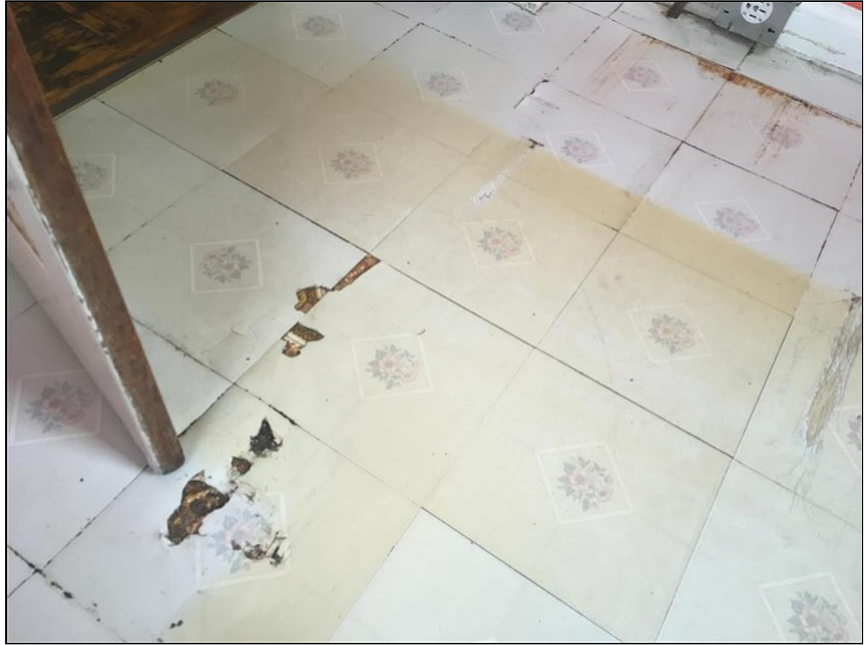
8.0 Item 1(Picture)

8.0 (2) Floor is damaged. Recommend review by licensed professional for repair or replacement as necessary.

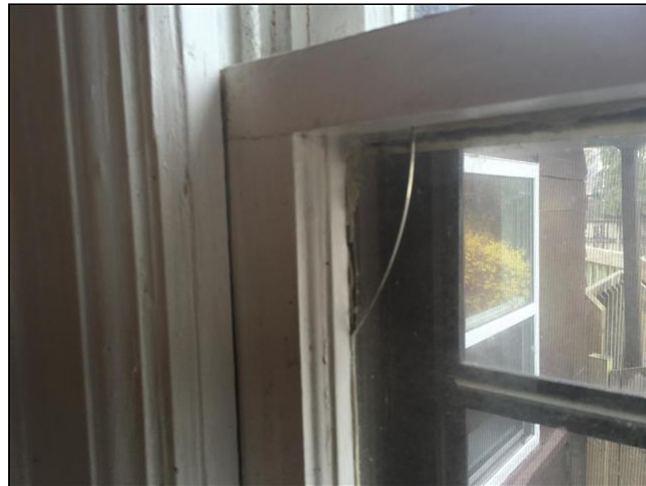
8.5 Item 1(Picture)

8.5 Broken/damaged windows(s) observed at the kitchen. Recommend review for repair or replacement as necessary.

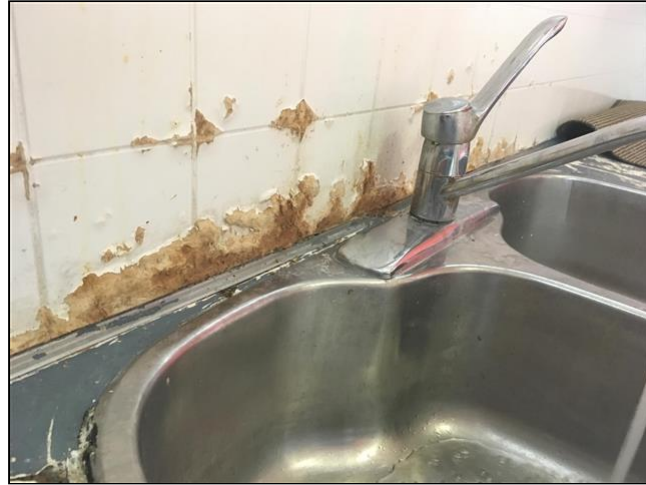
8.9 Item 1(Picture)

8.9 (2) We recommend caulking and sealing counter around sink and at back-splash area as part of routine maintenance to reduce the potential for water penetration beneath.

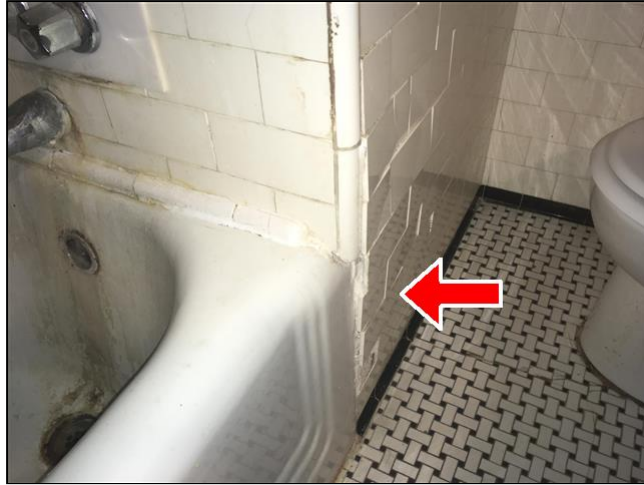
9.1 Item 1(Picture)

9.1 Broken/damaged tile observed.
Recommend review by a qualified contractor for repair or replacement, as necessary, prior to close.

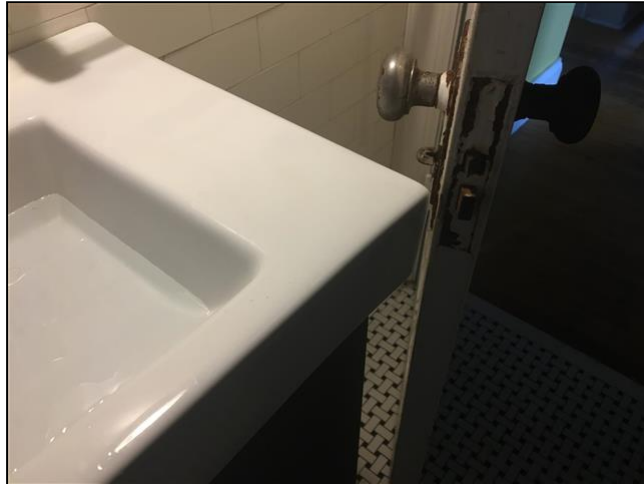
9.3 Item 1(Picture)

9.3 Door hits counter/sink, recommend corrections to deter the potential for damage.

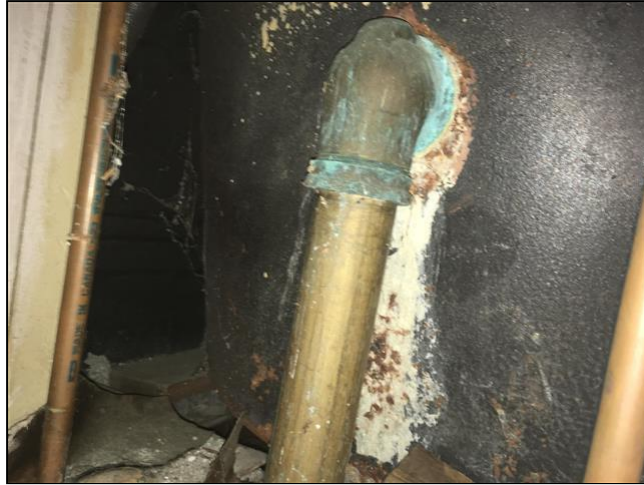
9.8 Item 1(Picture)

9.8 Rust observed at the tub drain assembly, not active leakage noted at the time of inspection. Recommend review by a licensed plumber for repair as necessary.

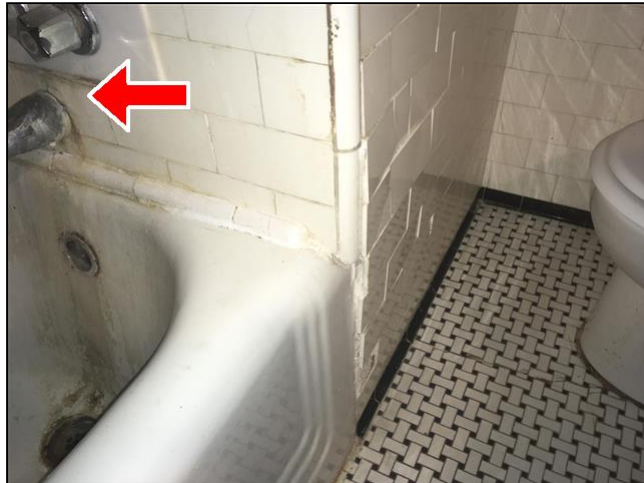
9.9 Item 1(Picture)

9.9 (1) Ceramic tile is "hollow sounding" when tapped at the faucet area, indicating poor bond with substrate. This usually results in loose tile and possible leakage; recommend review for corrections as needed.

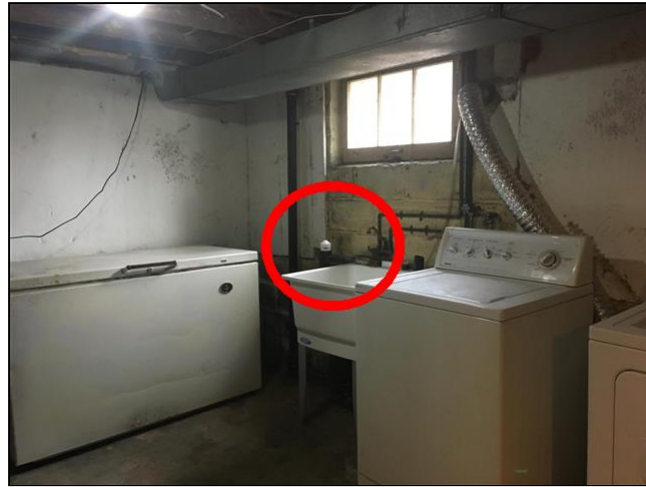
10.7 Item 1(Picture)

10.7 An air admittance valve is noted at the sink area located at laundry room. This device suggests that an issue exists with proper venting of the sink. Although the device may resolve the issue, they are not always permitted by local building departments. We recommend consulting with your building department or a licenced plumber for further direction.

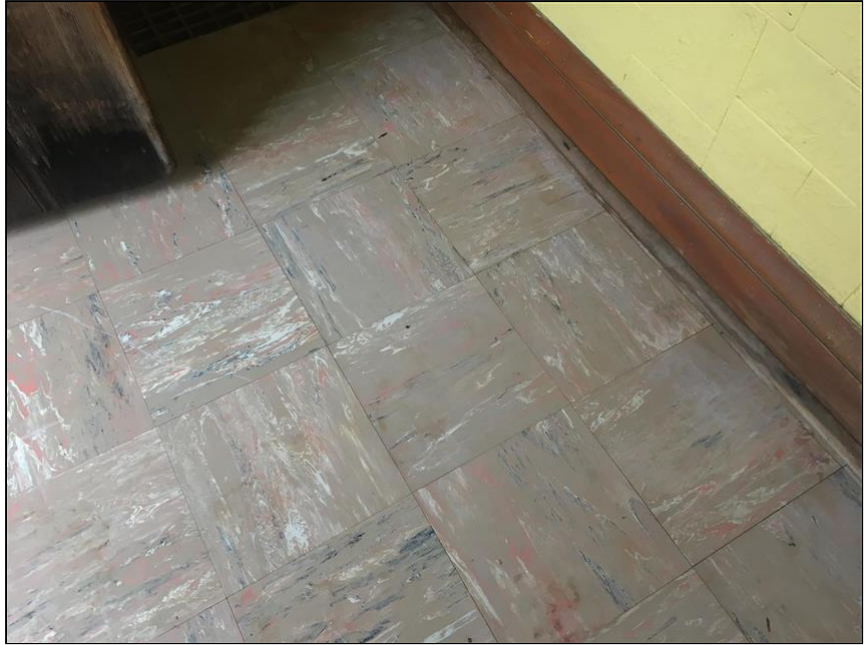
11.0 Item 1(Picture)

11.0 While asbestos detection and other chemical testing are beyond the scope of the inspection, the inspector's experience leads him to suspect that the flooring material at the front entry may contain asbestos. If client has any concerns regarding this possibility, an asbestos testing lab should be consulted prior to closing.

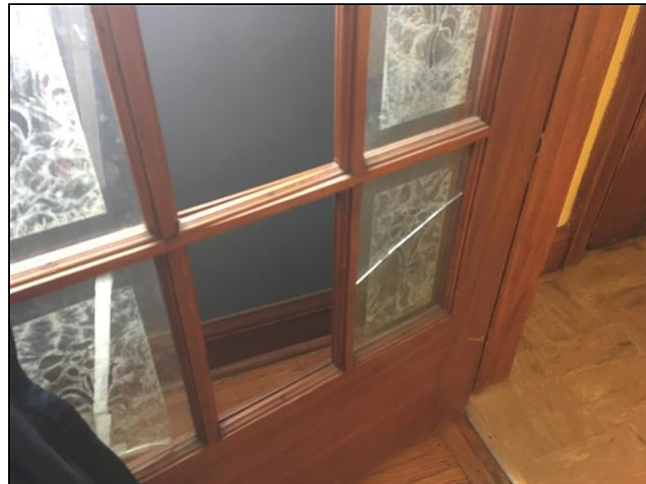
11.3 Item 1(Picture)

11.3 Broken/missing panes observed at the front entry, suggest repairing/ replacing for safety.

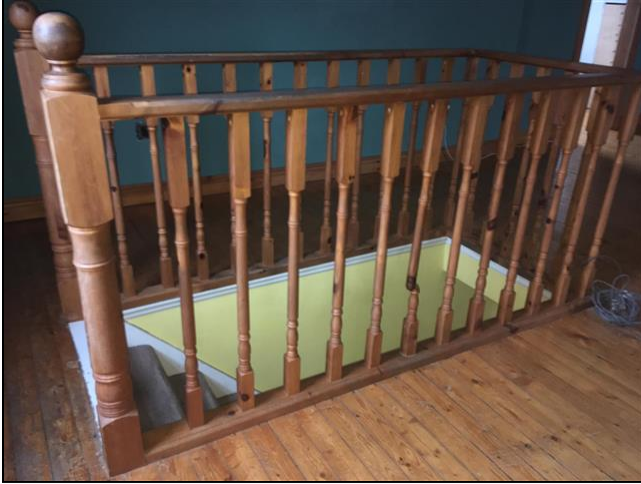
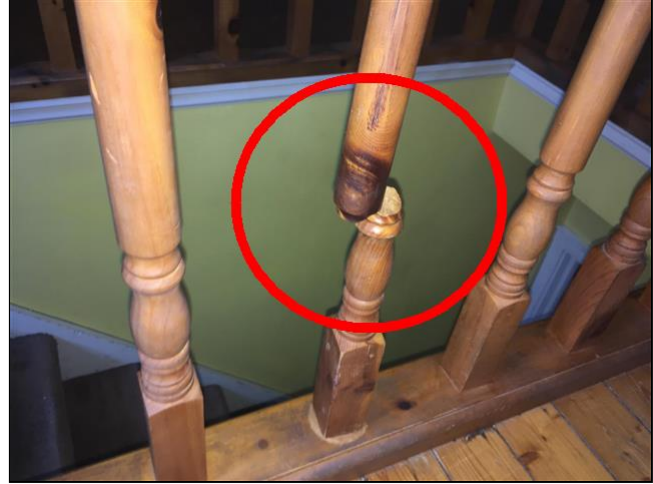
11.8 (1) Guardrail/handrail is loose/damaged. Recommend review for repair as necessary for safety.

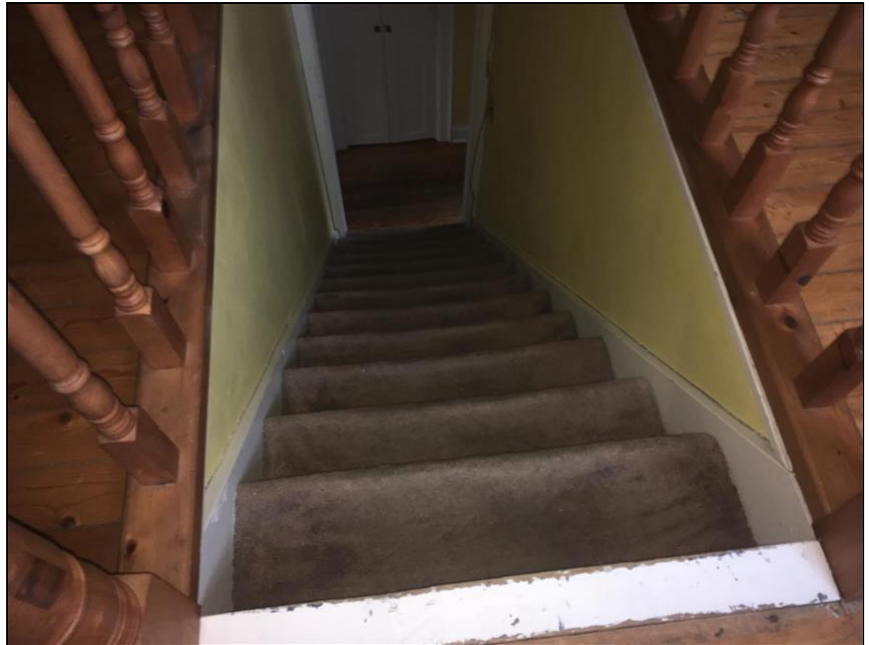
11.8 Item 3(Picture)

Stairs have low head room and may be a safety hazard. We recommend improvements, if possible.

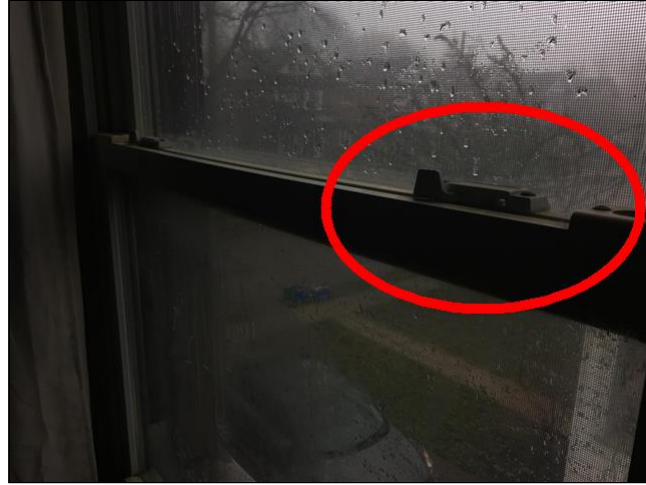
12.4 Item 1(Picture)

12.4 (1) Window lock(s) are misaligned/damaged a several areas corrections are needed for security.

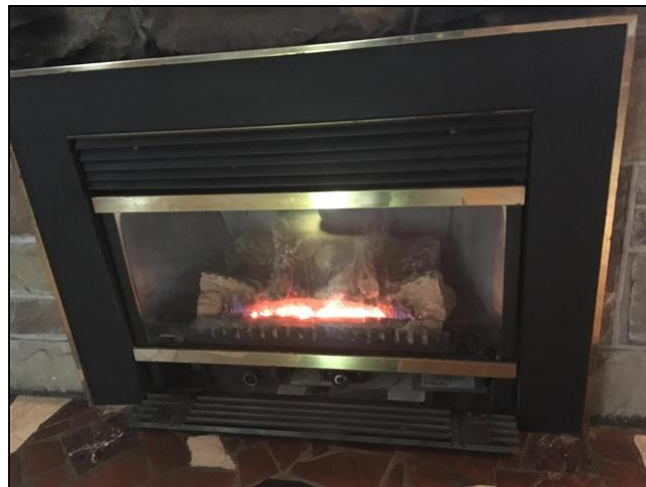
12.7 Item 1(Picture)

12.7 A fireplace insert was observed. We are unable to determine by a visual inspection if this system was installed according to manufacturer's specifications or local building authority requirements. Inserts, flues, and flue liners are not visible or accessible for examination unless the insert is removed. Due to safety concerns regarding dirty flues, cracks, damaged and/or deteriorating flues and chimney on fireplaces, we suggest complete review of these areas by a certified technician prior to closing to ensure fire safety.

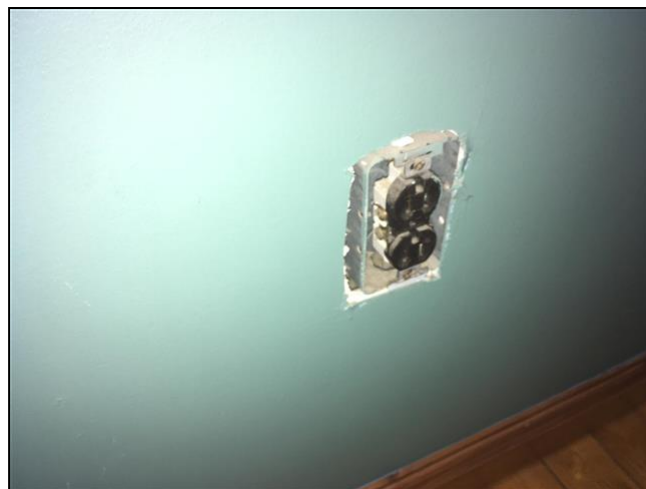
12.8 Item 1(Picture)

12.8 (1) Receptacle covers missing in the several locations. Recommend replacing for safety.

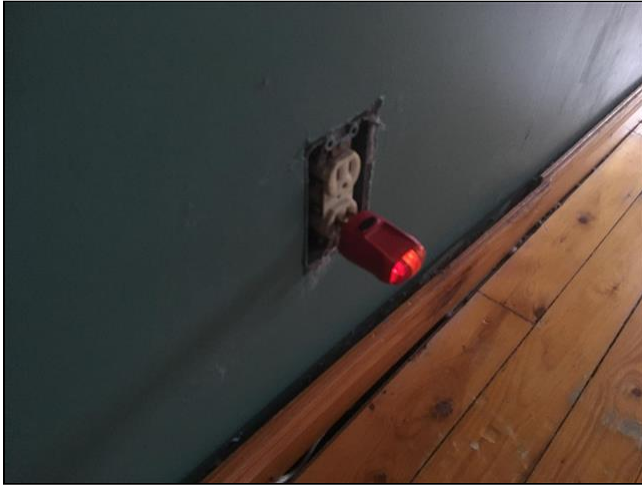
12.8 Item 2(Picture)

12.8 (3) Reversed polarity wiring conditions were observed. A reversed polarity condition occurs when the hot and neutral wires are connected to the opposite terminal connections of the outlet (i.e. hot wire connected to neutral terminal and neutral wire connected to hot terminal). This can be a safety hazard. This condition is usually easily corrected by minor wiring adjustments at the specific outlet(s)

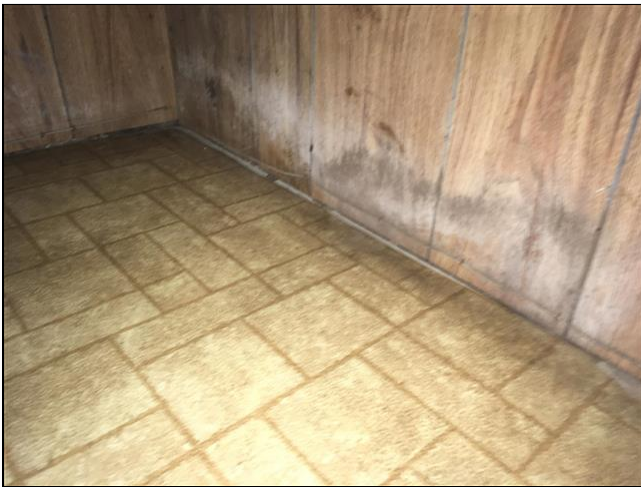
13.1 Item 1(Picture)

13.1 (2) Stains observed on paneling wall at the basement family room. The inspector probed stains with a moisture detector, which showed no moisture present at time of inspection. Client is advised to consult seller to determine the source of staining and verify that corrections have been made. Client should be aware that water entry into the home can lead to deterioration of the structure over time, mold growth and other issues. If you are concerned about this possibility, we recommend further review by a specialist, prior to close, which could include an intrusive inspection.

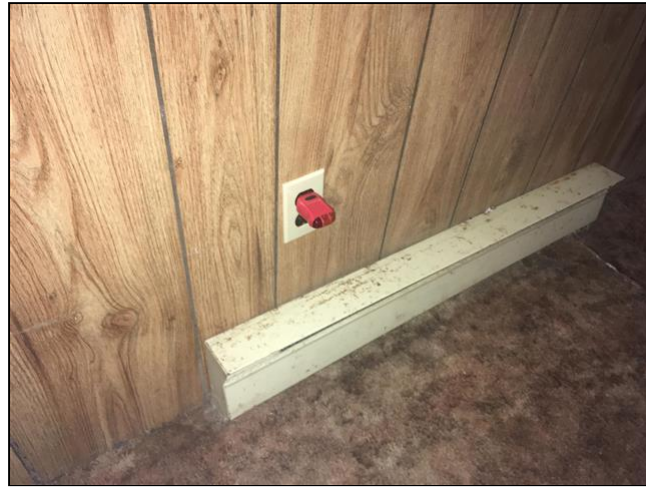
13.9 Item 1(Picture)

13.9 (1) Electrical outlet noted over baseboard heater. We recommend relocating the outlet for safety reasons.

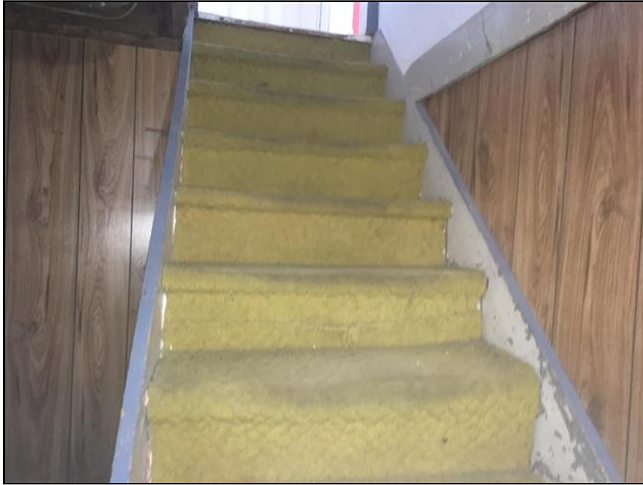
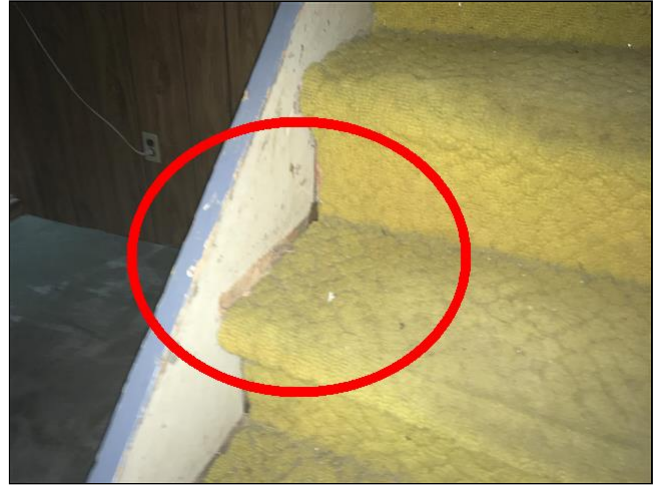
No handrailings noted, recommend installing handrails for safety.

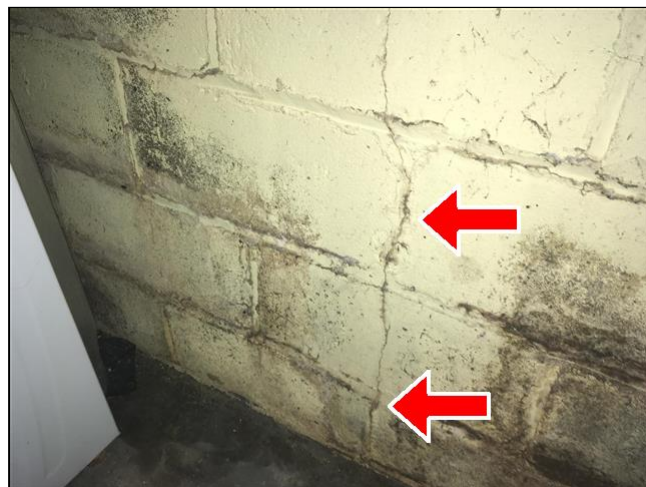
15.2 Item 1(Picture)

15.2 (2) Cracking observed at the right side of the basement; recommend review by a qualified contractor for corrections as needed.

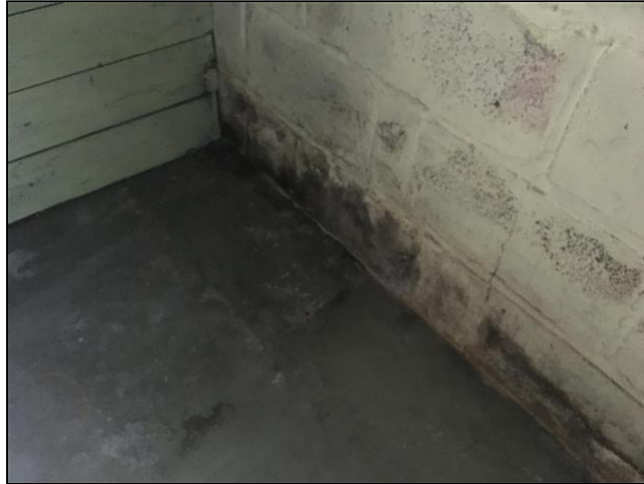
15.2 Item 2(Picture)

15.2 (3) Stains observed on wall at the right side of the basement. The inspector probed stains with a moisture detector, which showed no moisture present at time of inspection. Client is advised to consult seller to determine the source of staining and verify that corrections have been made. Client should be aware that water entry into the home can lead to deterioration of the structure over time, mold growth and other issues. If you are concerned about this possibility, we recommend further review by a specialist, prior to close, which could include an intrusive inspection.

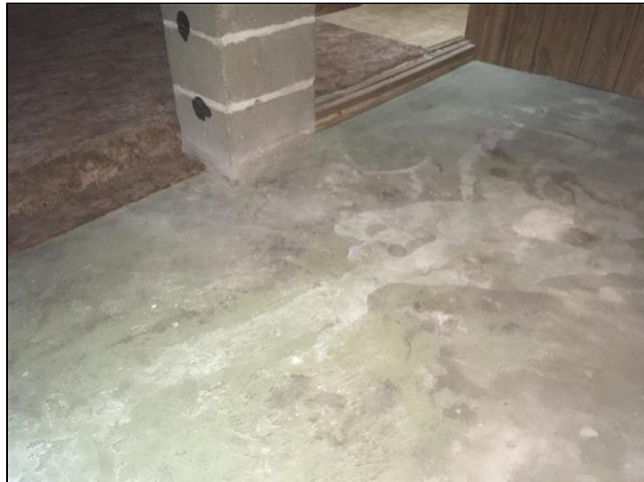
15.8 Item 1(Picture)

15.8 Due to the presence of a subfloor in the basement, we are unable to inspect the area beneath the subfloor for material type, condition and water and pest intrusion. Should you be concerned about these issues, we recommend that you request the current homeowner to provide you with access to this area prior to closing.

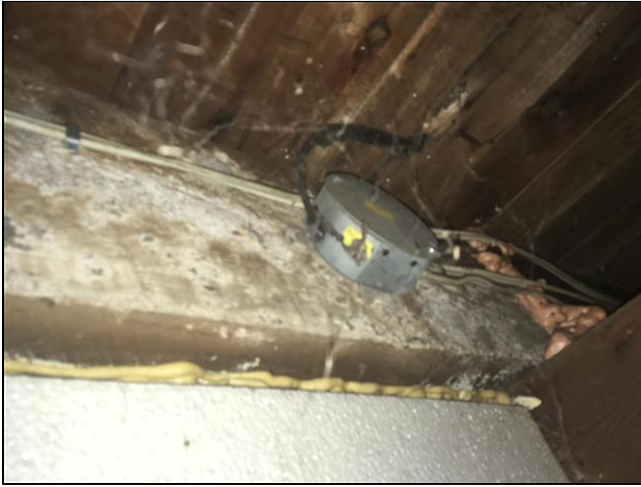
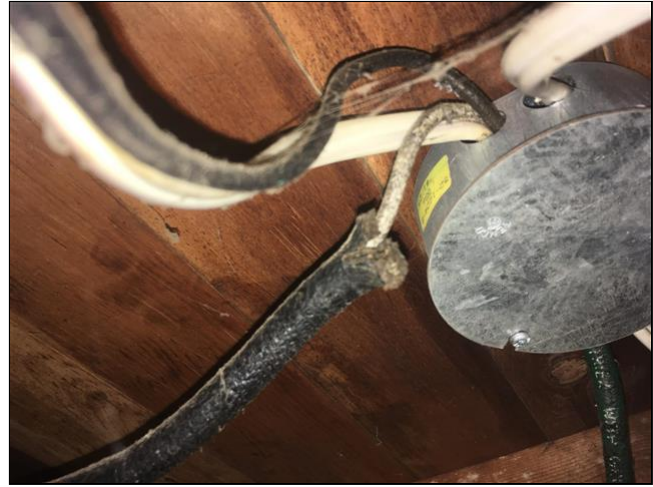
15.13 (3) Knob and tube wiring observed at junction box with updated wiring present. Suggest further review by a qualified licensed electrician to ensure this system is properly and safely installed.
