AmeriSpec of Toronto West & Mississauga Report

Client: Mr. & Mrs. Client Inspection No: 201105-00001
 Address: 123 Main Street Inspection Date: 20/05/2011
 Anywhere, ON A5B 4C9
 Inspector: Roger Orvis

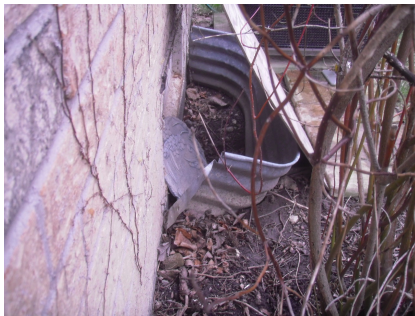
Loose window well noted at the rear. We suggest it be reinstalled to prevent erosion and possible water penetration.

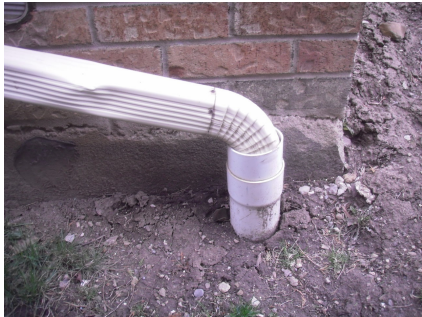
2.10 Gutters & Downspouts

Metal. Downspouts discharge to the subsurface. Due to the inaccessibility of the subsurface components we were not able to verify the proper functionality of the roof storm water management system. In order to verify that this system is working properly, we recommend that downspout locations be monitored during several rainfall/snowmelt events on a regular basis. If water appears to be surcharging (backing up) we recommend contacting a qualified contractor to clear any obstructions that may be blocking the downspouts and/or subsurface components or retrofitting the downspouts so that they discharge directly to the surface soils away from the foundation.

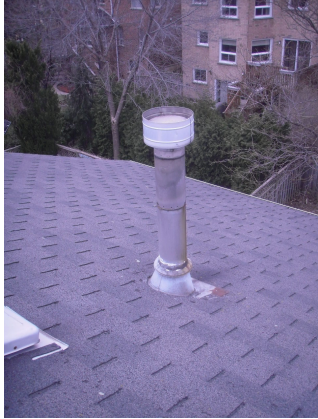
2.15 Chimney

The chimney is located at the rear. The chimney consists of a pre-fabricated metal unit. The chimney is used to vent the water heater.

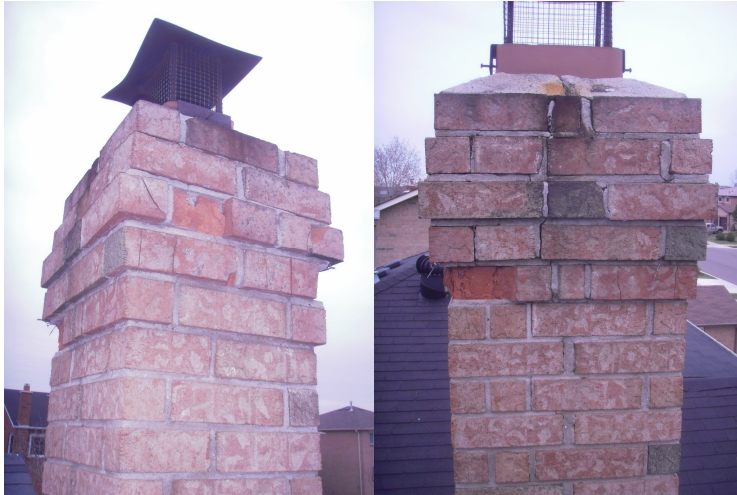
2.16 Chimney #2

The chimney is located at the right side. The chimney structure is comprised of brick or concrete block masonry. The chimney is used to vent the fireplace. A spark arrester/rain cap is installed as a safety feature and to minimize the possibility for pest intrusion and water infiltration into the home.

Flaking or spalling bricks noted. Suggest monitoring and repairs or rebuilding by a qualified chimney contractor when required.

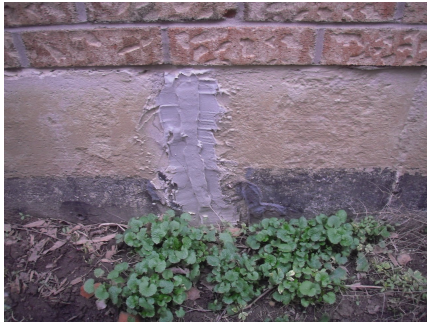
2.19 Exposed Foundation

Poured concrete. Crack and repair noted at the left side. Crack noted at the front. We were unable to view either crack from the interior due to finished walls.

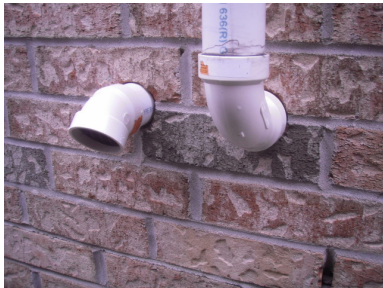
We suggest sealing around the furnace vents to prevent air infiltration and possible water penetration.

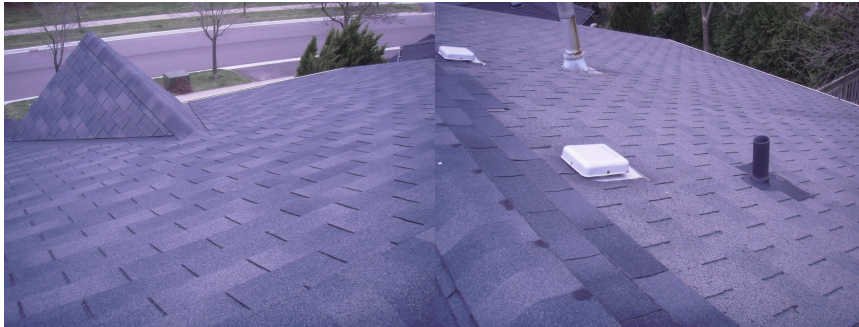
3.3 Condition

The roofing materials are of different ages. The garage roofing appears to be new. The upper level roof at the front appears to be older as the edges have sagged into the gutters. The rear slope of the roof has the original shingles present.

Whereas the roofing materials show normal wear for their age and type, the age of the roofing materials at the rear, appear to be reaching their normal lifespan. Therefore, we recommend that the client budget for a replacement roof in the near future. A qualified roofing contractor should be consulted to determine replacement options, associated costs and timing to reduce the risk of roof leaks and water damage to interior and concealed portions of the home.

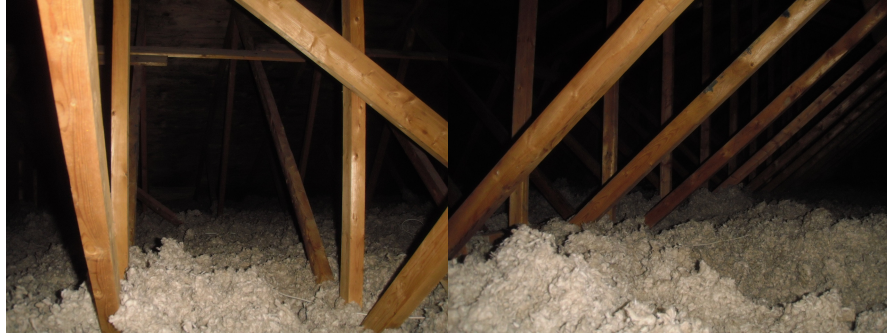
6.1 Access

Attic access located at the middle left bedroom. The attic was partially accessed and viewed from hatch area only. Entering attics that are insulated can cause damage to the insulation and/or the attic framing. In addition attics with deep insulation cannot be safely inspected due to the limited visibility of the framing members. Based on this our review of the attic space is limited to visually accessible areas as observed from the hatch only.

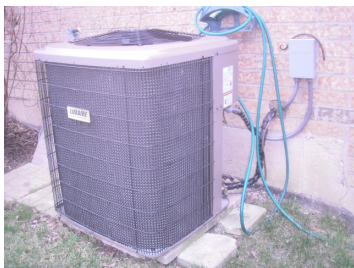
9.1 Description/Conditions

The air conditioning system is electric. The condenser/compressor components of the air conditioner are located at the rear. This is a split system where the condensing unit, (located on the exterior of the house), works in conjunction with the furnace fan to deliver cooled air throughout the house via the heating ducts. This is the standard type of air conditioning system for our locality.

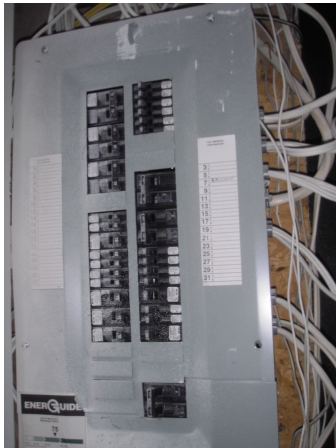
The panel is not properly labeled. We suggest all the circuits be labeled for safety and convenience. Overload protection of the distribution wiring in the home is provided by breakers.

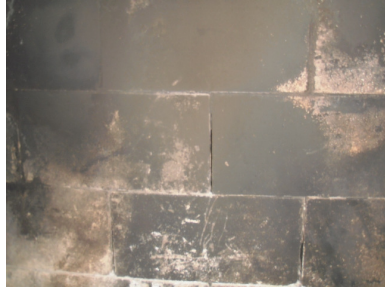
Loose mortar in the firebrick. We suggest further review and repointing as required by a qualified mason.
