# "Canada's leading Home Inspection Company"

Doc #: Sample Report Inspector: Terry Fulljames

Date: July 25, 2014

Dwelling Address: Terrace B.C.

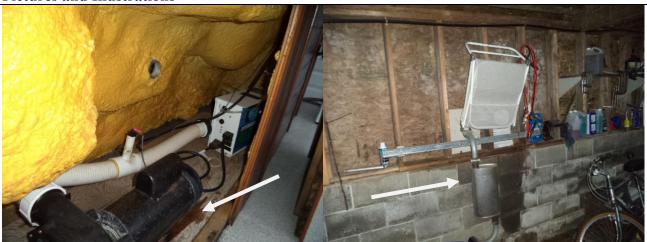
The older hot tub on the deck appeared to be in reasonable condition with some minor dripping noted inside the pump compartment. Recommend monitoring this area for possible repairs. Suggest installing gutters around the perimeter of the deck to prevent weeping inside the workshop area under the deck. The visible wood components are showing some signs of ongoing moisture but did not appear to be deteriorated. Note the water stains on the block work.

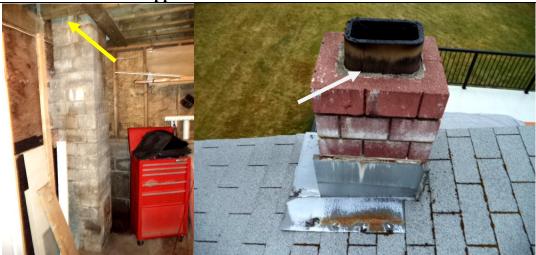
This chimney is showing signs of moisture infiltration; moisture migration through the top of the chimney is causing the staining all the way to the base of the assembly Ideally the chimney requires a proper cap as noted in the illustration on the next page. Note that this chimney requires 2 inches clearance to combustibles some of the framing on the wall does not conform to this standard. Also, recommend installing a basement ceiling fire stop using sheet metal at the ceiling level to block off the chimney chase.

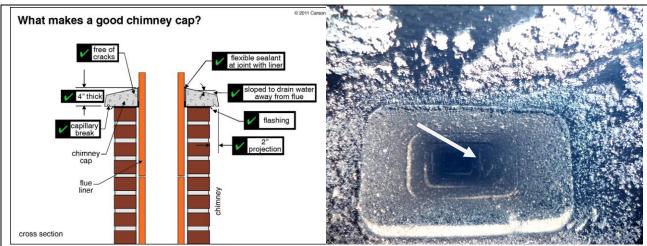
The right hand picture shows cracking of the clay liner, further down inside the chimney the buyer has completely broken away. From a wall deposits can accumulate between the liner and the block work creating a dangerous chimney fire situation. Recommend repairing this chimney by adding a stainless steel liner if the chimney is to be used. Consider consulting a qualified wood stove installation contractor for estimates.

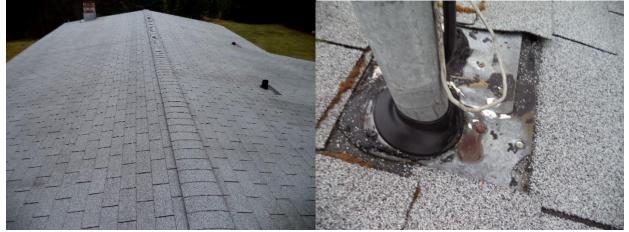
The roof appeared to be in reasonable condition with some minor moss located on the back slope. The seller was made aware of the recessed area around the chimney mast that should be better sealed with roof patch. The seller was actively patching this area at the time of the inspection. There is a continuous venting material at the peak of the roof. The seller has had problems with roof ice suggest adding additional ventilation such as hooded roof vents near the peak of the roof.

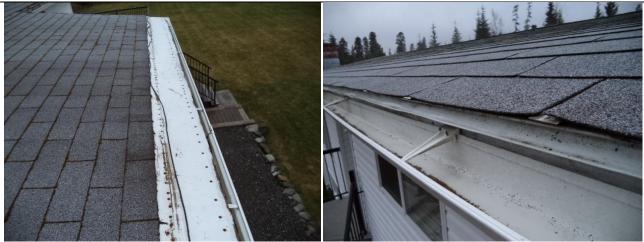
The left picture shows the entry addition with metal on the edge with heat cables. This appears to be a provision to control roof ice. Vinyl siding pieces have been added in the key ways at the eves of the roof which appeared to be a provision to prevent dripping behind the gutters. It also appears that the drip edge flashing was installed and bent out of position to further prevent dripping.

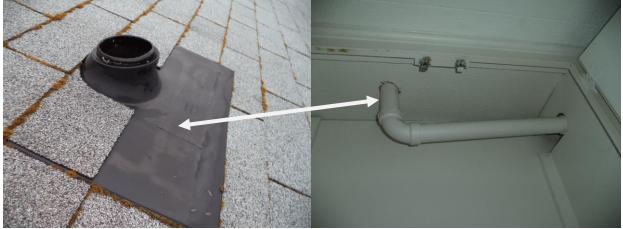
This plumbing stack seen on the back slope above the electrical sub panel on the main floor has settled out of position. Ideally this item should be pushed out and secured into place before the unit settles causing leakage issues.

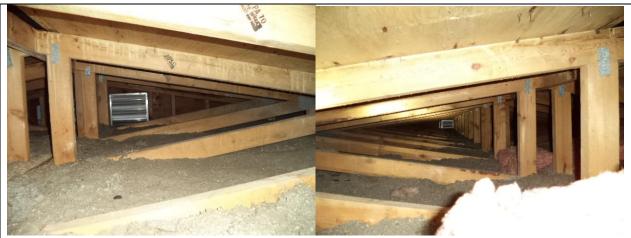
The attic appeared to be in reasonable condition in the visible areas. The attic was inspected from the hatch due to the small area. Fiberglass and cellulose insulation present approximately R32 insulation value. Engineered trusses were present and appeared to be in reasonable condition.

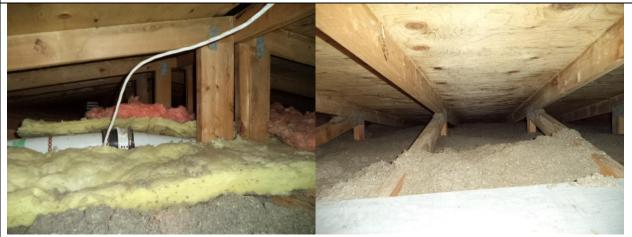
A provision to exhaust the bathroom fan to the exterior is visible and the left hand picture. Some minor staining at the eves possibly related to previous roof ice or condensation.

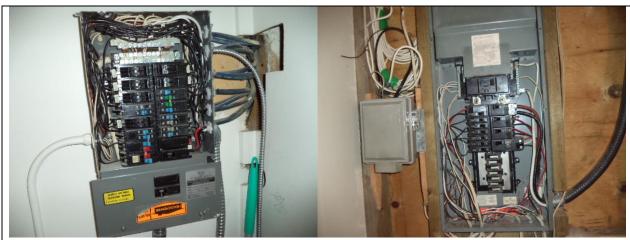
Both electrical panels appeared to be in reasonable condition shown here with the covers removed. Copper wiring present.

The main panel is fused at 200 amps and the sub panel 100 amps.

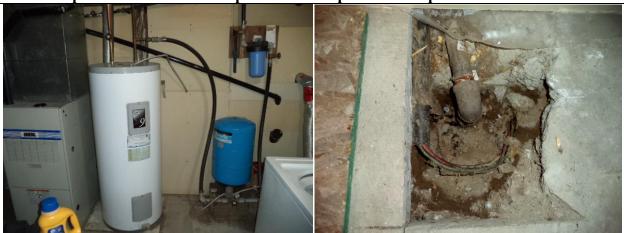
Pressure tank and cartridge filter appeared to be in reasonable condition the water pressure was 40 PSI. Note the sloped drain line which services the kitchen sink, seller indicated this was installed in this manner to facilitate better water flow. The right hand picture shows the power line going to the exterior well and the incoming water line in the concrete slab in the basement. Recommend better protecting the electrical cable and installing a proper hatch in this location.

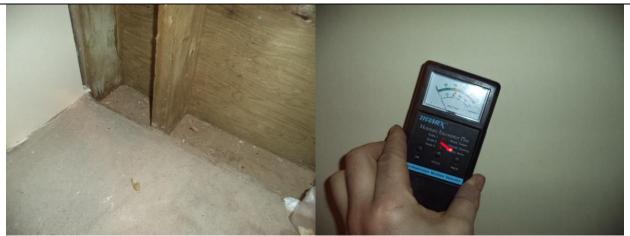
The treated wood foundation appeared to be in reasonable condition, several areas were checked with a moisture meter all areas were dry the time of inspection. Note the vapor barrier extending out behind the drywall. Consider cutting back the insulation inside the wall assembly has drywall can still be removed as it is currently and finish. Insulation should terminate approximately 1 to 2 inches above the base plate to facilitate minor moisture seepage. Insulation can retain moisture. Typically the vapor barrier is also cut back approximately 1 inch off the concrete floor.

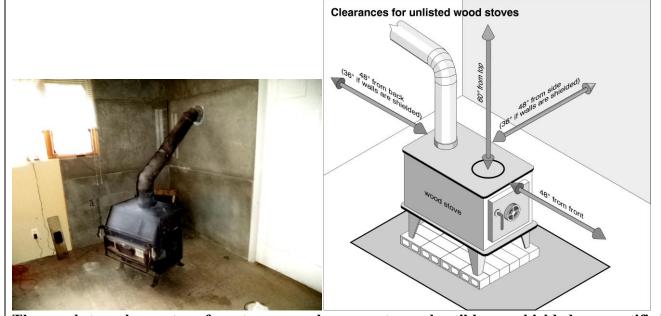
The wood stove does not conform to proper clearances to combustibles; unshielded non-certified stoves require 48 inches to combustible wall assemblies. Shielding is required or updating the stove with a new unit.

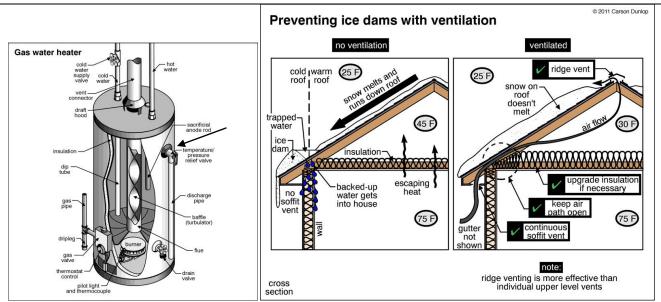
Recommend installing a discharge pipe for added safety around the hot water tank. The right hand illustration shows proper ventilation which offsets roof ice.

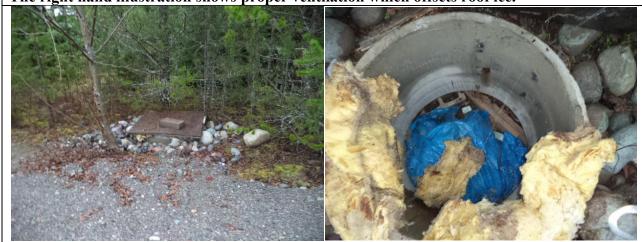
The drilled cased well is located in the driveway area the seller indicated that the well is approximately 98 feet deep with about 40 feet of water. There have been no water shortages during the ownership of the home as per the seller.

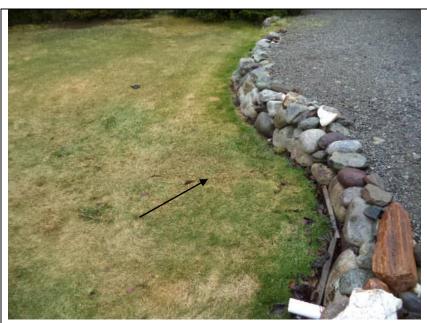
A septic tank and field are located in the backyard the septic tank hatch is approximately 12 feet off the corner the building as per the seller. The septic tank was serviced and 2008 and November 11, 2013. The seller indicated that this was a concrete tank.
