SUMMARY REPORT

AmeriSpec Inspection Services of Hamilton, Brantford and Stratford
32 Livingstone Cres
Cambridge ON N3H 5S7
226-341-9569

URGENT REVIEW SUMMARY

Doc #: 071721SH8

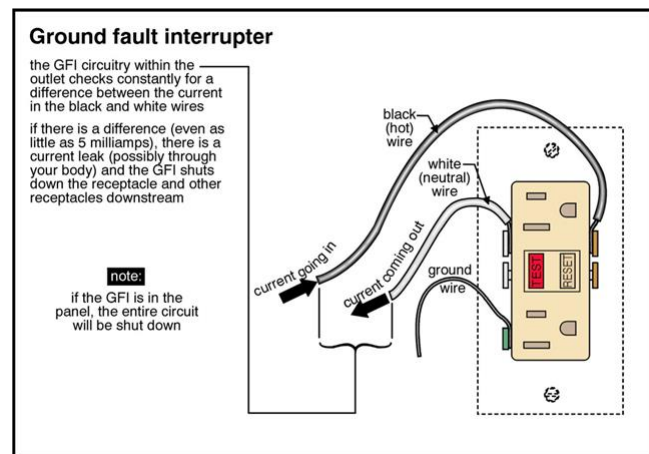
1.8 Item 1(Picture)

A Ground Fault Circuit Interrupter (GFCI) is not present at exterior, suggest installing GFCI for safety. A qualified electrical contractor is needed for further review and to make necessary repairs/corrections

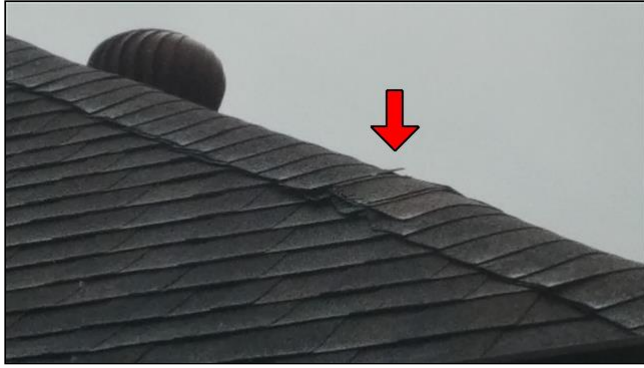
2.0 Item 1(Picture) Front right

Damaged shingles observed at several locations. We recommend review by a licensed roofer for repair or replacement, as necessary.

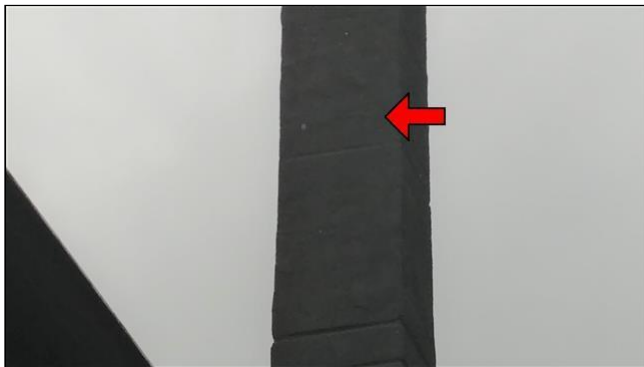
3.0 Item 1(Picture)

(1) Evidence of repairs observed at masonry chimney. We are unable to determine the effectiveness of these repairs and suggest the client consult with sellers for additional information.

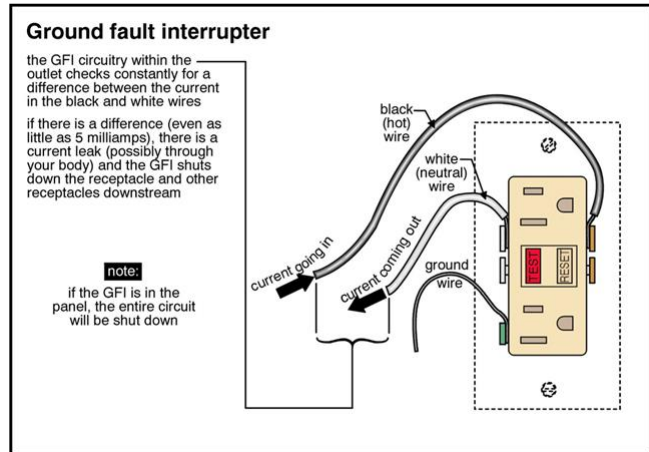
6.7 Item 1(Picture)

(1) A Ground Fault Circuit Interrupter (GFCI) is not present at kitchen, suggest installing GFCI for safety. A qualified electrical contractor is needed for further review and to make necessary repairs/corrections

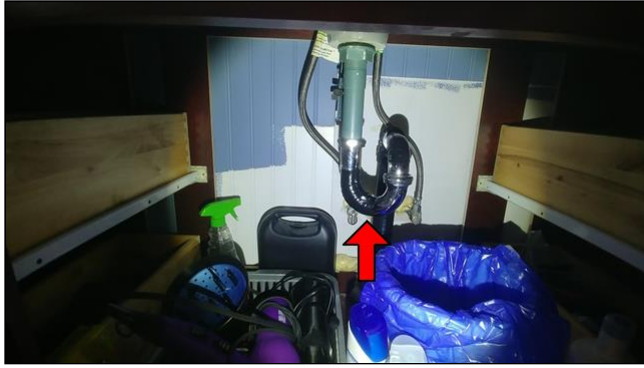
7.16 Item 3(Picture)

(2) Tape observed wrapped around the drain assembly. The purpose of the tape is unknown and non-standard. We recommend confirming the purpose with the seller or review by a qualified plumber prior to closing.

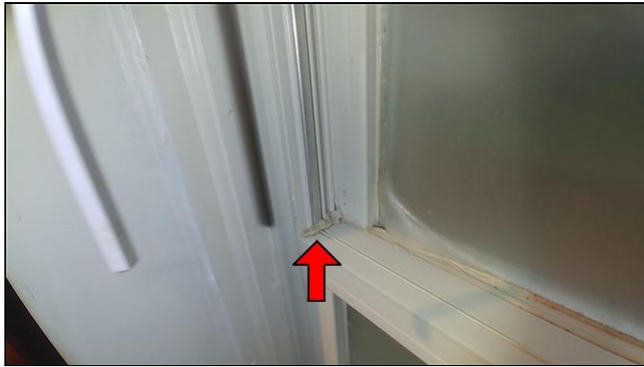
10.4 Item 1(Picture)

Sealed-up window observed in the bathroom. We recommend consulting sellers for additional information regarding condition and operation.

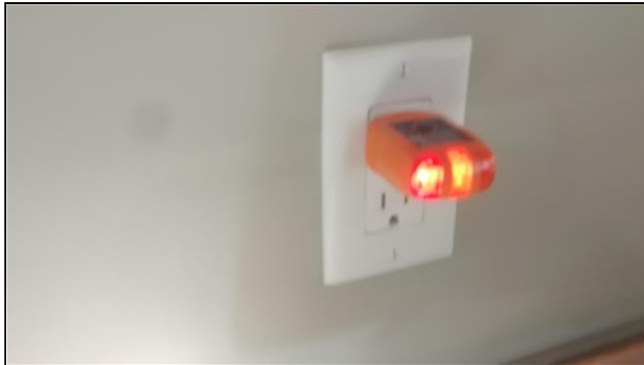
10.8 Item 1(Picture)

Reversed polarity detected at numerous outlets on the first and second floor. Reversed polarity, hot and neutral wires reversed, is usually easily corrected by minor wiring adjustments at the affected outlet(s). When this condition is observed, a qualified electrical contractor is needed for repairs/corrections.

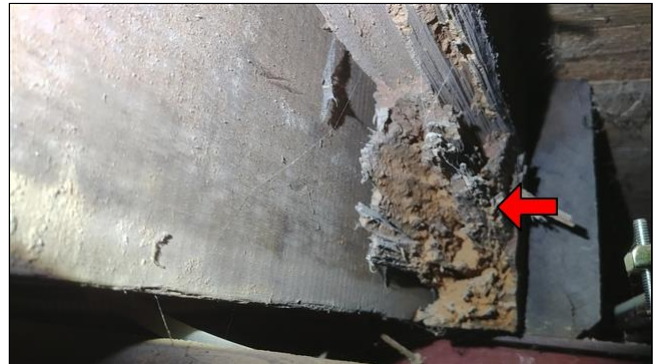
12.6 Item 2(Picture)

(1) Evidence of prior wood destroying insects observed at basement and crawlspace. We recommend review by a qualified exterminator for evaluation and further treatment, as necessary.

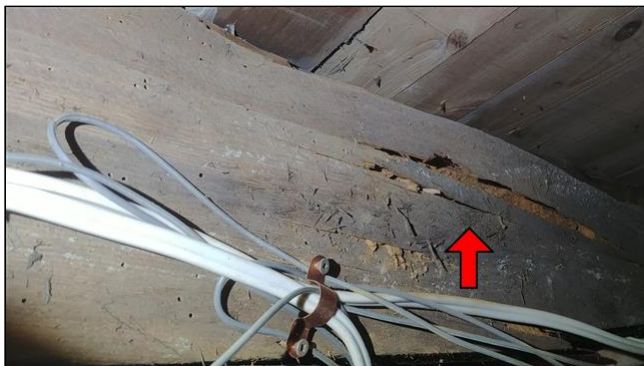
12.6 Item 3(Picture)

(2) Wood deterioration observed to floor framing members at several locations in the basement. Review is needed by a licensed contractor for repairs as needed.

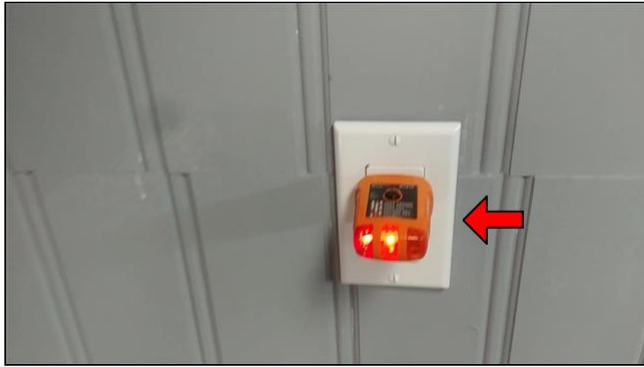
12.13 Item 1(Picture)

Reversed polarity detected at basement. Reversed polarity, hot and neutral wires reversed, is usually easily corrected by minor wiring adjustments at the affected outlet(s). When this condition is observed, a qualified electrical contractor is needed for repairs/corrections.

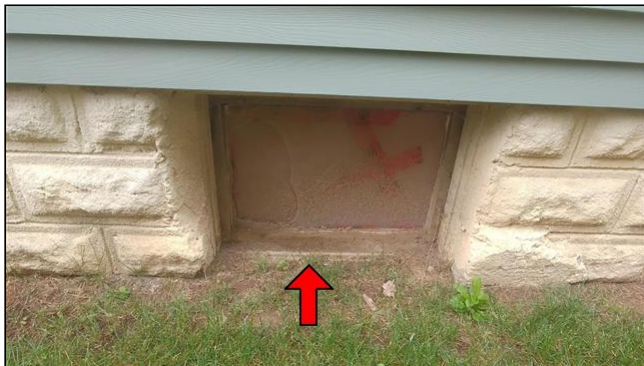
1.4 Item 1(Picture)

(1) As a result of grading, position of the window or other reasons, the basement window at the right side may be prone to water entry. We recommend that window wells be added at to minimize the potential for water infiltration around the basement windows.

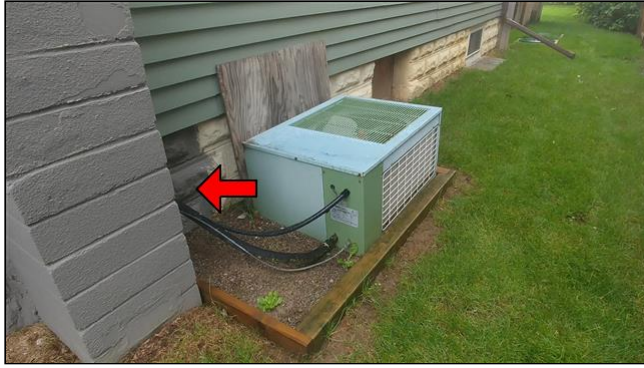
4.1 Item 1(Picture)

No electric disconnect noted, an electric disconnect is usually located within site of exterior condenser unit, this may not have been required when home was built, client may wish to install electric disconnect to enhance safety.

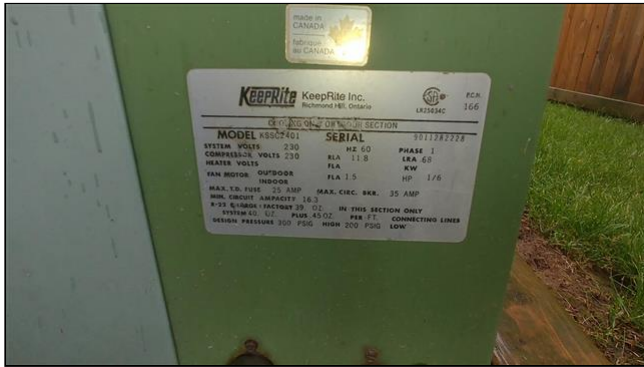
4.2 Item 1(Picture)

(1) Based on the estimated age of the air conditioner or other conditions (this unit uses an obsolete refrigerant that limits many repair options) noted at the time of the inspection. The unit is at or near the end of its useful life and the client should budget for a replacement.

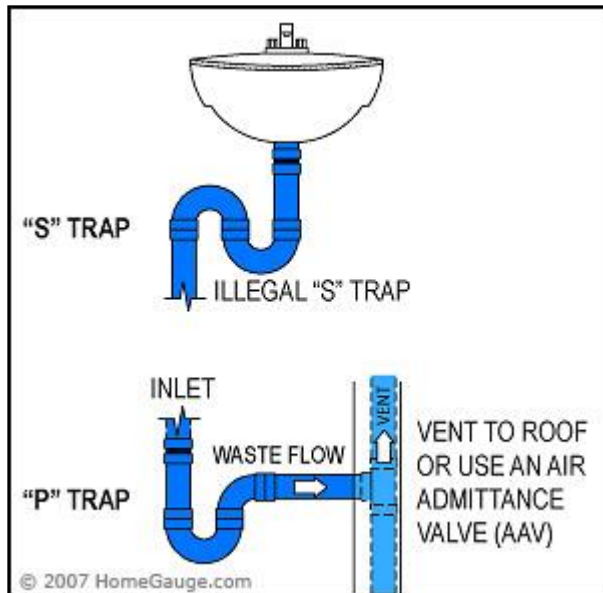
6.12 Item 1(Picture)

An S trap was noted at kitchen sink drain assembly. We recommend replacing with a P-trap to help prevent the venting of sewer gases inside the structure.

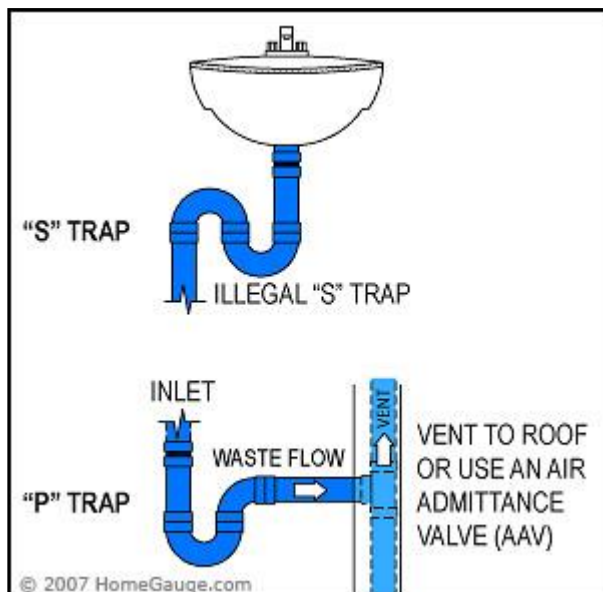
7.16 Item 1(Picture)

(1) An S trap was noted at main floor bathroom (with the laundry). We recommend replacing with a P-trap to help prevent the venting of sewer gases inside the structure.

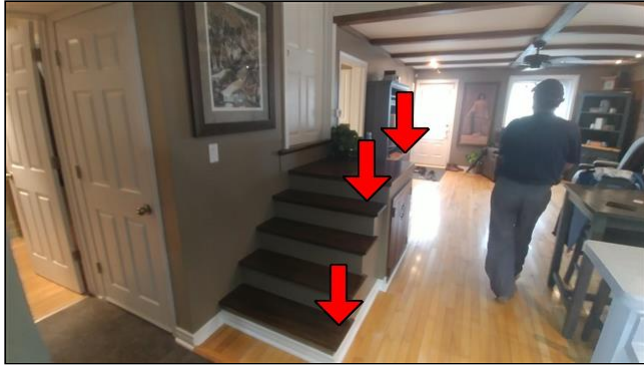
9.8 Item 2(Picture)

(2) No handrailings or guardrails noted at the stairs to upper level. We recommend installing handrails and guardrails for safety.

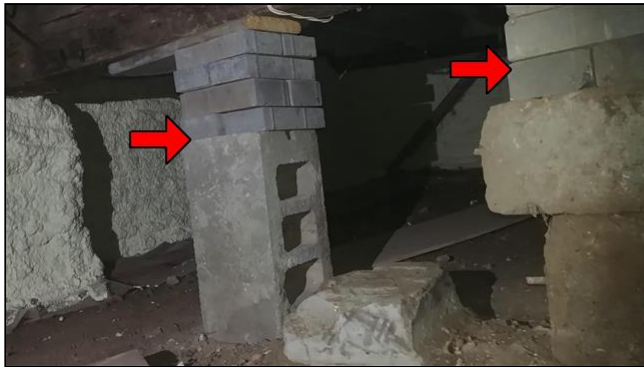
12.10 Item 1(Picture)

Temporary block/brick columns observed supporting the beam in the crawlspace. We recommend review by a qualified contractor and the installation of properly supported permanent column(s).

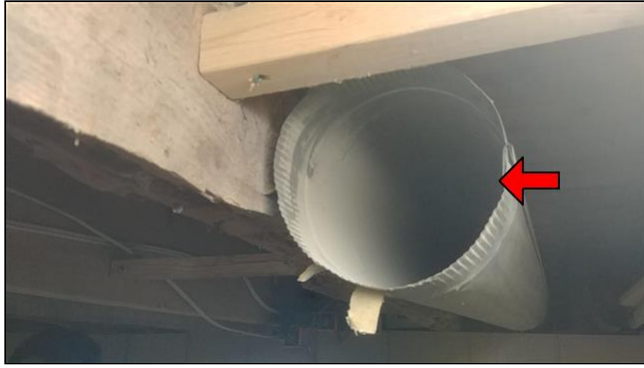
12.12 Item 1(Picture)

(1) Air register missing at the basement. Replacement is recommended.

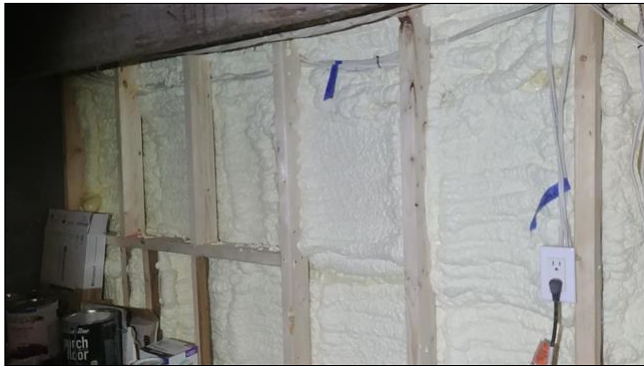
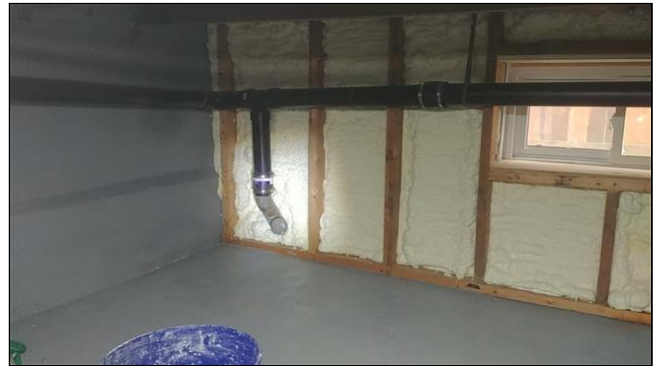
Exposed spray foam insulation noted. This type of insulation may be a fire hazard and should be covered with a fire resistant barrier for safety.

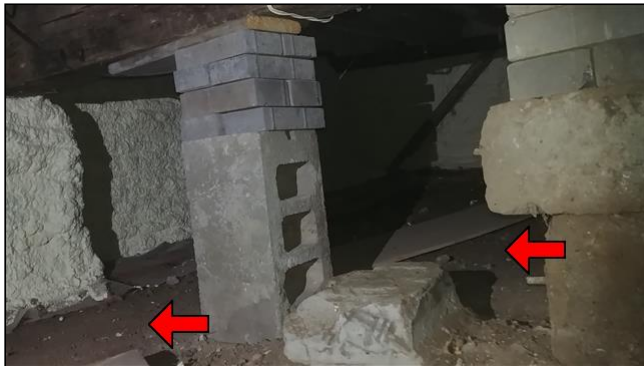
12.16 Item 1(Picture)

No moisture barrier observed on crawlspace earth floor. Moisture barriers may not have been required at the time the home was built. We recommend a complete review of the crawlspace by a qualified contractor for possible installation of a moisture barrier to prevent any future/further damage/deterioration to the structure and to ensure a dry clean crawlspace.

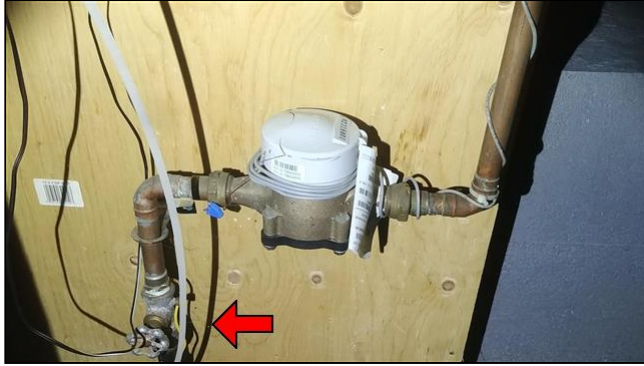
13.0 Item 1(Picture)

Gate-type valve observed. Since main shut-off valves are operated infrequently, it is not unusual for them to become frozen over time. They often leak or break when operated after a period of inactivity. For this reason main shut-off valves are not tested during a home inspection. We suggest caution when operating shut-offs that have not been turned for a long period of time. We recommend that the client consider upgrading the shut-off valve to a high quality ball-type valve which tend to be more reliable than gate valves.

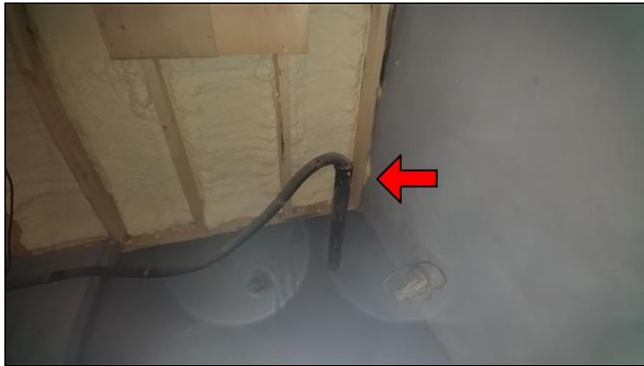
13.4 Item 1(Picture)

Flexible hosing and no backflow valve observed at the sump pump discharge. Also, the sump pump turns on at a relatively high water level. We recommend review by a licensed plumber to ensure proper installation and operation, as necessary.

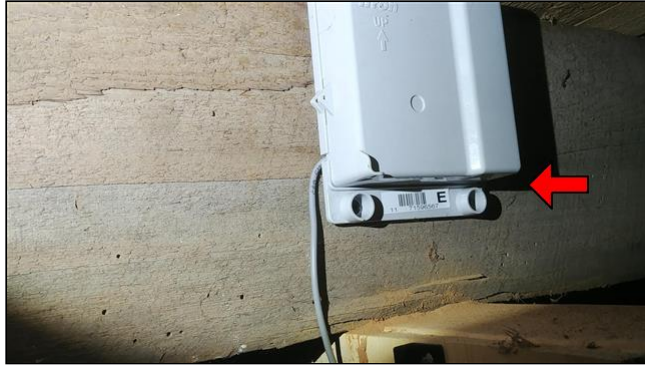
13.7 Item 1(Picture)

(1) Water meter reader installation is incomplete. Recommend follow-up with the township to complete the installation.

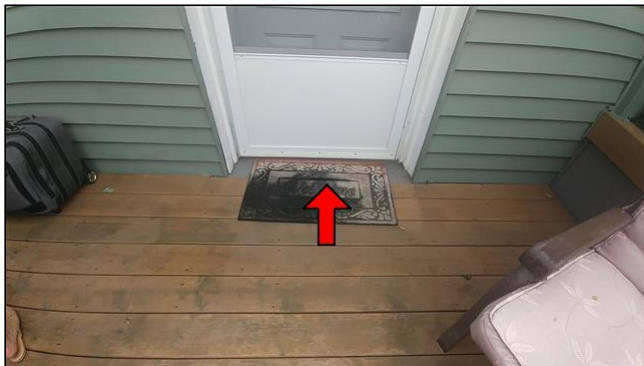
1.5 Item 1(Picture)

There is no clearance between the rear entry door and the deck. This arrangement may be susceptible to water entry. We recommend monitoring for snow and ice accumulation that may result in water intrusion and correct as required.

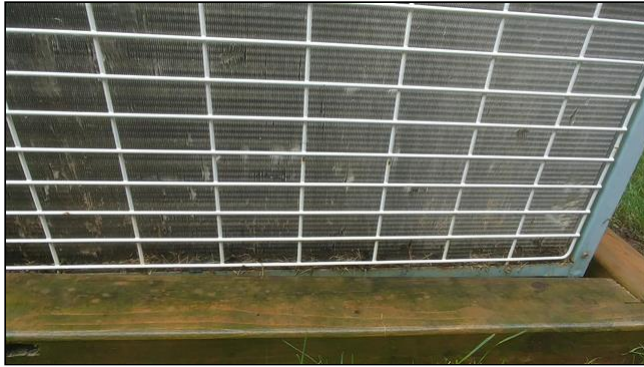
4.2 Item 2(Picture)

(2) The condenser fins at the outside compressor at bent, damaged and dirty. We recommend straightening and cleaning the outside condenser cooling fins on the exterior condenser to help assure adequate airflow and operation.

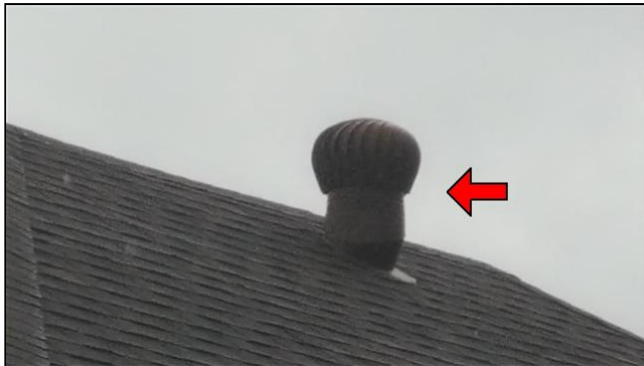
5.6 Item 1(Picture)

Turbine vent(s) noted. These types of vents can oftentimes be problematic: the bearings may wear out and the device can become noisy or stop working; and they can draw excessive air out of the attic space creating negative pressure thereby drawing conditioned air from the living space into the attic. This can cause warm, moist air to condense on the roof sheathing promoting the growth of mold. We recommend monitoring for future issues.

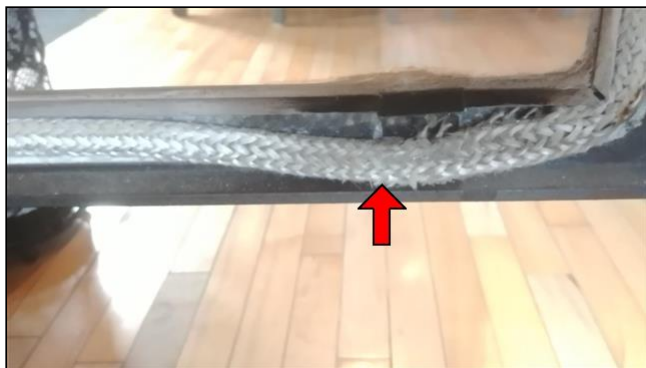
10.7 Item 2(Picture)

(2) The wood stove door gasket is damaged. We recommend review and repair by a qualified technician prior to use.

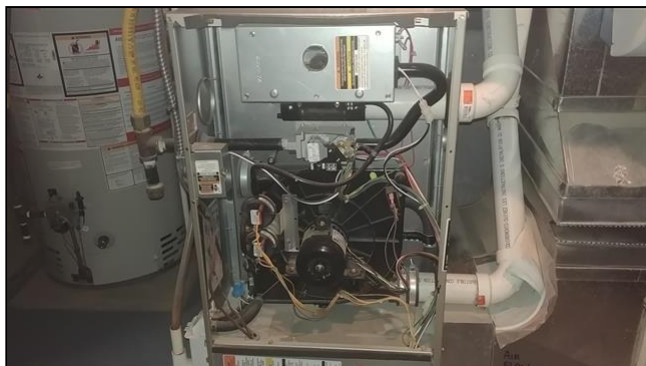
11.1 Item 1(Picture)

(1) High efficiency gas furnace noted. These types of appliances normally have a lifespan of 15 - 20 years. We recommend that the client consult with the current owner and obtain any documentation and service records that may be available for this system. If recent service records cannot be produced (i.e. completion of service within the past year), the furnace should be serviced by a qualified heating contractor prior to possession to ensure proper operation.

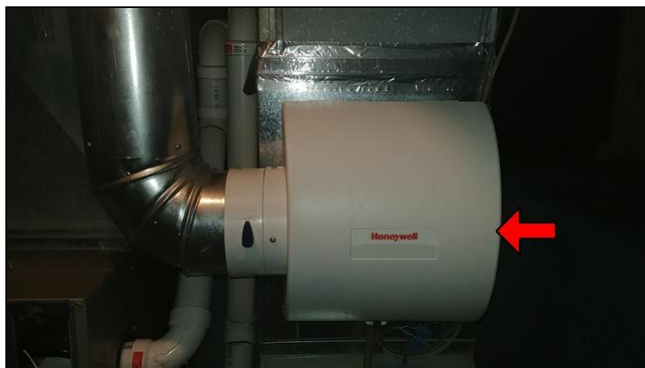
11.7 Item 1(Picture)

A humidifier is connected to the homes air handling system. In accordance with the CAHPI Standards of Practice, inspection of humidifier systems is not within the scope of a home inspection. We recommend consulting with the current owner or a qualified contractor to determine/obtain operations and maintenance information associated with the humidifier.

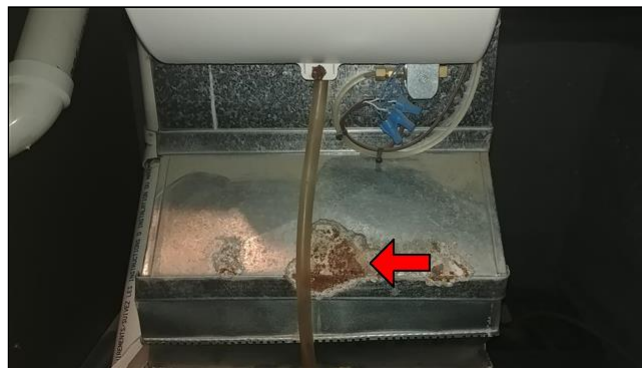
11.7 Item 2(Picture) Corrosion associated with leak from humidifier

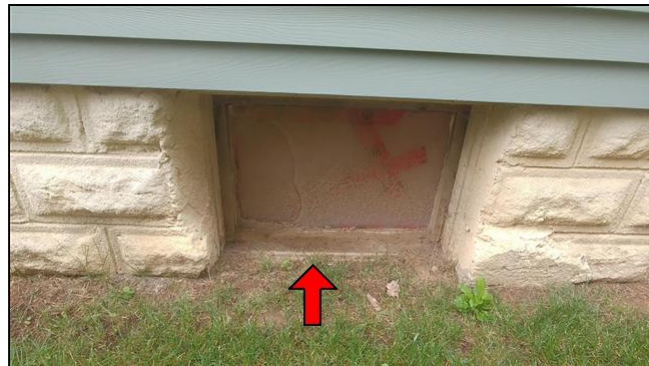
1.4 Item 1(Picture)

(1) As a result of grading, position of the window or other reasons, the basement window at the right side may be prone to water entry. We recommend that window wells be added at to minimize the potential for water infiltration around the basement windows.

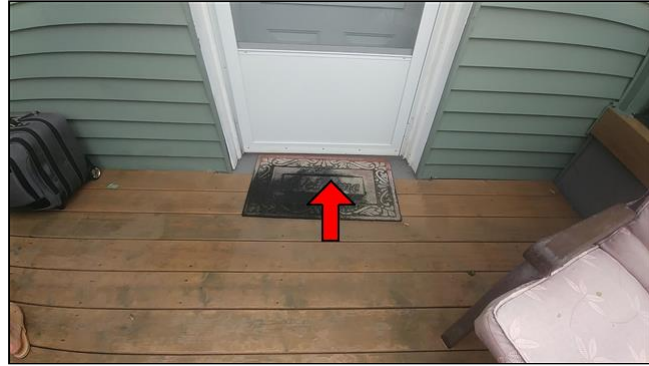
1.5 Item 1(Picture)

There is no clearance between the rear entry door and the deck. This arrangement may be susceptible to water entry. We recommend monitoring for snow and ice accumulation that may result in water intrusion and correct as required.

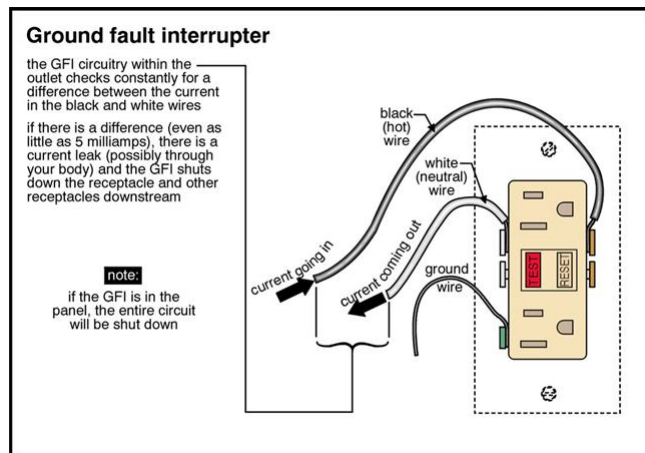
1.8 Item 1(Picture)

A Ground Fault Circuit Interrupter (GFCI) is not present at exterior, suggest installing GFCI for safety. A qualified electrical contractor is needed for further review and to make necessary repairs/corrections

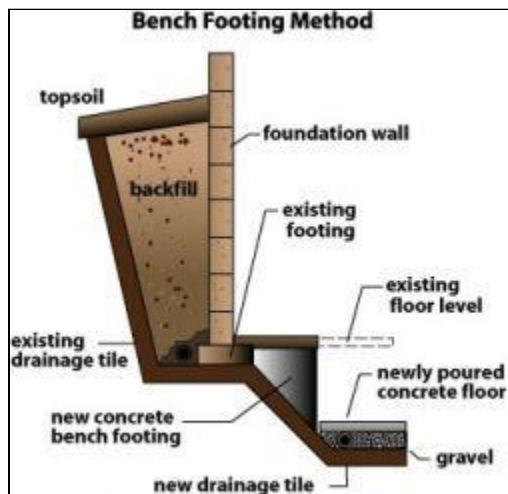
1.15 Item 1(Picture)

(2) Bench foundation observed where the basement floor has been lowered.

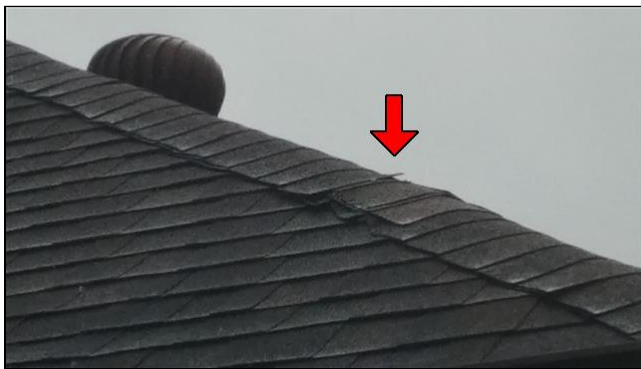
Damaged shingles observed at several locations. We recommend review by a licensed roofer for repair or replacement, as necessary.

2.0 Item 1(Picture) Front right

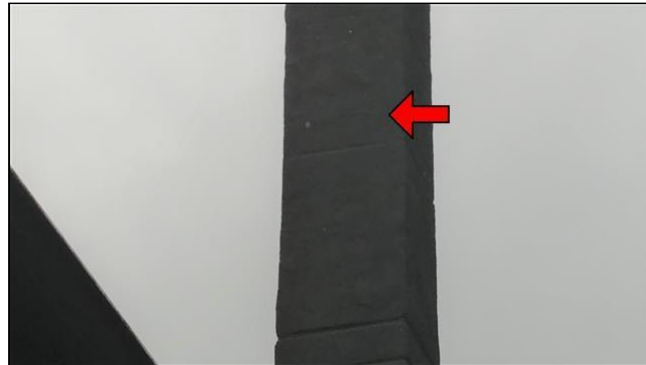
3.0 Item 1(Picture)

(1) Evidence of repairs observed at masonry chimney. We are unable to determine the effectiveness of these repairs and suggest the client consult with sellers for additional information.

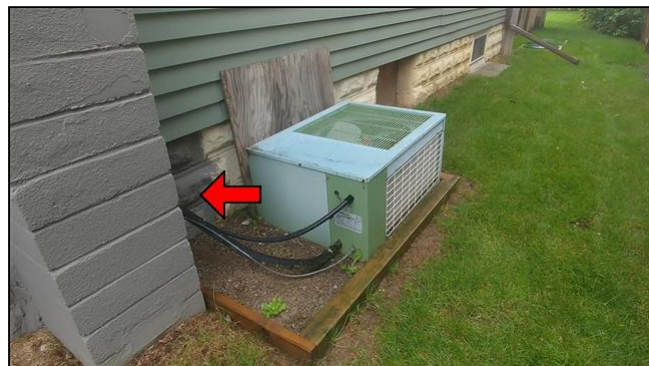
4.1 Item 1(Picture)

No electric disconnect noted, an electric disconnect is usually located within site of exterior condenser unit, this may not have been required when home was built, client may wish to install electric disconnect to enhance safety.

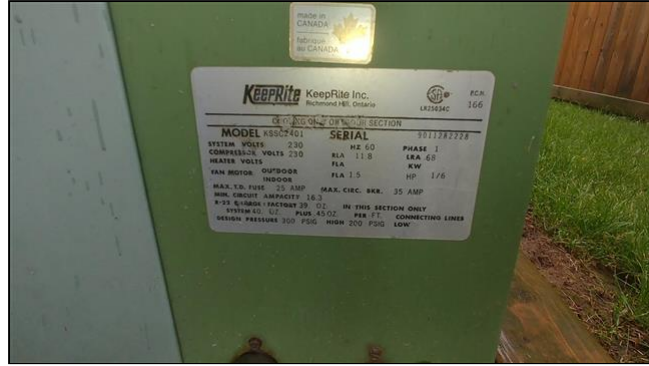
4.2 Item 1(Picture)

(1) Based on the estimated age of the air conditioner or other conditions (this unit uses an obsolete refrigerant that limits many repair options) noted at the time of the inspection. The unit is at or near the end of its useful life and the client should budget for a replacement.

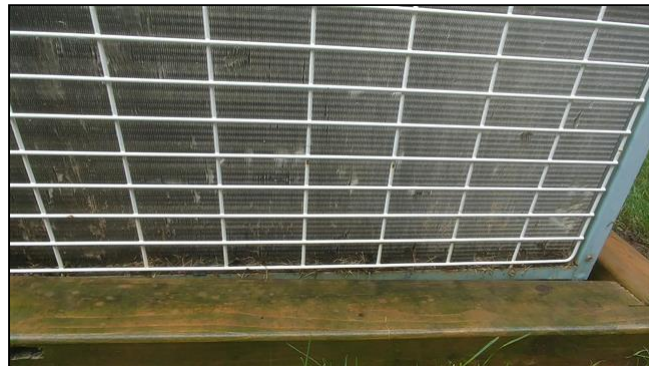
4.2 Item 2(Picture)

(2) The condenser fins at the outside compressor at bent, damaged and dirty. We recommend straightening and cleaning the outside condenser cooling fins on the exterior condenser to help assure adequate airflow and operation.

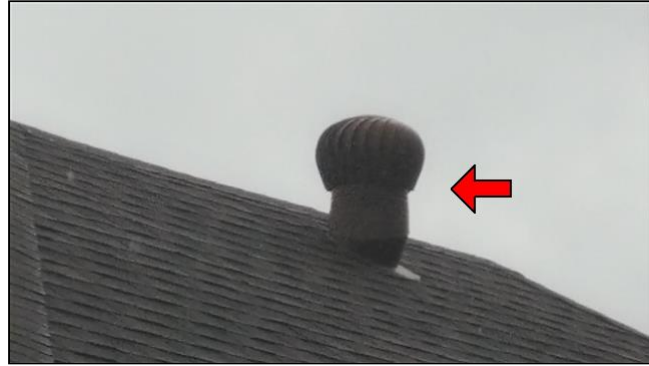
5.6 Item 1(Picture)

Turbine vent(s) noted. These types of vents can oftentimes be problematic: the bearings may wear out and the device can become noisy or stop working; and they can draw excessive air out of the attic space creating negative pressure thereby drawing conditioned air from the living space into the attic. This can cause warm, moist air to condense on the roof sheathing promoting the growth of mold. We recommend monitoring for future issues.

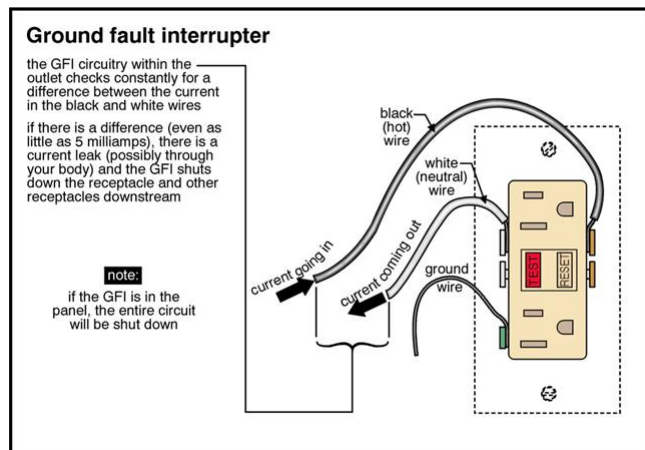
6.7 Item 1(Picture)

(1) A Ground Fault Circuit Interrupter (GFCI) is not present at kitchen, suggest installing GFCI for safety. A qualified electrical contractor is needed for further review and to make necessary repairs/corrections

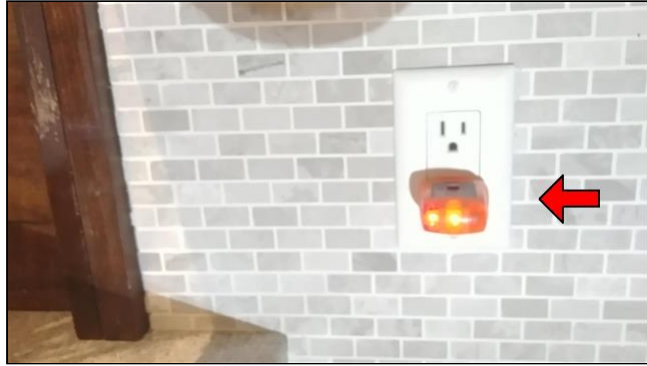
6.7 Item 2(Picture)

(2) Reversed polarity wiring conditions were observed. A reversed polarity condition occurs when the hot and neutral wires are connected to the opposite terminal connections of the outlet (i.e. hot wire connected to neutral terminal and neutral wire connected to hot terminal). This can be a safety hazard. This condition is usually easily corrected by minor wiring adjustments at the specific outlet(s)

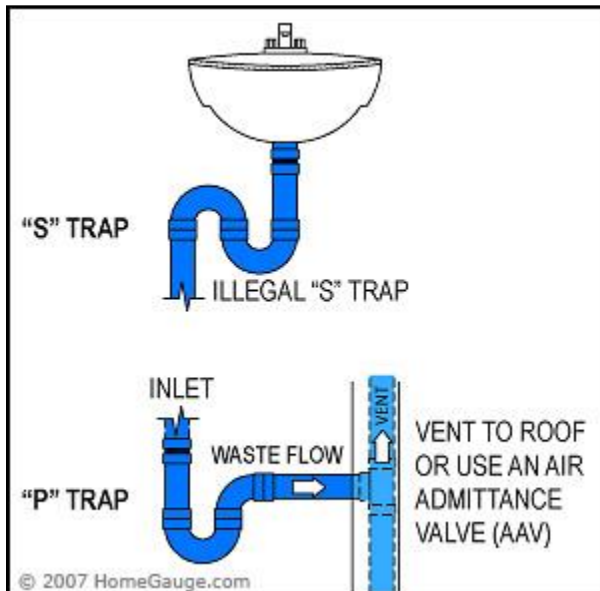
6.12 Item 1(Picture)

An S trap was noted at kitchen sink drain assembly. We recommend replacing with a P-trap to help prevent the venting of sewer gases inside the structure.

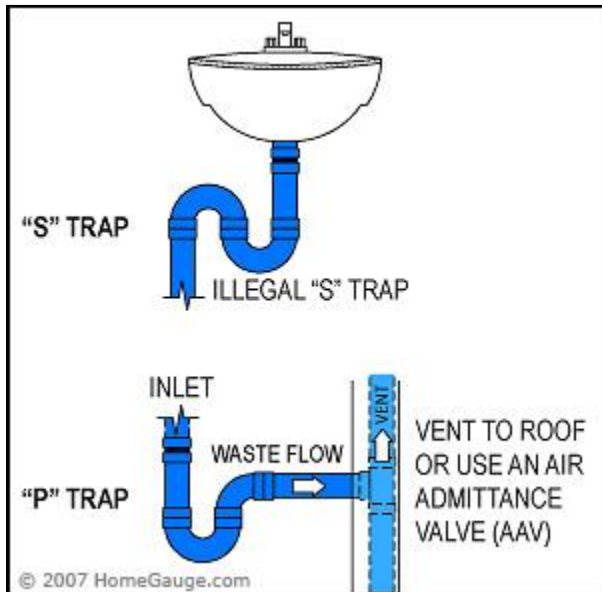
7.16 Item 1(Picture)

(1) An S trap was noted at main floor bathroom (with the laundry). We recommend replacing with a P-trap to help prevent the venting of sewer gases inside the structure.

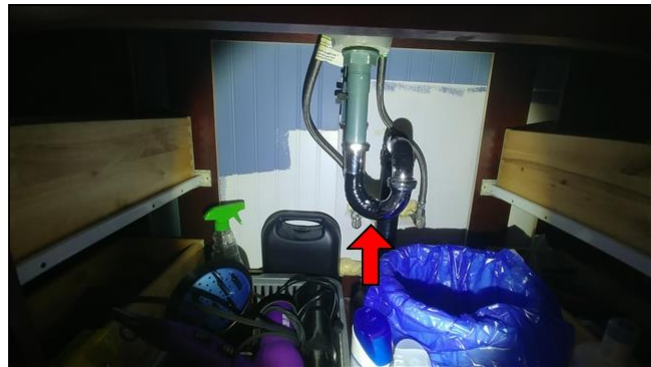
7.16 Item 3(Picture)

(2) Tape observed wrapped around the drain assembly. The purpose of the tape is unknown and non-standard. We recommend confirming the purpose with the seller or review by a qualified plumber prior to closing.

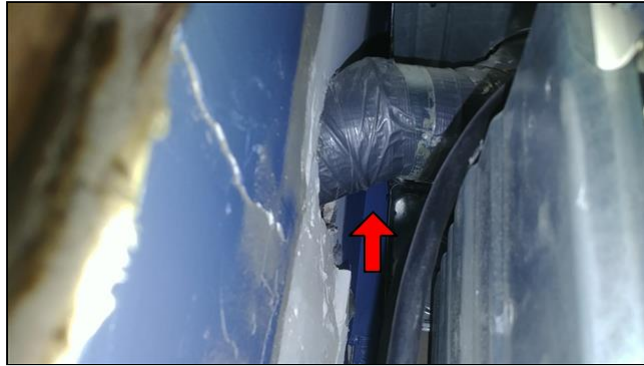
8.12 Item 1(Picture)

(2) Flexible tape used on the dryer discharge pipe. Flexible tape (duct tape) is not designed for high temperature applications and becomes brittle quickly. We recommend removal of the tape and replacement with an appropriate vent pipe sealant or tape.

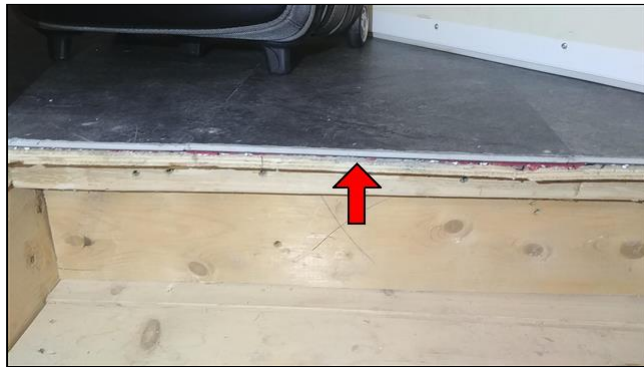
9.0 Item 1(Picture)

Missing transition observed at the head of the basement stairs. This arrangement presents a fall/trip hazard and is subject to physical damage. We recommend installing a proper transition to protect the flooring and improve safety.

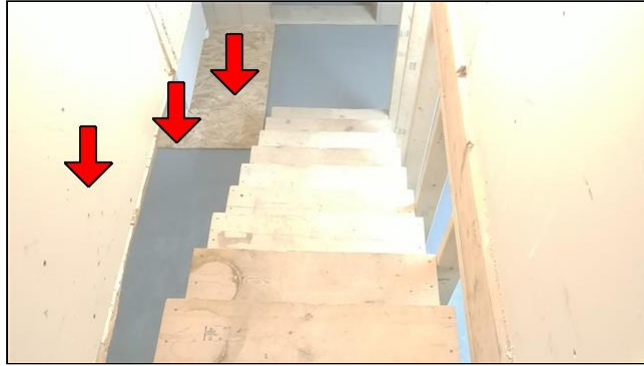
9.8 Item 1(Picture)

(1) No handrailings or guardrails noted at the basement stairs. We recommend installing handrails and guardrails for safety.

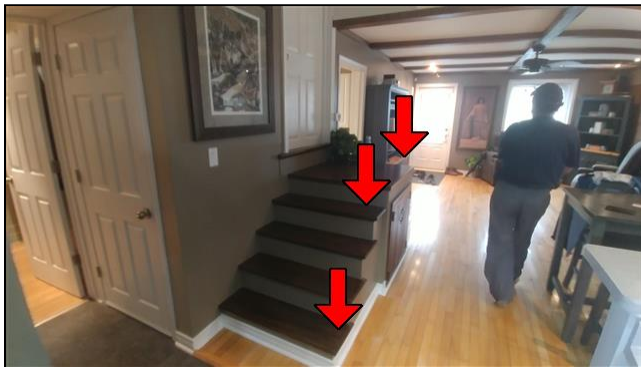
9.8 Item 2(Picture)

(2) No handrailings or guardrails noted at the stairs to upper level. We recommend installing handrails and guardrails for safety.

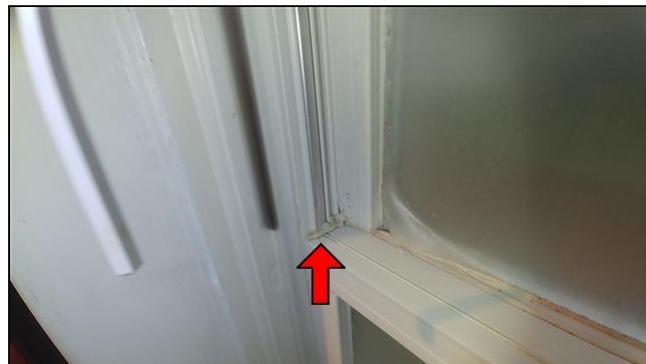
10.4 Item 1(Picture)

Sealed-up window observed in the bathroom. We recommend consulting sellers for additional information regarding condition and operation.

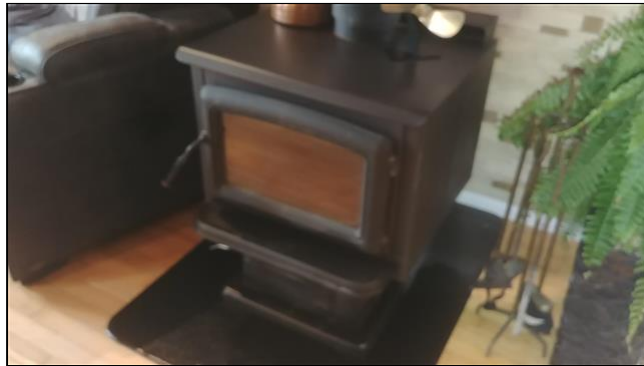
10.7 Item 1(Picture)

(1) A wood burning appliance is noted. A detailed assessment of the adequacy of the installation, clearances to combustibles materials and shielding was not completed as part of the home inspection. We recommend consulting with a Wood Energy Transfer Technology (WETT) certified inspector or contractor for further assessment to ensure safe and proper installation prior to use. Given that more recently home insurance companies have very restrictive policies regarding the presence of wood stoves in homes, we recommend consulting with your insurance company to obtain policy information regarding wood burning appliances and verify proper installation in accordance with their requirements.

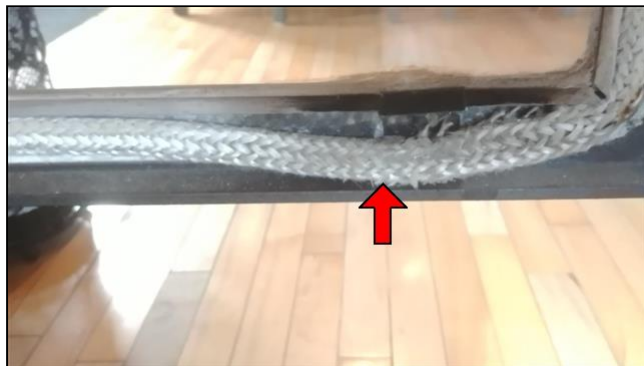
10.7 Item 2(Picture)

(2) The wood stove door gasket is damaged. We recommend review and repair by a qualified technician prior to use.

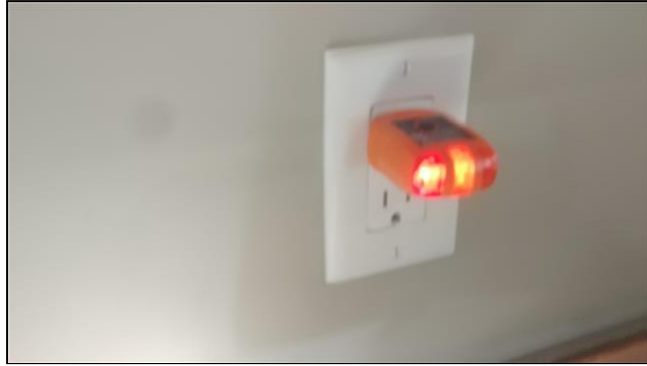
10.8 Item 1(Picture)

Reversed polarity detected at numerous outlets on the first and second floor. Reversed polarity, hot and neutral wires reversed, is usually easily corrected by minor wiring adjustments at the affected outlet(s). When this condition is observed, a qualified electrical contractor is needed for repairs/corrections.

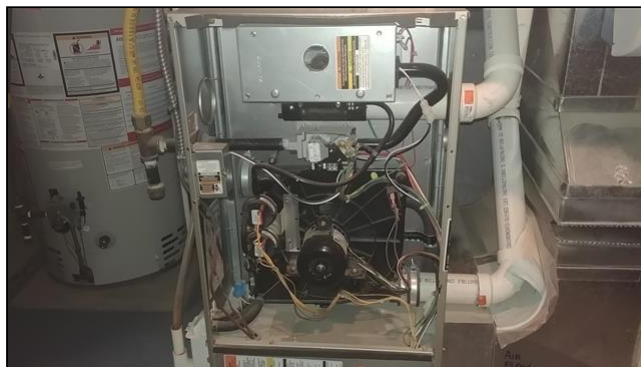
11.1 Item 1(Picture)

(1) High efficiency gas furnace noted. These types of appliances normally have a lifespan of 15 - 20 years. We recommend that the client consult with the current owner and obtain any documentation and service records that may be available for this system. If recent service records cannot be produced (i.e. completion of service within the past year), the furnace should be serviced by a qualified heating contractor prior to possession to ensure proper operation.

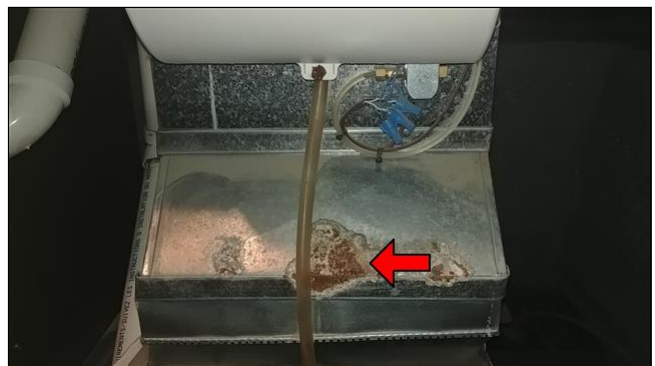
11.7 Item 2(Picture) Corrosion associated with leak from humidifier

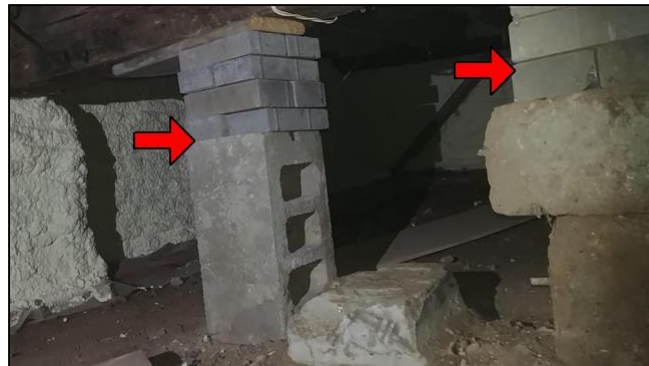
12.10 Item 1(Picture)

Temporary block/brick columns observed supporting the beam in the crawlspace. We recommend review by a qualified contractor and the installation of properly supported permanent column(s).

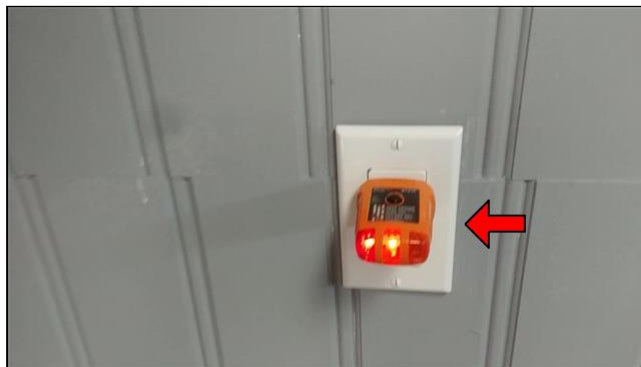
12.13 Item 1(Picture)

Reversed polarity detected at basement. Reversed polarity, hot and neutral wires reversed, is usually easily corrected by minor wiring adjustments at the affected outlet(s). When this condition is observed, a qualified electrical contractor is needed for repairs/corrections.

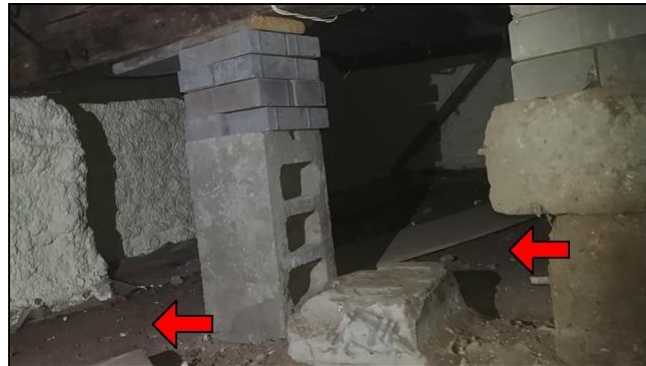
12.16 Item 1(Picture)

No moisture barrier observed on crawlspace earth floor. Moisture barriers may not have been required at the time the home was built. We recommend a complete review of the crawlspace by a qualified contractor for possible installation of a moisture barrier to prevent any future/further damage/deterioration to the structure and to ensure a dry clean crawlspace.
