Inspection Report

Property Address:
1234 Anywhere St.
Toronto ON M2N 1W7

Amerispec of Toronto West & Mississauga

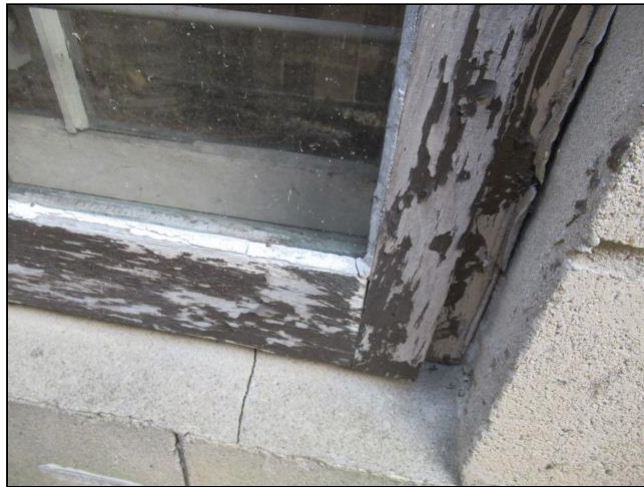
1.4 Item 1(Picture)

1.4 (2) Peeling paint/weathered conditions observed. Suggest scraping and painting/staining as necessary as part of normal maintenance.

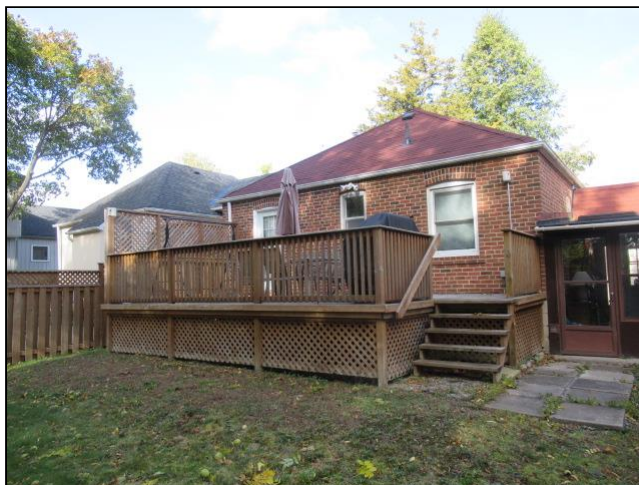
1.13 Item 1(Picture)

1.13 (2) A deck located at the rear limits our review of the grade and condition of the foundation. Should the grade be low near the foundation wall and/or there be cracks in the foundation, water infiltration could occur into the home. We recommend consulting with the current owner or conducting a further review of this area prior to closing.

1.13 (1) Adding earth to any low lying areas located around the foundation is recommended to ensure proper drainage away from the foundation at all times.

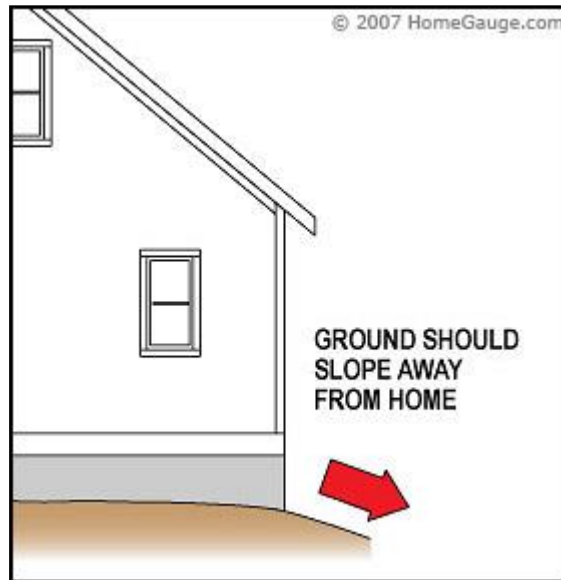
1.13 Item 2(Picture)

1.13 (3) The grade at the foundation appears to be inadequate. Recommend review by licensed contractor for corrections as needed.

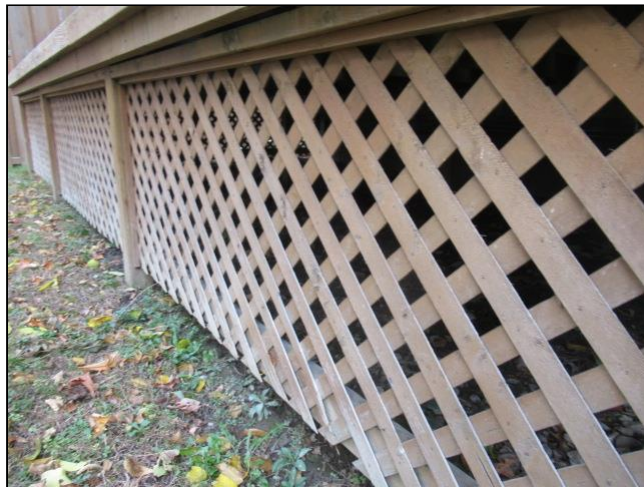
1.15 Item 1(Picture)

1.15 Skirting around the deck prevented a review of the structure of the deck and grade.

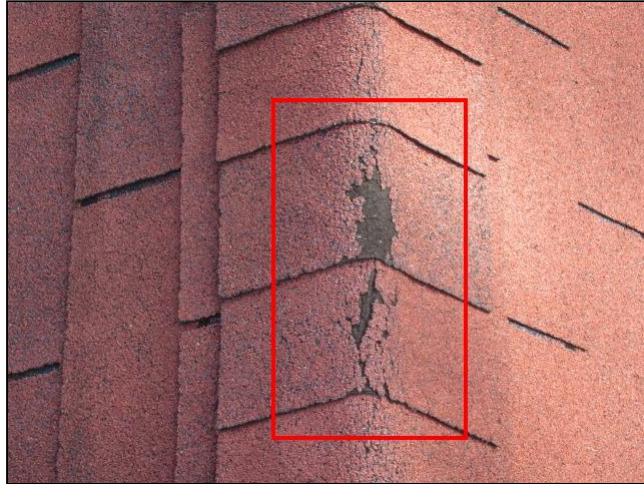
2.2 Item 1(Picture)

2.2 deteriorated shingles observed.
Recommend review by a licensed roofer
for repair or replacement prior to close.

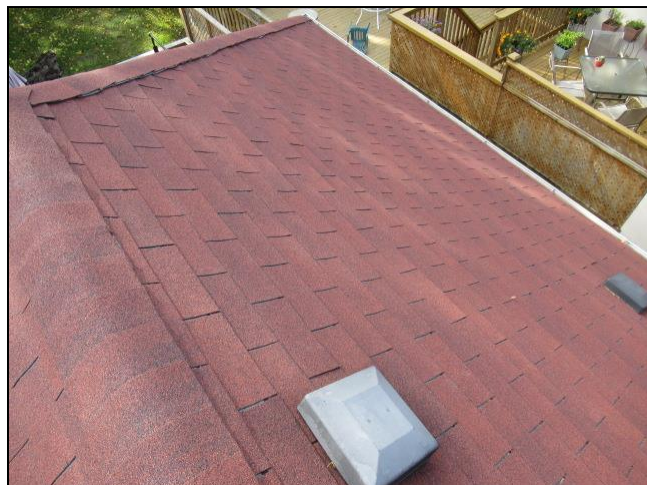
3.0.A Item 2(Picture)

3.0.A (2) Roof shows normal wear for its age and type. No damaged, deteriorated, or missing roofing materials were observed; it appears to be in serviceable condition.

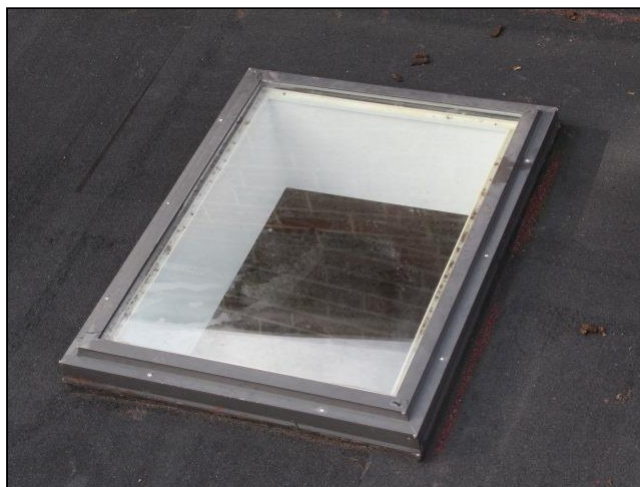
3.2.B Item 1(Picture)

3.2.B Skylight(s) are present in the home. Skylights are very vulnerable with respect to the potential for water infiltration into the home. On this basis, we recommend properly sealing skylight flashings as part of routine maintenance to prevent potential water infiltration into the home and water damage to concealed components of the home.

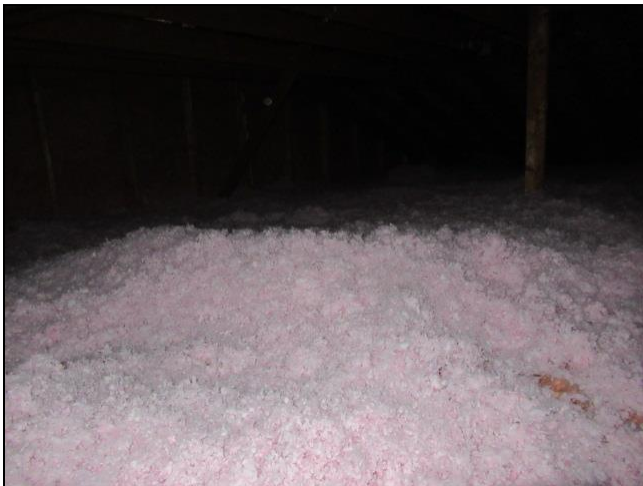
4.2 Item 1(Picture)

4.2 10-12" of insulation present, equivalent to approximately R32.

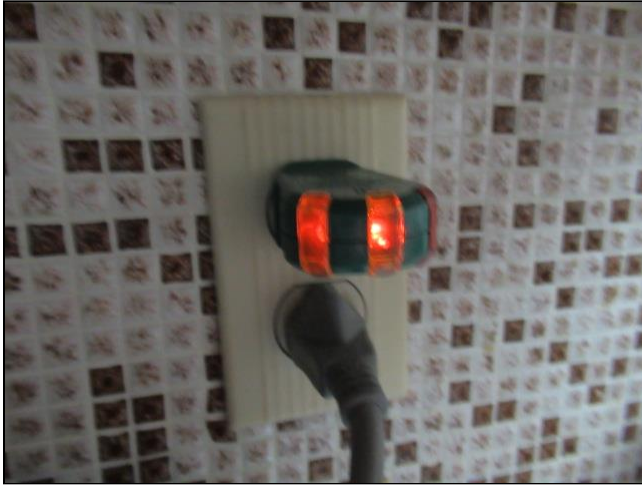
6.6.A Item 1(Picture)

6.6.A Reversed polarity detected in bathroom. Reversed polarity, hot and neutral wires reversed, is usually easily corrected by minor wiring adjustments at the affected outlet(s). When this condition is observed, a qualified electrical contractor is needed for repairs/corrections.

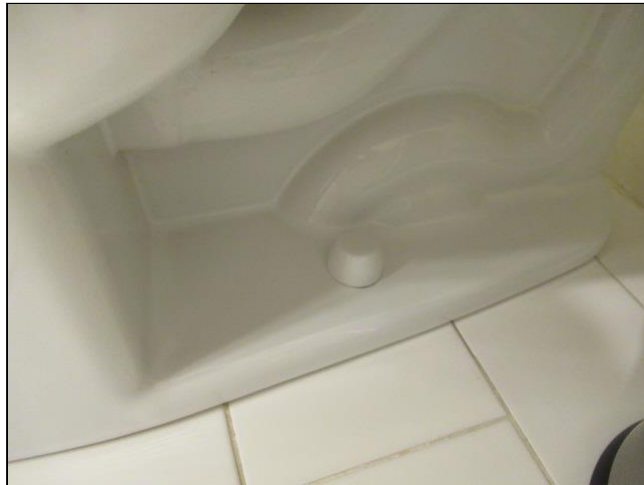
6.16.A Item 1(Picture)

6.16.A The toilet bowl is loose at floor anchor bolts. The wax ring inside the unit must have a snug, secure fit in order to keep from leaking. Properly resealing and re-securing this unit is suggested to prevent water leakage and damage to the sub-floor area. This type of damage is not always visible or accessible to the inspector at time of inspection. Recommend review by a qualified plumber for repair or replacement, as necessary.

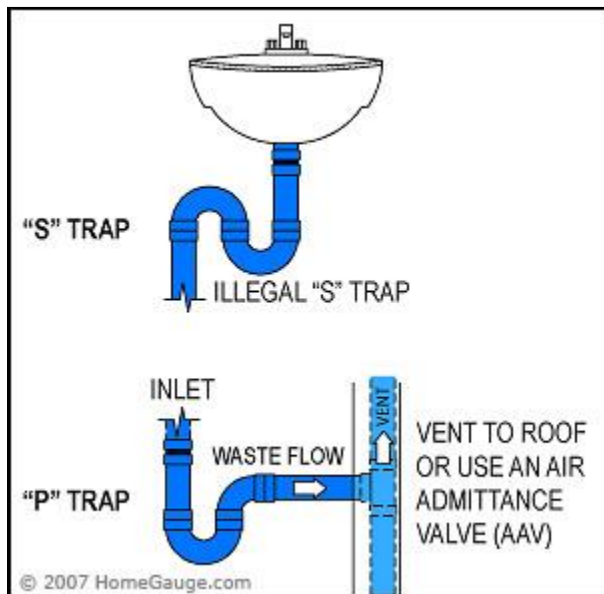
7.10 Item 1(Picture)

7.10 An S trap was noted at kitchen sink. We recommend replacing with a P-trap to help prevent the venting of sewer gases inside the structure.

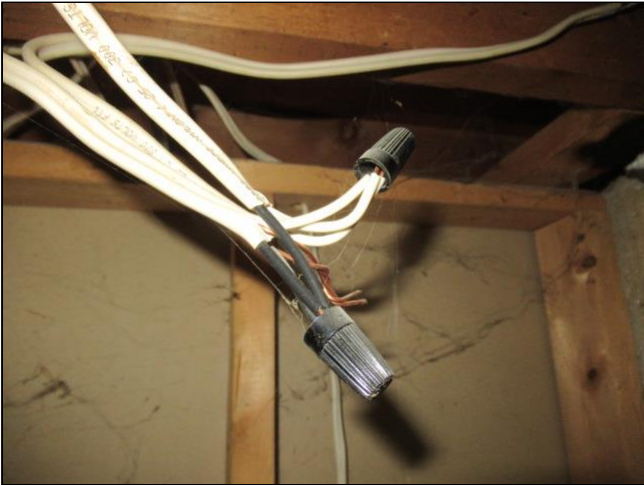
14.8 Item 1(Picture)

14.8 (1) Open splice observed. This is a "Safety Concern". Whenever an electric wire is cut and reconnected, the "splice" should be encased in a covered "junction box" to prevent shocks and separation of the splice. Client is advised to consult with a licensed electrician prior to closing for repairs/replacement as needed to ensure safety.

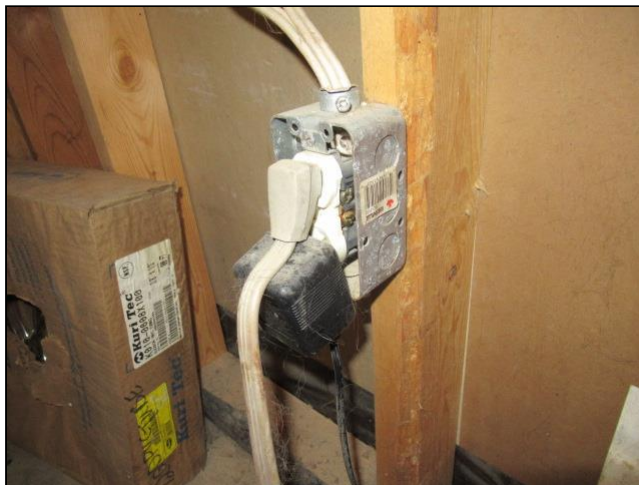
14.8 Item 2(Picture)

14.8 (2) Receptacle cover missing in furnace room, recommend replacing for safety.

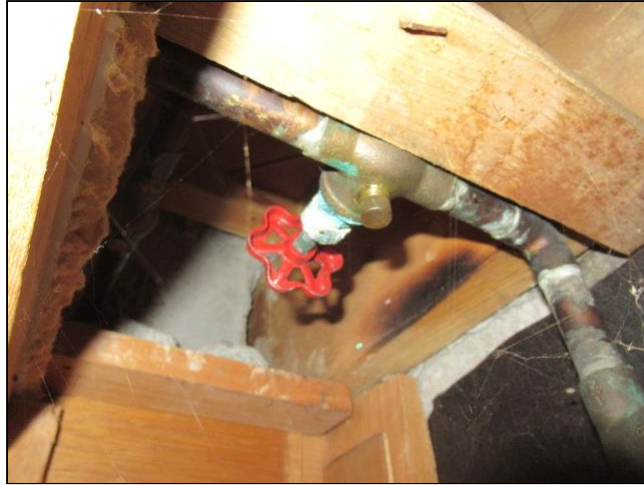
15.0 Item 1(Picture)

15.0 Gate-type valve observed. Since main shut-off valves are operated infrequently, it is not unusual for them to become frozen over time. They often leak or break when operated after a period of inactivity. For this reason main shut-off valves are not tested during a home inspection. We suggest caution when operating shut-offs that have not been turned for a long period of time. We recommend that the client consider upgrading the shut-off valve to a high quality ball-type valve which tend to be more reliable than gate valves.

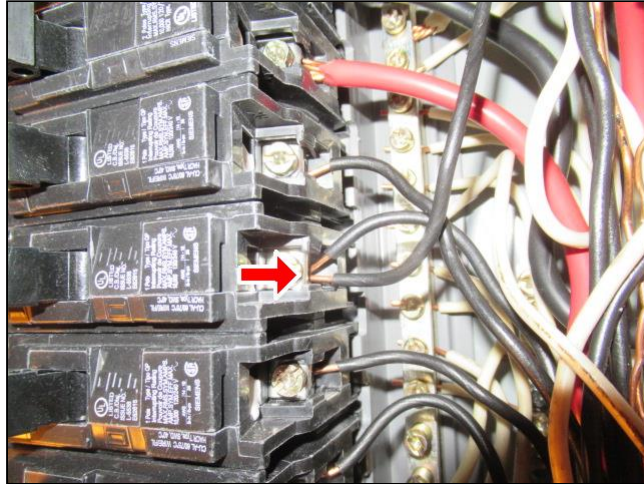
16.1 Item 2(Picture)

16.1 (2) Double tapping observed in main electrical panel. Double tapping (i.e. 2 wires on a single pole breaker) can add to the load of the affected circuit causing a possible overload and tripping breakers. We recommend review by a qualified professional electrician for repair or replacement as necessary.

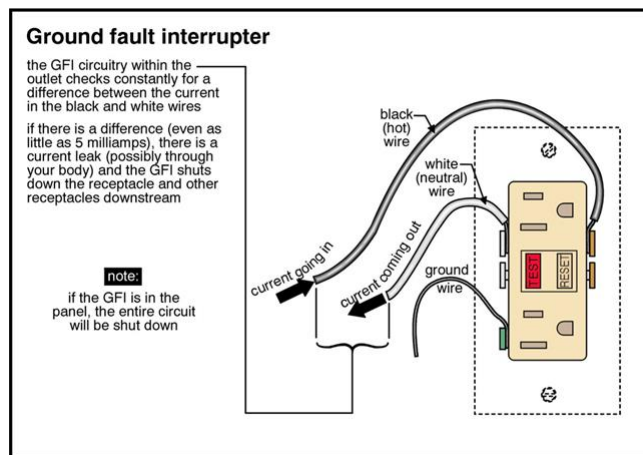
16.6 Item 1(Picture)

16.6 Ground fault circuit interrupters (GFCI's) are special electrical devices that shut off the power to a circuit when as little as .005 amps of electricity leaks from the electrical system. GFCI's/GFI's may be incorporated into circuit breakers or outlets. GFCI's/GFI's should ideally be installed on all outdoor outlets and bathroom outlets to enhance safety where electricity may be in close proximity to water.

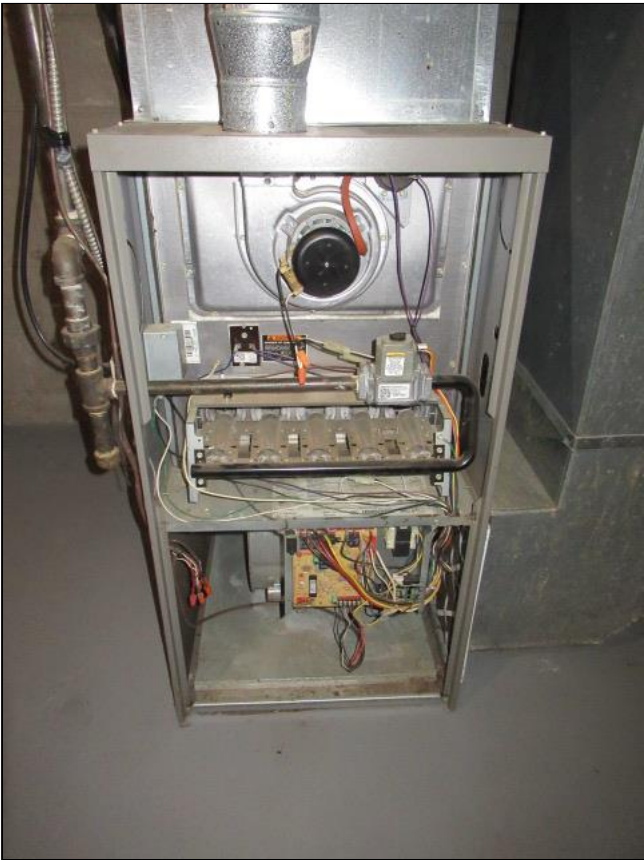
17.0 Item 1(Picture)

17.0 (1) Mid-efficiency gas furnace noted. These types of appliances normally have a lifespan of 18 - 25 years. The appliance operated under normal controls at the time of the inspection and appeared to be in serviceable condition. We recommend that the client consult with the current owner and obtain any documentation and service records that may be available for this system. If recent service records cannot be produced (i.e. completion of service within the past year), the furnace should be serviced by a qualified heating contractor prior to possession to ensure proper operation.

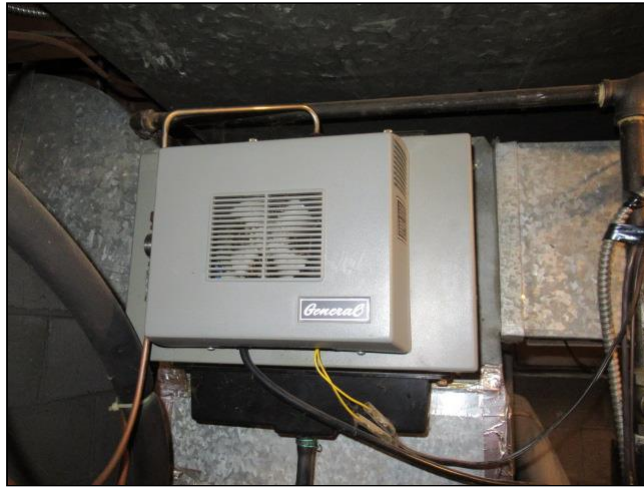
17.6 Item 1(Picture)

17.6 A humidifying system is present on the furnace. As per the Inspection Agreement, humidifiers are beyond the scope of this inspection, suggest client verify operation with sellers.
