AmeriSpec Inspection Service
2336 Whitburn Crescent
Kamloops, BC V1S1W4
Ph#: (250) 377-0026 Fax#: (250) 372-1309

Doc #: 201803-1875 Inspector: Bill Johnson

Dwelling Address: 1234 Any Road
Kamloops, BC

AmeriSpec General Home Inspection**GENERAL CONDITIONS**

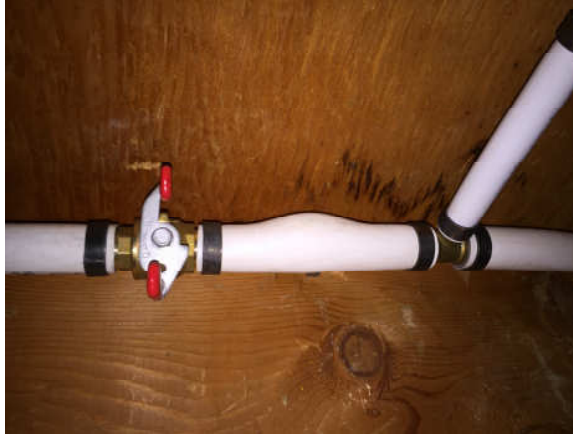
1620. Visible
Plumbing

Review. Bulging/split water pipe observed in the ceiling of the basement bedroom. Recommend review by a licensed plumber for repair or replacement, as necessary.

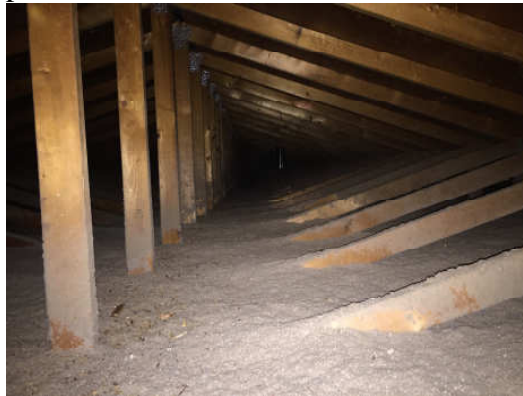
Step #	Component	Comment
2701.	Access location / Inspection method	Serviceable. The attic access is located at garage. Our attic inspection determines the presence of insulation, visible evidence of leakage and the underside of the roof, ventilation, and a visual review of the rafters and/or trusses.
2702.	Framing	Serviceable. Trusses. Wood truss construction noted.
2703.	Sheathing	Serviceable. Plywood.
2704.	Evidence of Leaking	No water stains observed on the ceilings/roof decking at the time of inspection.
2705.	Insulation	Serviceable. Fiberglass; Cellulose fiber. 12" of insulation present.
