# Inspection Report

AmeriSpec Inspection Services(A Division of CanaSpec Services Inc.)

2023-05-23

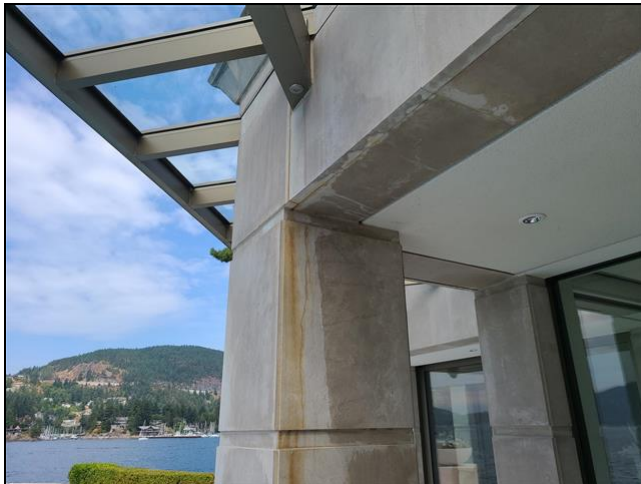
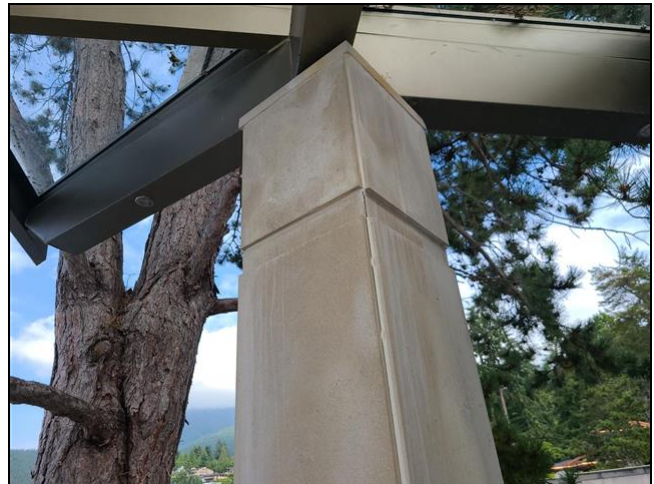
1.4 Item 1(Picture)

No water noted but evidence of previous leaks at rear patio cover. Dry at time of inspection. Seller stated this was a past leak that was repaired. Monitor.

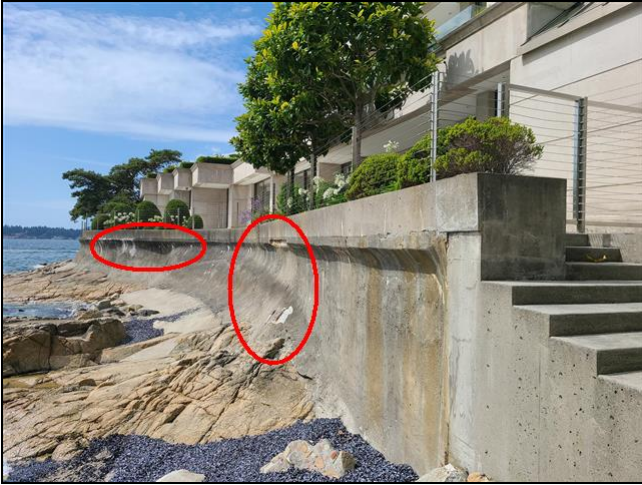
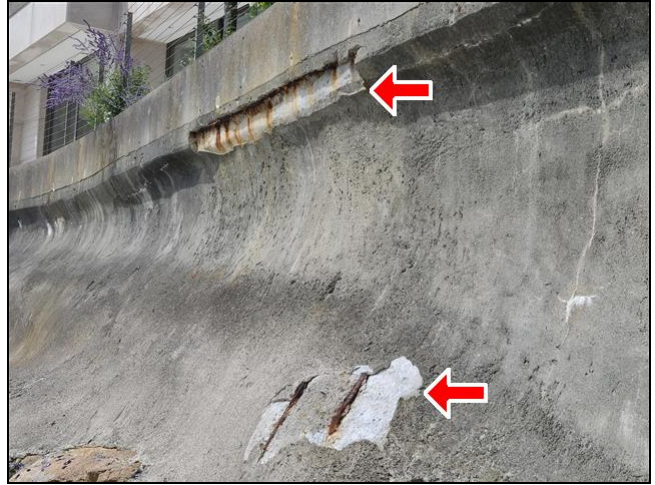
1.13 Item 1(Picture)

Cracking and flaking concrete noted sea wall. The preceding conditions should be reviewed by a qualified contractor and repaired Item 2(Picture) as required.

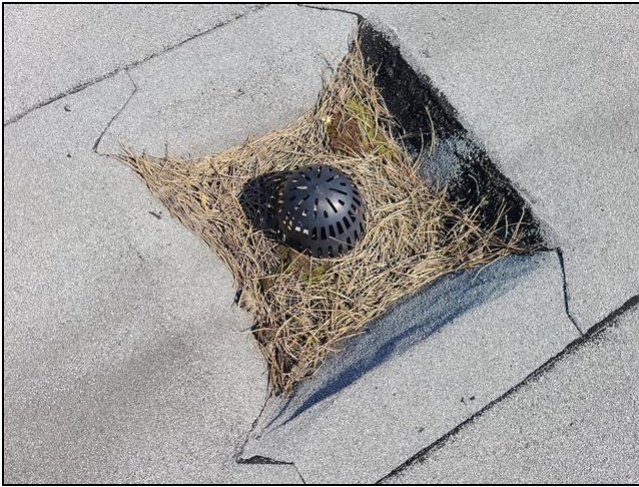
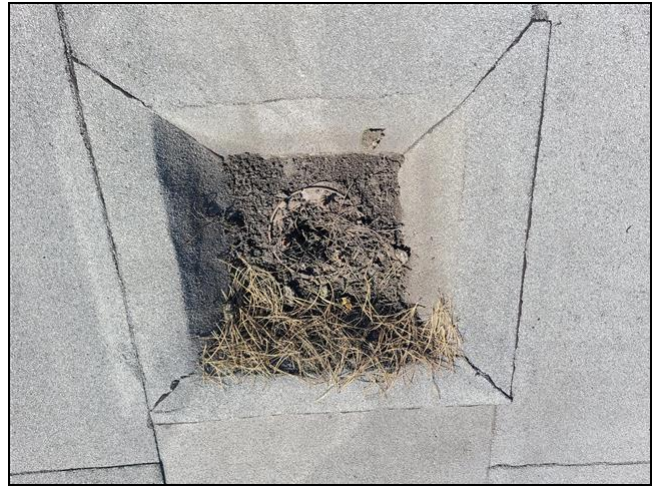
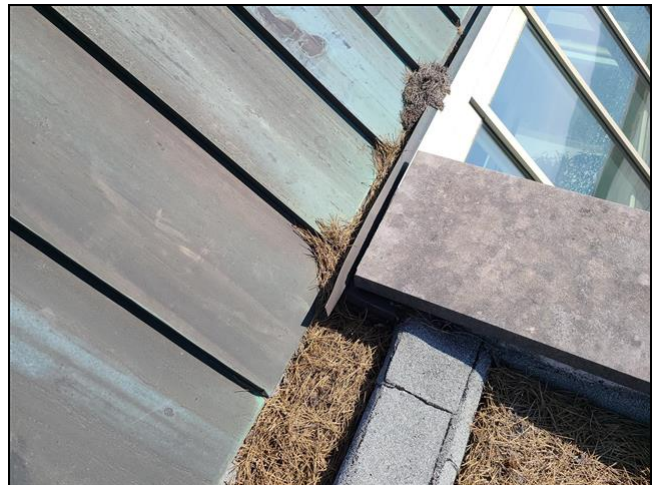
3.0 Item 1(Picture)

(2) Debris observed on the roof limits view of roof and prevents the roof from draining or drying out. One drain missing grate and is plugged. Recommend cleaning and regular maintenance.

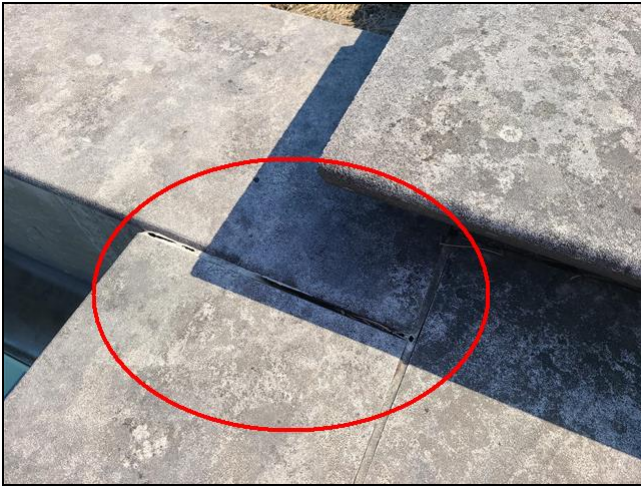
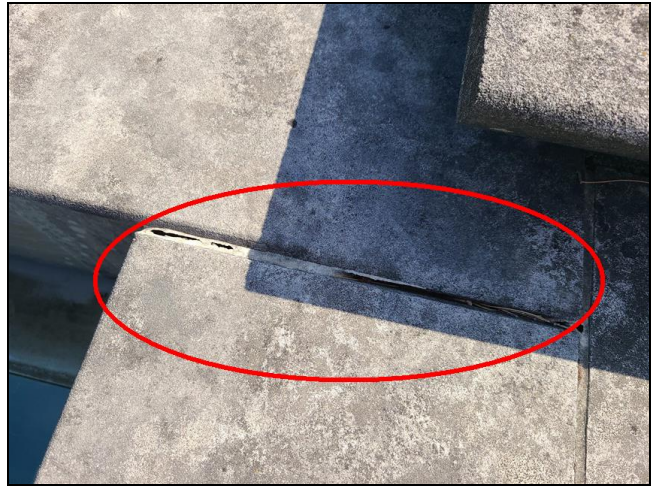
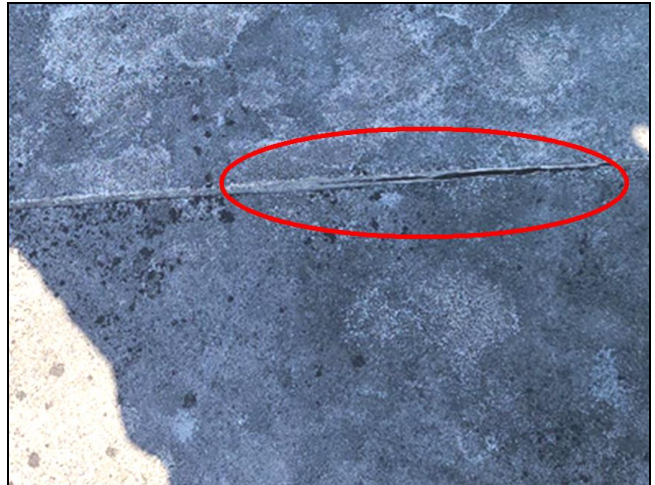
3.4 Item 1(Picture)

Horizontal concrete parapet walls present around the perimeter of the roof system. Cracking and missing mortar in spots. Seal any openings to prevent moisture penetration as preventative maintenance.

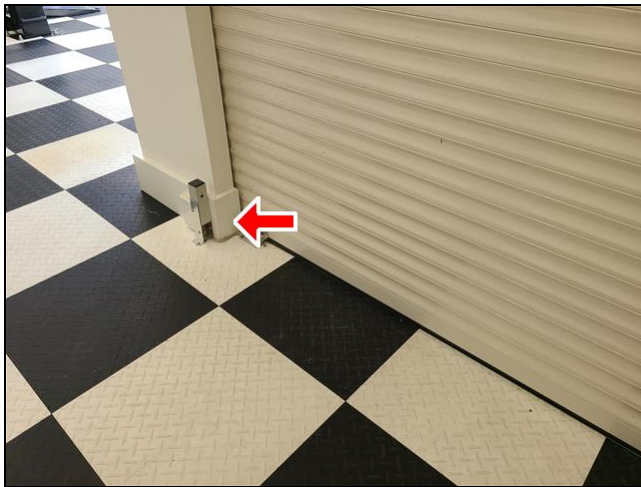
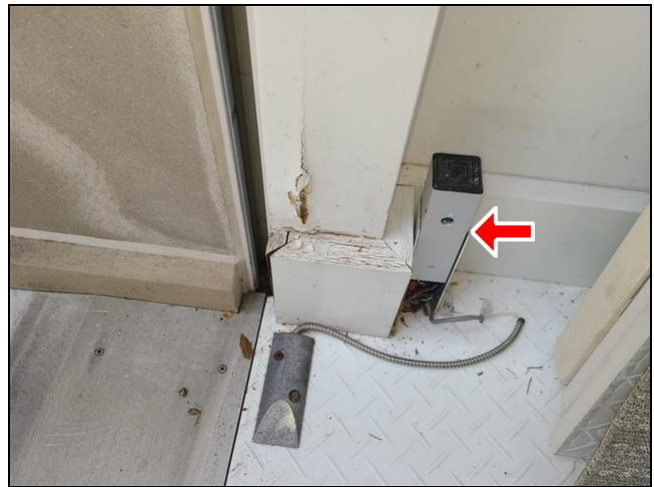
4.2 Item 1(Picture)

Safety reverse did not respond to test at the two smaller car doors. This garage door opener is equipped with a safety reverse device which did not operate when tested at the time of inspection. Recommend review for repair or adjustment, as necessary to ensure safety.

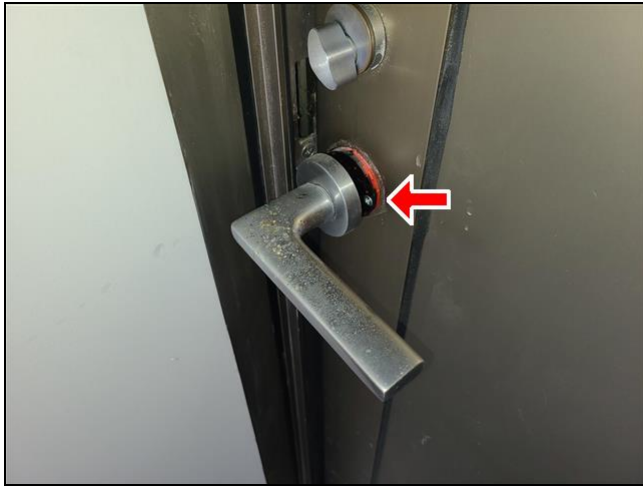
4.3 Item 1(Picture)

Loose door handle at right most garage, exterior door. Tighten as required.

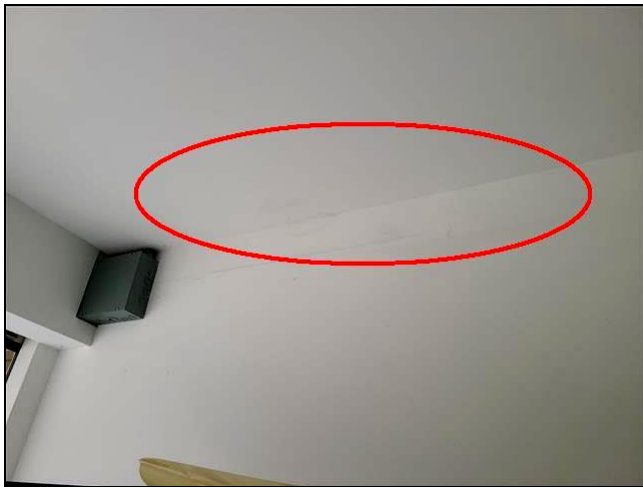
4.6 Item 1(Picture)

No water noted but evidence of previous leaks. Dry at time of inspection. Seller stated that leak was repaired some time ago.

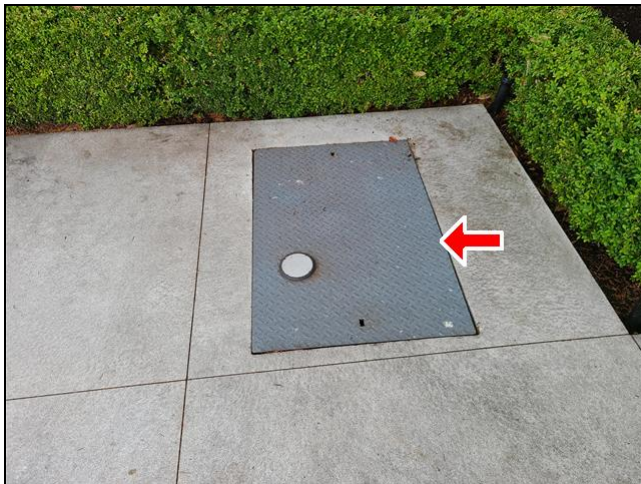
8.0 Item 1(Picture)

Main water shutoff not located at time of inspection. Recommend confirming the location with the seller or HVAC contractor in case emergency shutoff is required. Possibly located at front driveway gate under access panel. This could not be easily lifted at time of inspection. There may be a shut off located inside the home as well.

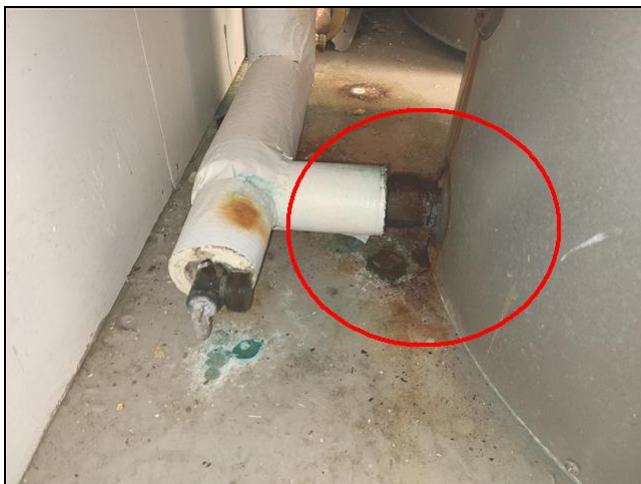
9.1 Item 1(Picture)

Small drip leak noted behind one of the holding tanks. The preceding conditions should be reviewed by a qualified contractor and repaired or replaced as required.

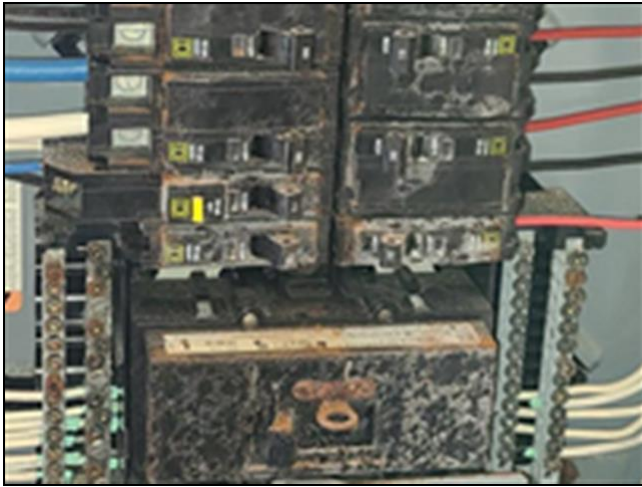
10.3 Item 1(Picture)

Corrosion noted inside pool equipment room sub panel. This may affect the operation of the breakers. Recommend this be reviewed by a qualified electrician when present onsite for other work.

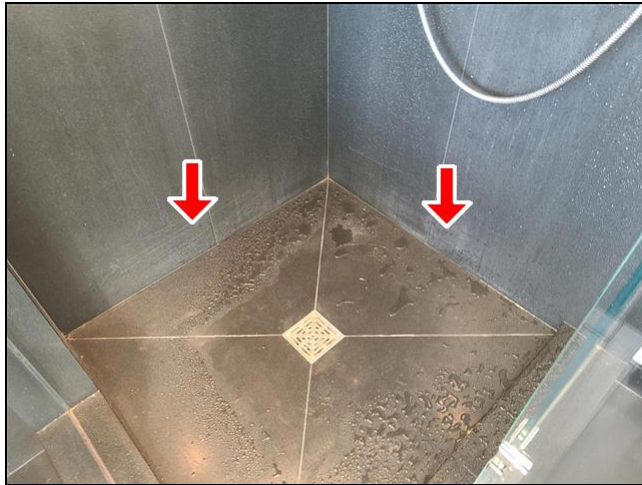
12.7.C Item 1(Picture)

Moisture detected behind tiles around the base of the walls with moisture meter.

Recommend water sealing grout. This can help prevent moisture penetration through the grout and into the wall. Recommended that this be done every 2-3 years.

Recommend installing or re-installing mildew resistant silicon around the perimeter of the tub/shower and at the vertical wall joints.

The tile grout and edges of the tub/shower walls should be caulked and sealed to prevent moisture penetration. Failure to keep walls sealed can cause deterioration and moisture damage to the interior walls, which is not always visible to the inspector at the time of inspection.

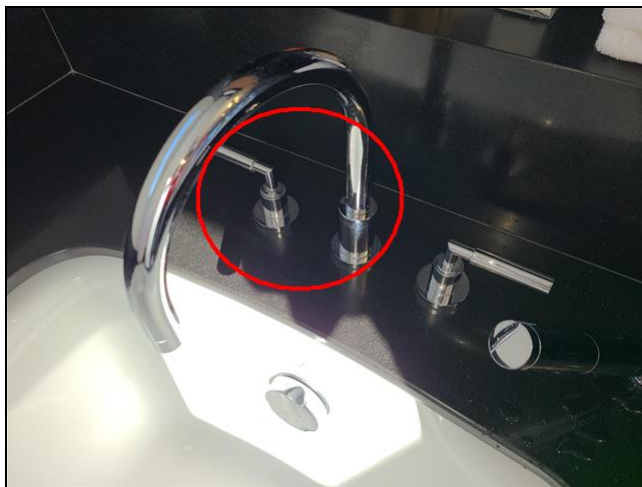
12.8.C Item 1(Picture)

Loose spout and control handles. Repair as required.

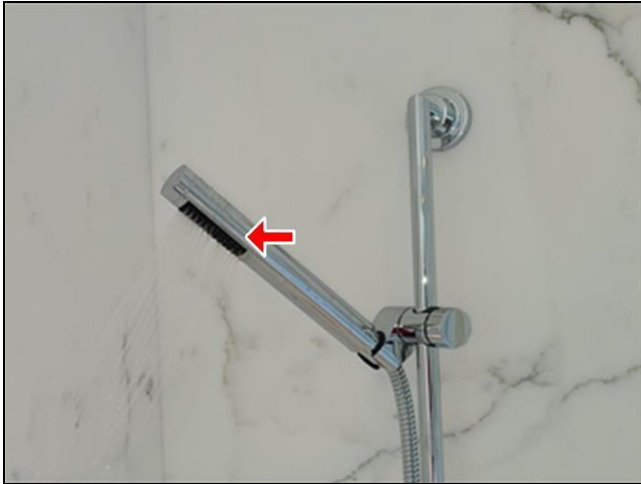
12.7.D Item 1(Picture)

Loose handles. Repair as required. Some water restriction at shower head. Clean as required.

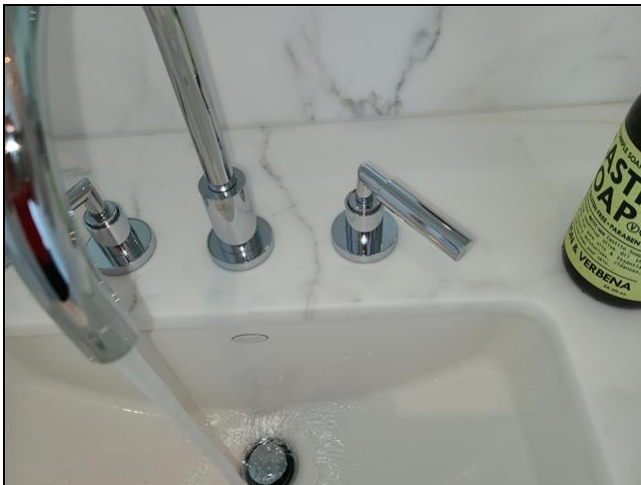
12.9.D Item 1(Picture)

Loose handle.

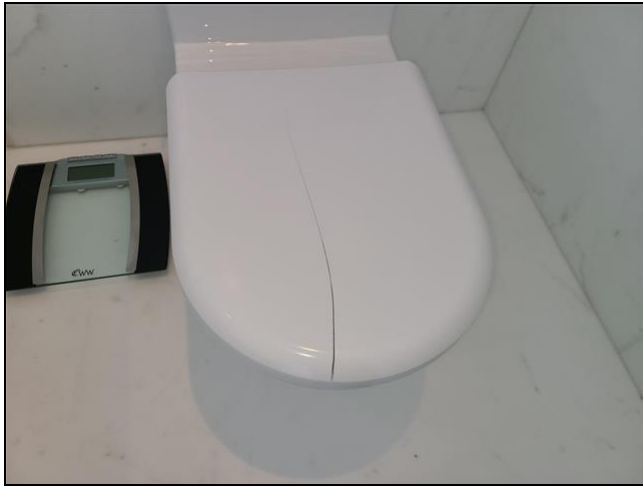
12.10.D Item 1(Picture)

Cracked lid. Owner has ordered a replacement.

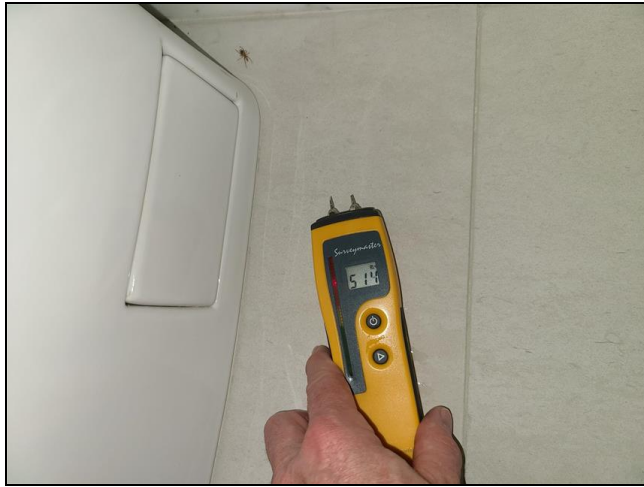
12.0.E Item 1(Picture)

Moisture detected with moisture meter beside toilet. See report line # 11.9.E.

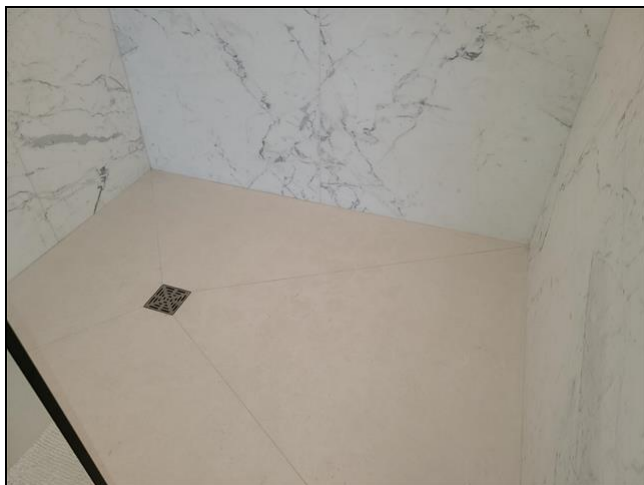
12.7.E Item 1(Picture)

(1) Worn/cracked silicone noted. Recommend installing or re-installing mildew resistant silicon around the perimeter of the tub/shower and at the vertical wall joints.

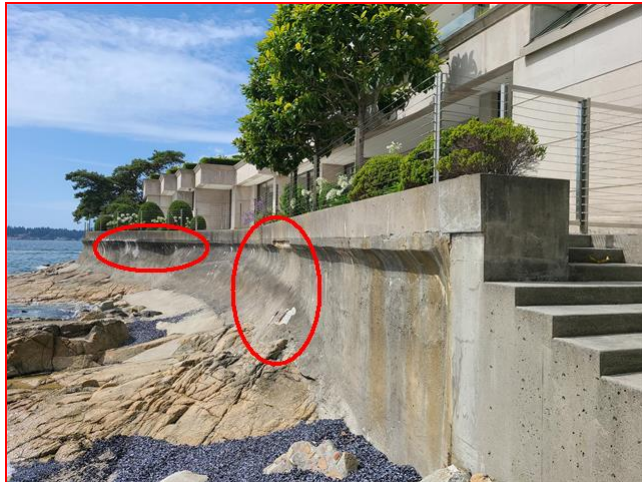
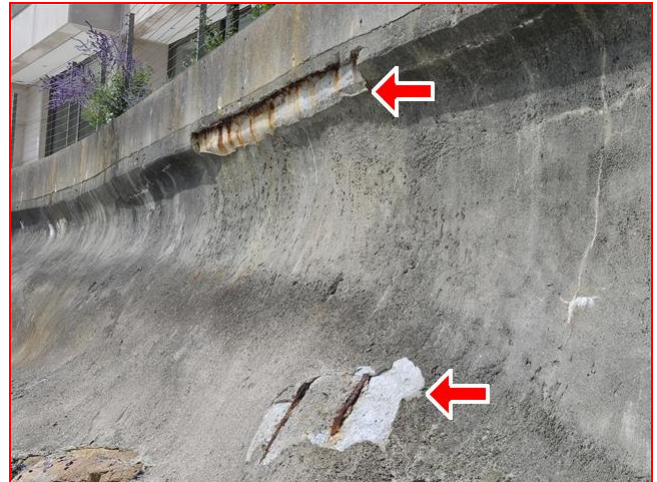
1.13 Item 1(Picture)

Cracking and flaking concrete noted sea wall. The preceding conditions should be reviewed by a qualified contractor and repaired Item 2(Picture) as required.

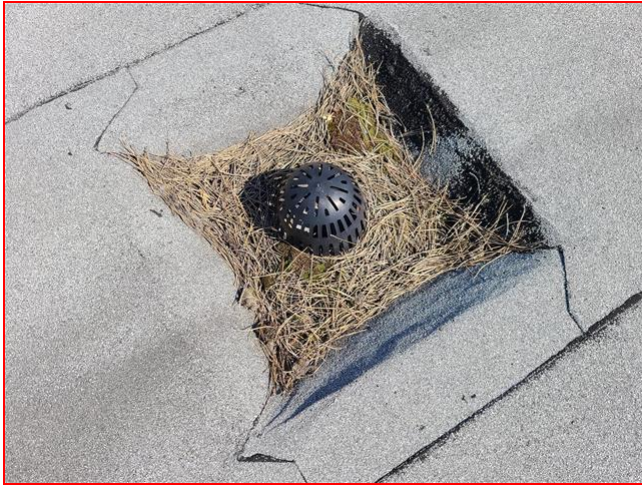
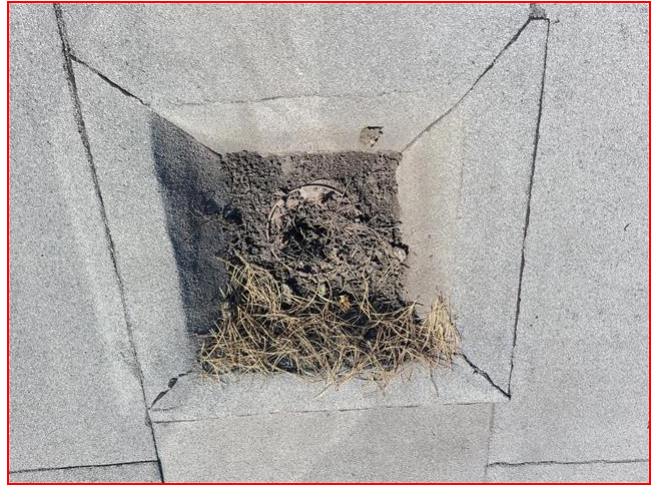
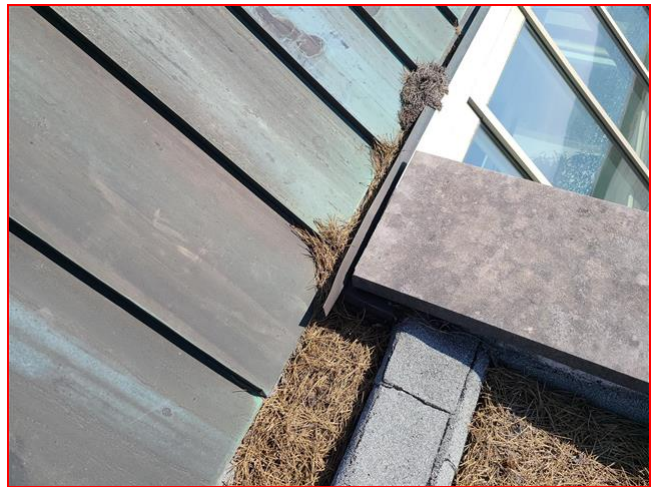
3.0 Item 1(Picture)

(2) Debris observed on the roof limits view of roof and prevents the roof from draining or drying out. One drain missing grate and is plugged. Recommend cleaning and regular maintenance.

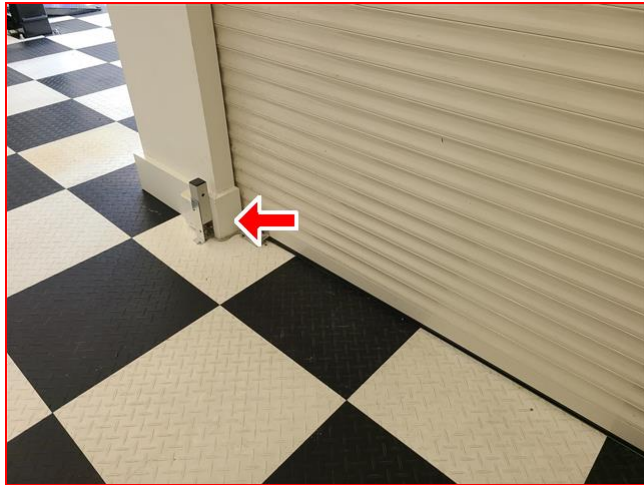
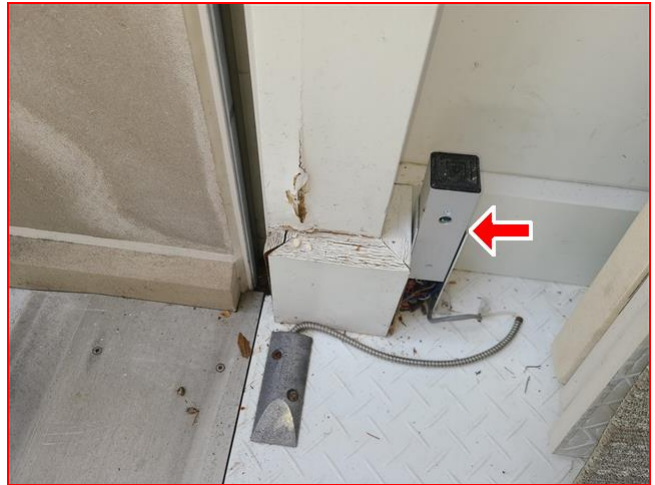
4.2 Item 1(Picture)

Safety reverse did not respond to test at the two smaller car doors. This garage door opener is equipped with a safety reverse device which did not operate when tested at the time of inspection. Recommend review for repair or adjustment, as necessary to ensure safety.

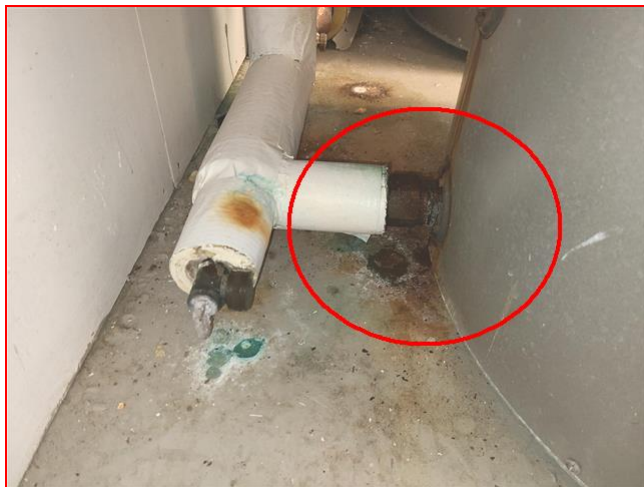
9.1 Item 1(Picture)

Small drip leak noted behind one of the holding tanks. The preceding conditions should be reviewed by a qualified contractor and repaired or replaced as required.

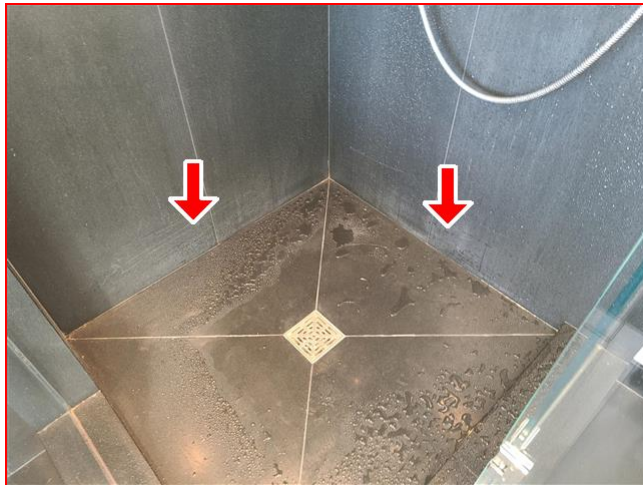
12.7.C Item 1(Picture)

The tile grout and edges of the tub/shower walls should be caulked and sealed to prevent moisture penetration. Failure to keep walls sealed can cause deterioration and moisture damage to the interior walls, which is not always visible to the inspector at the time of inspection.

Recommend installing or re-installing mildew resistant silicon around the perimeter of the tub/shower and at the vertical wall joints.

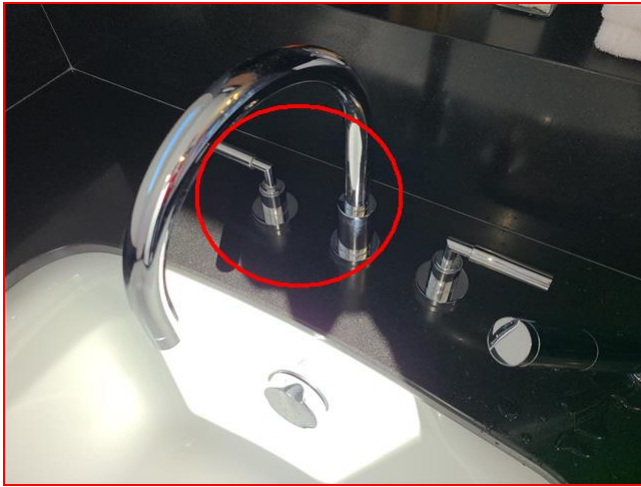
12.8.C Item 1(Picture)

Loose spout and control handles. Repair as required.

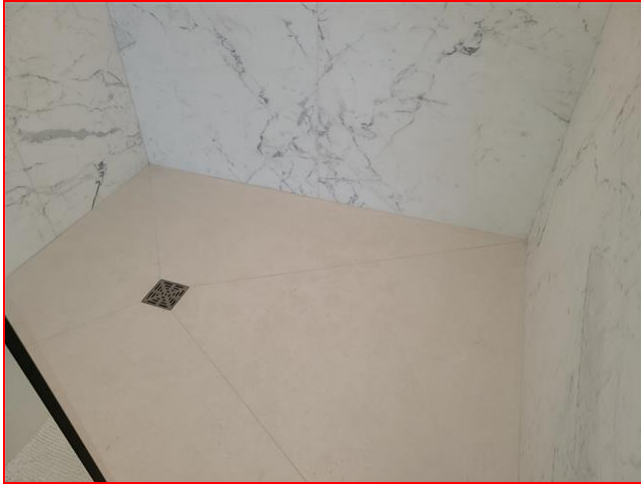
12.7.E Item 1(Picture)

(1) Worn/cracked silicone noted. Recommend installing or re-installing mildew resistant silicon around the perimeter of the tub/shower and at the vertical wall joints.
