AmeriSpec Inspection Service of SEBC

Doc #: 3072 Inspector: Sean Swinwood

Date: 3/12/2021

Dwelling Address: Cranbrook, BC

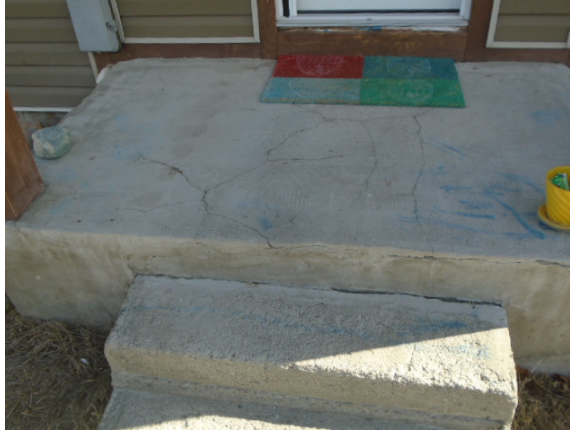
1121. Porch **Review. Concrete. Stairs are cracked and damaged. Corrections are needed to ensure longevity.**

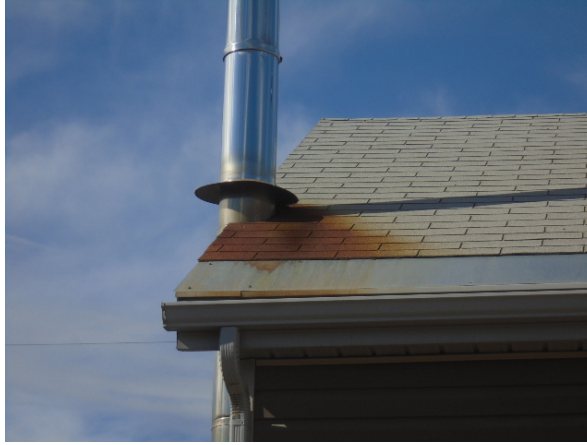
1205. Conditions

Review. Scorched and discoloured shingles observed. Recommend review by a licensed roofer for repair or replacement as necessary.

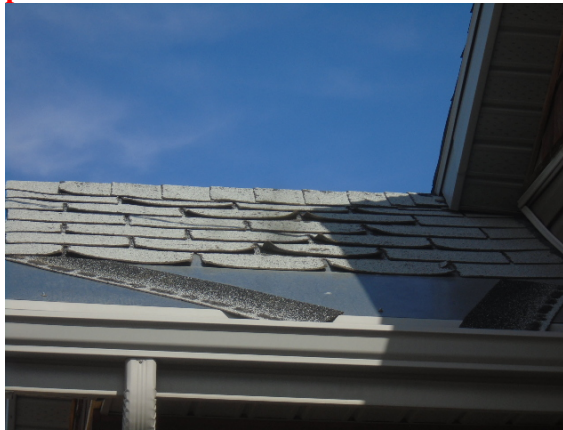
Curling shingles observed. Recommend review by a licensed roofer for repair or replacement, as necessary, prior to close.
