Doc #: 123456-7890

Date: 17/05/2021

Address: 123 Main Street

AmeriSpec Home Inspection Service

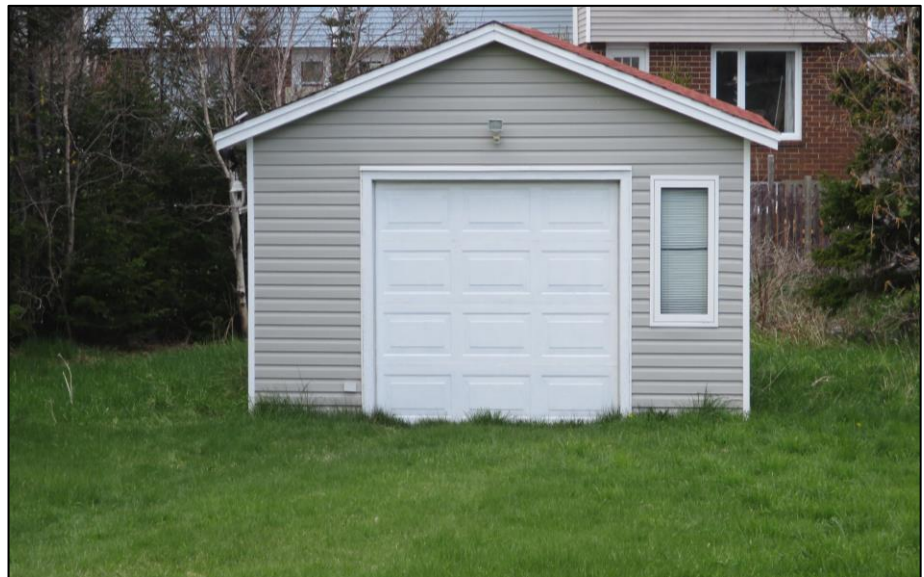
Step #	Component	Comment
1201.	Type	Detached garage.

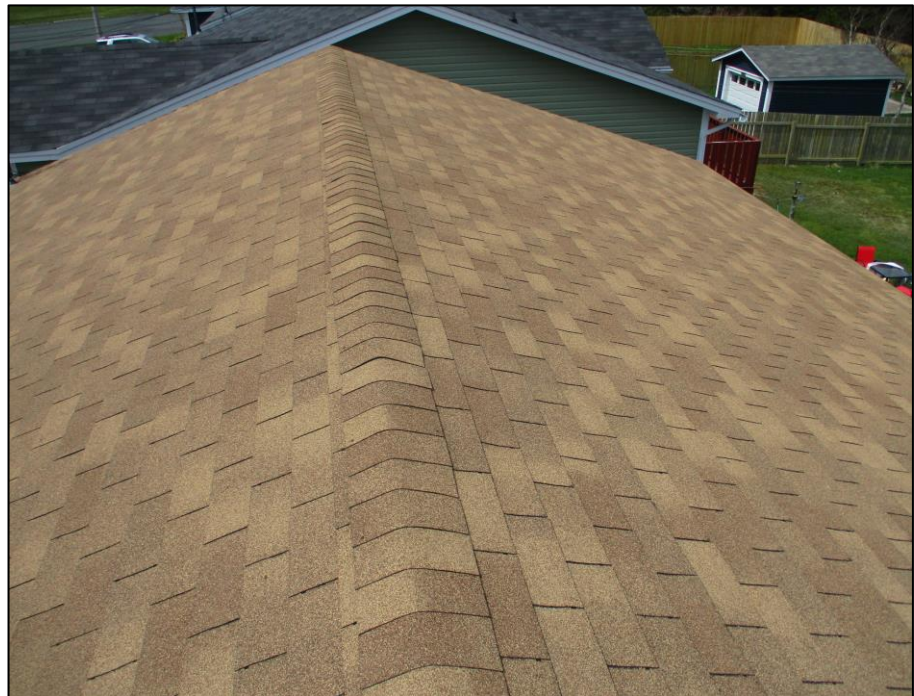
1401.	Methods Used to Inspect	The roof was inspected from atop of the roof.
-------	-------------------------	---

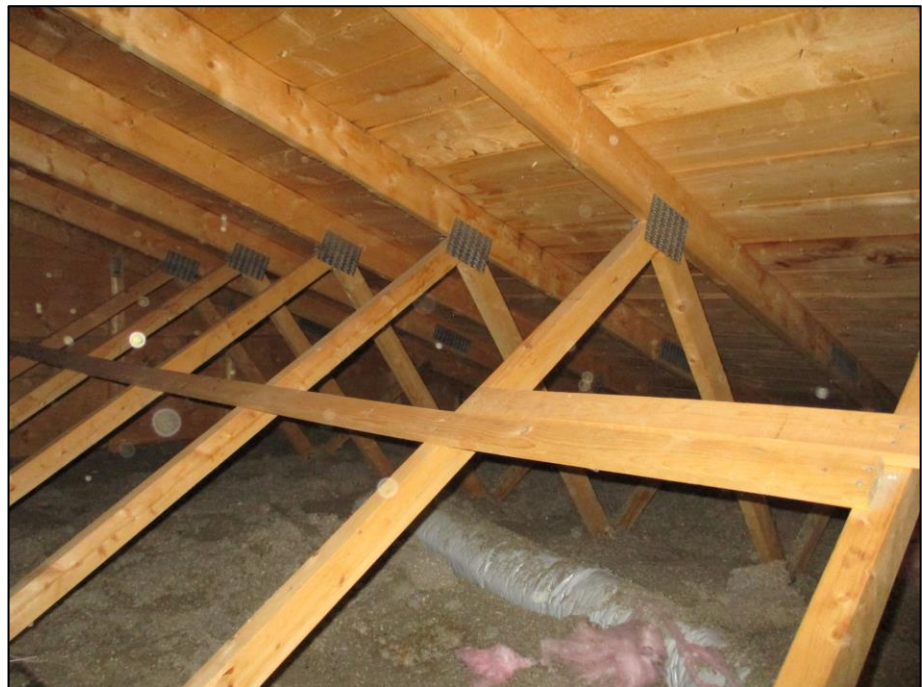
Step #	Component	Comment
1501.	Access	The attic access is located at hall closet. The attic was entered and a visual inspection was performed.
1502.	Hatch	The hatch is sealed and insulated. Suggest additional insulation is installed on the top of the hatch to match the R-value in the attic.
1503.	Framing	Serviceable. Wood truss. Verifying appropriate installation and calculations is beyond the scope of this inspection. No alterations or obvious issues were observed.

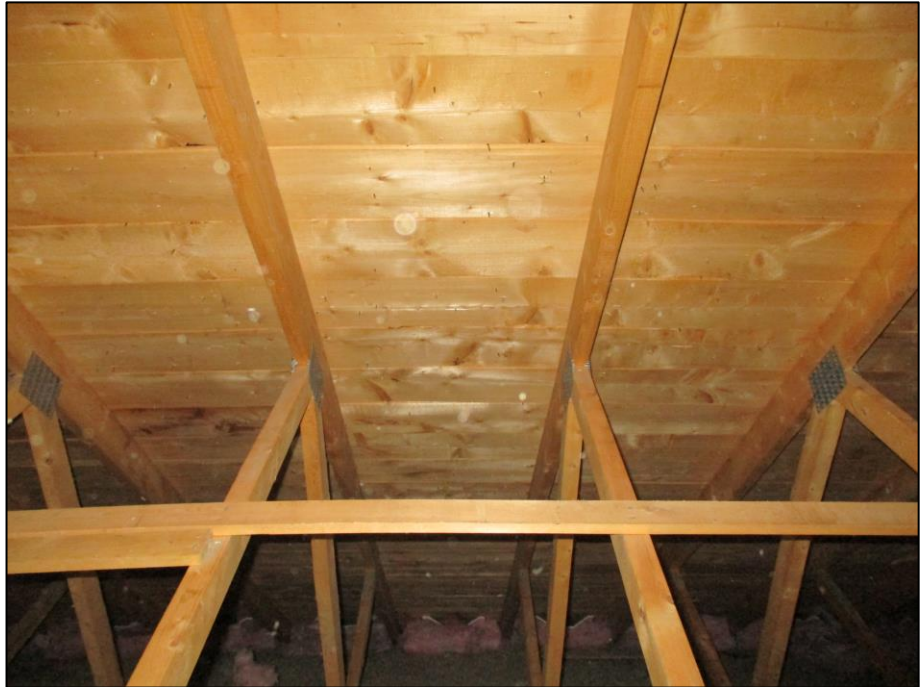
1504. Sheathing Serviceable. The wood sheathing that could be reasonably viewed appeared in serviceable condition at time of inspection.

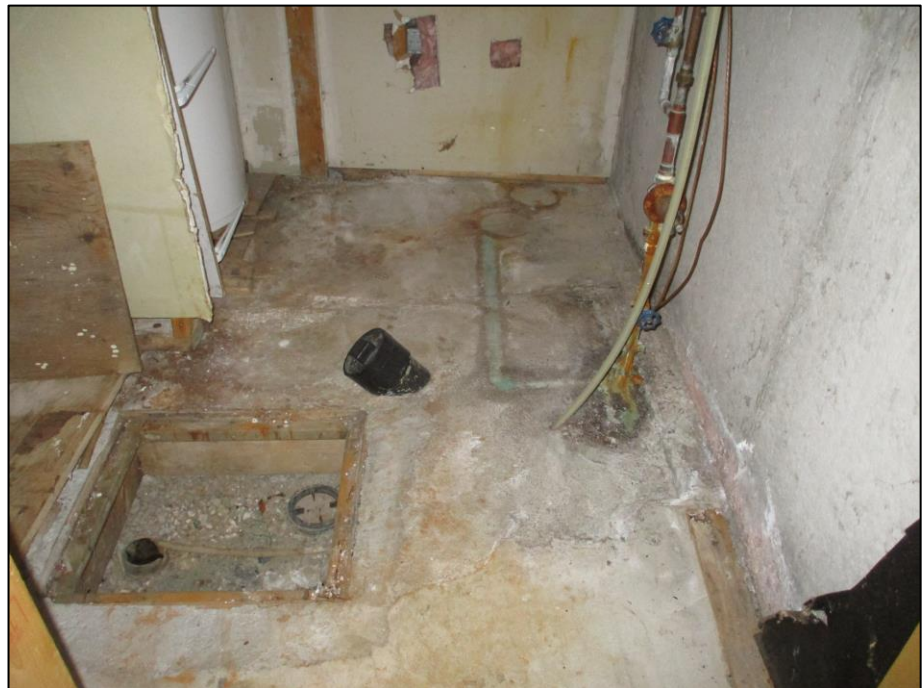
Step #	Component	Comment
1701.	Shut Off Valve Location	Main shut off is located in the front of the basement. Since main shut off valves are operated infrequently, it is not unusual for them to leak or break when operated after a period of inactivity. For this reason main shut off valves are not tested during a home inspection. Recommend caution when operating shut offs that have not been turned for a long period of time. A pressure regulator was present.

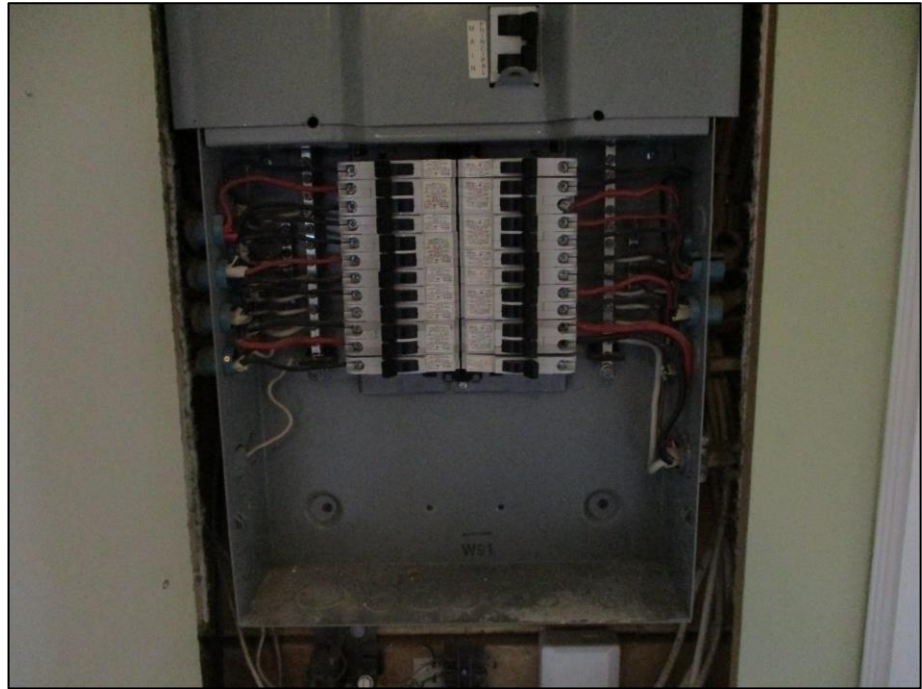
Step #	Component	Comment
1901.2.	Electrical Description	The service entrance is overhead and the panel is located in the basement. Circuit overload protection is provided by breakers and the service panel rating is approximately 100 amps with 120 and 240 volts. The branch circuit wiring is copper. This panel appears to be grounded to the water supply.

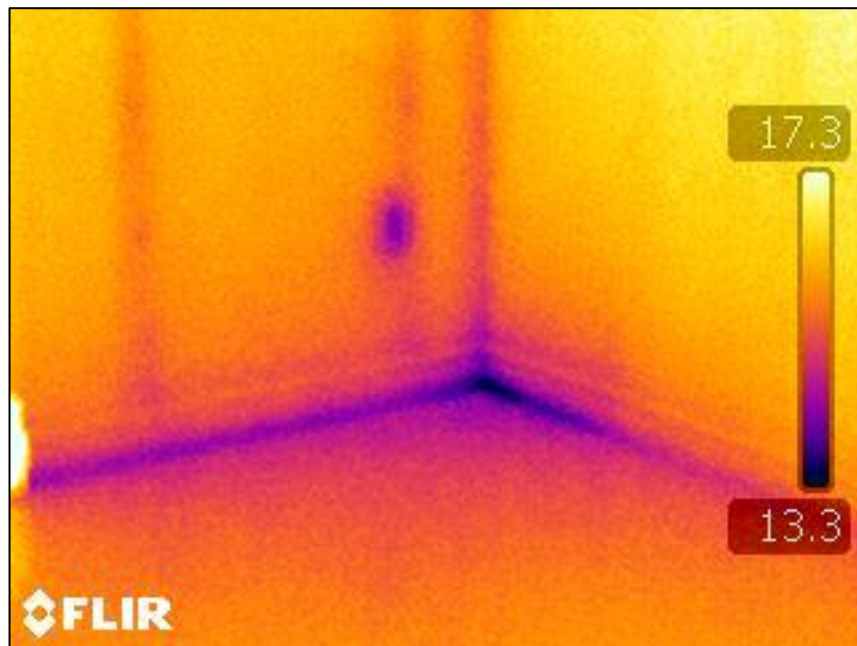
Step #	Component	Comment
2202.	Basement Floor	The floor was scanned and typical cold zones were identified. This is a common observation and is caused from minor thermal transfer that occurs with wood framing.

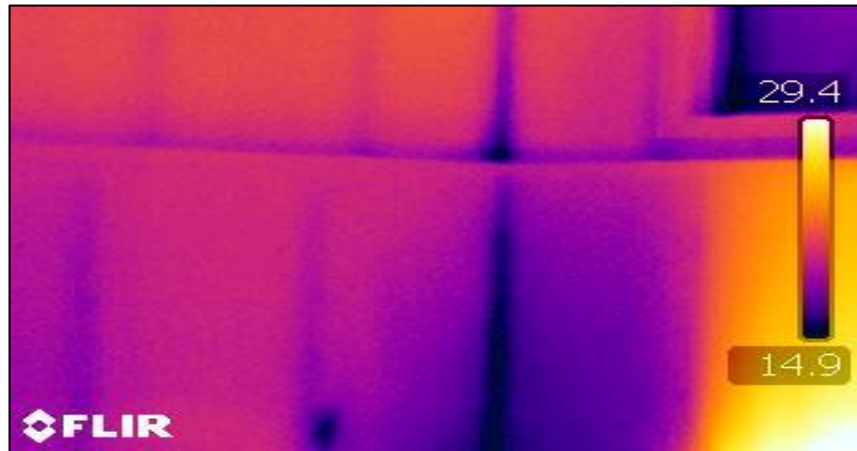
2203. Basement Walls Cold areas were detected at the framing, outlets and base of the walls. This is related to the thermal transfer of materials that have less insulating value than the insulation. No anomalies or abnormal images that may indicate moisture penetration or missing, loose or disturbed insulation were noted at time of inspection.

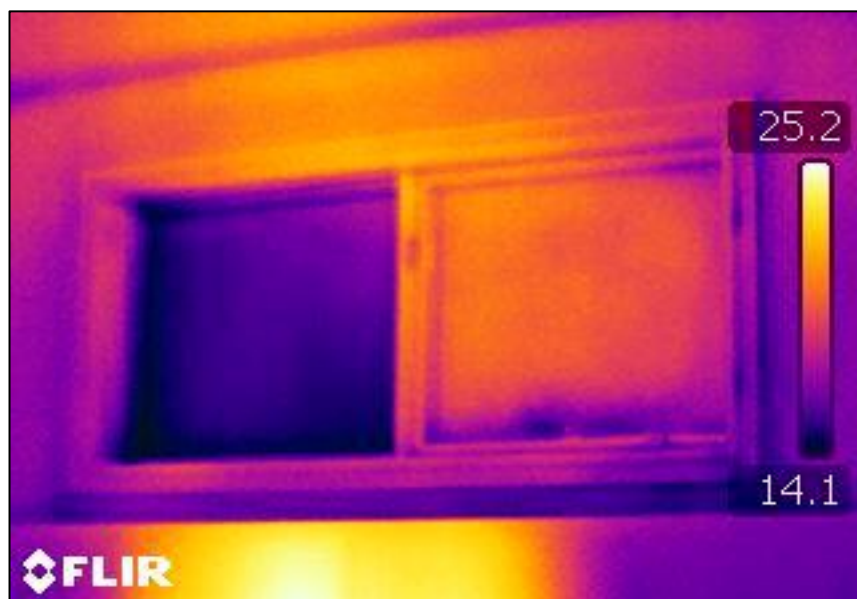
2204. Basement Windows The windows were scanned and typical cold zones were detected. No anomalies or abnormal images that may indicate moisture penetration or missing, loose or disturbed insulation were noted.

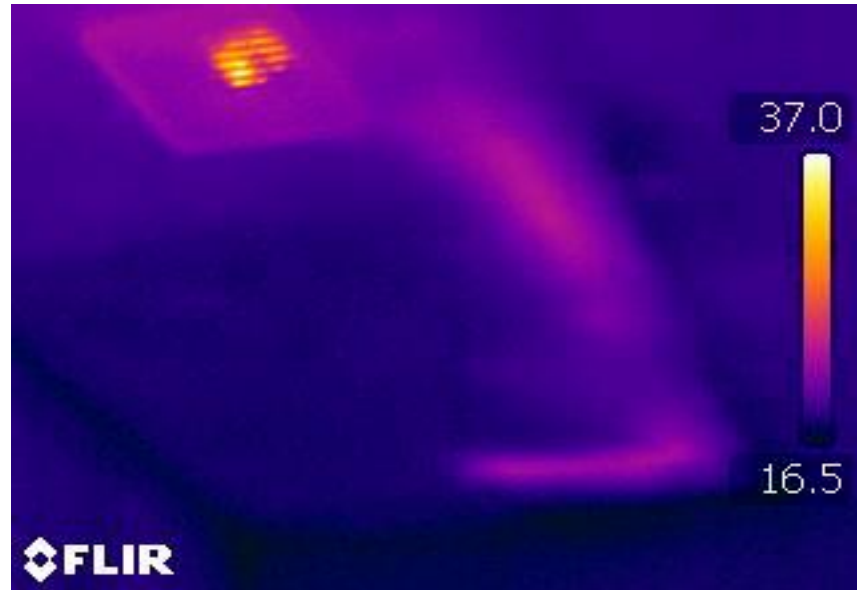
2205. Basement Ceilings The ceiling was scanned, specifically under the bathrooms and kitchens and no signs of any moisture or leaking were observed. Typical warm and cold lines were noted radiating from the water supply lines and the drains.

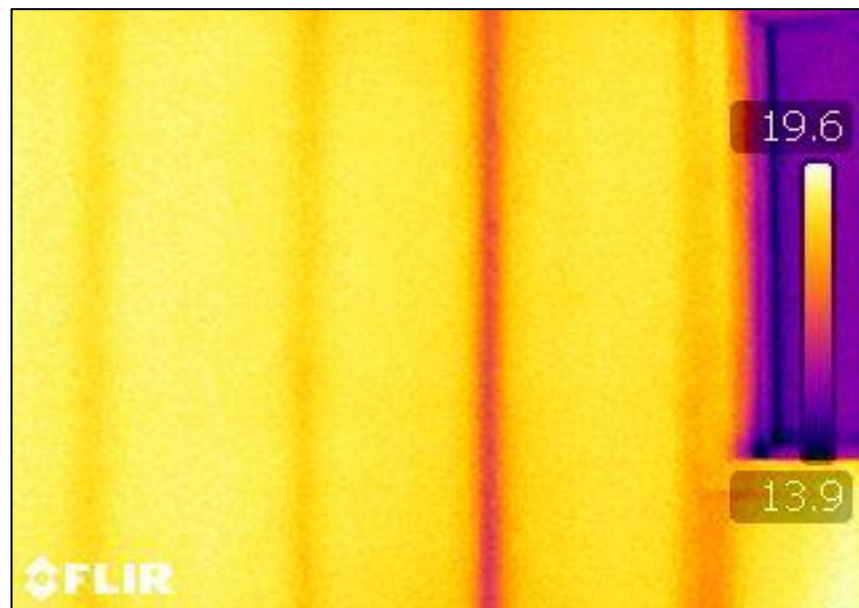
2210. Main Level Walls The exterior walls were scanned and typical cold zones in the corners and framing were detected. No anomalies or abnormal images that may indicate moisture penetration or missing, loose or disturbed insulation were noted.

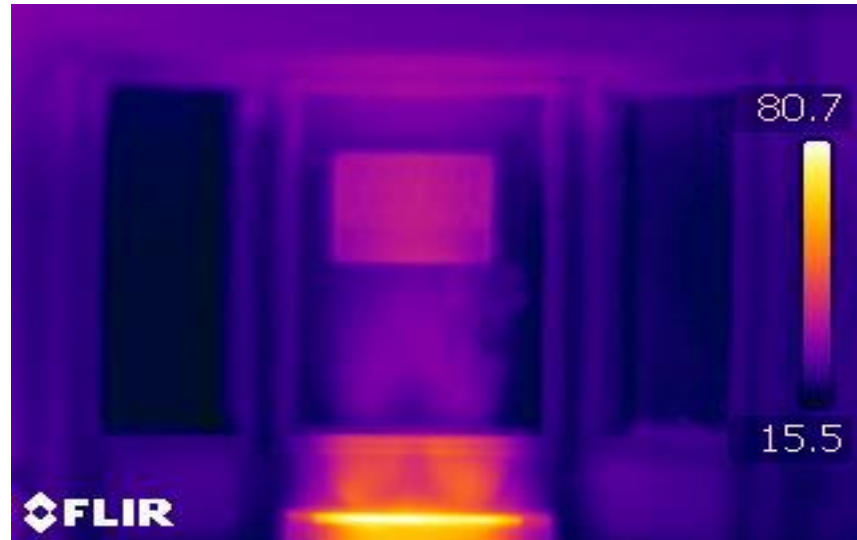
2212. Main Level Windows The windows were scanned and typical cold zones were detected. No anomalies or abnormal images that may indicate moisture penetration or missing, loose or disturbed insulation were noted.

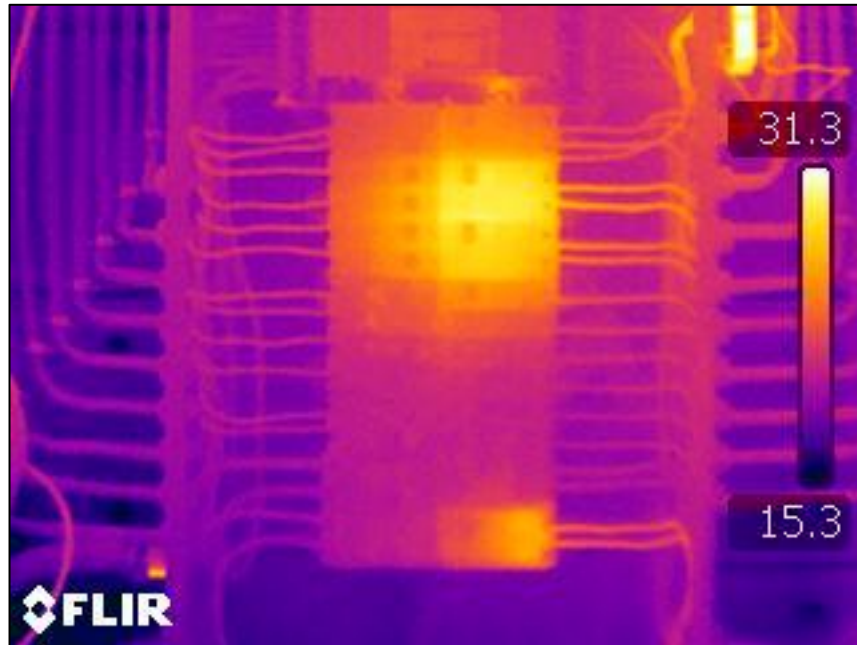
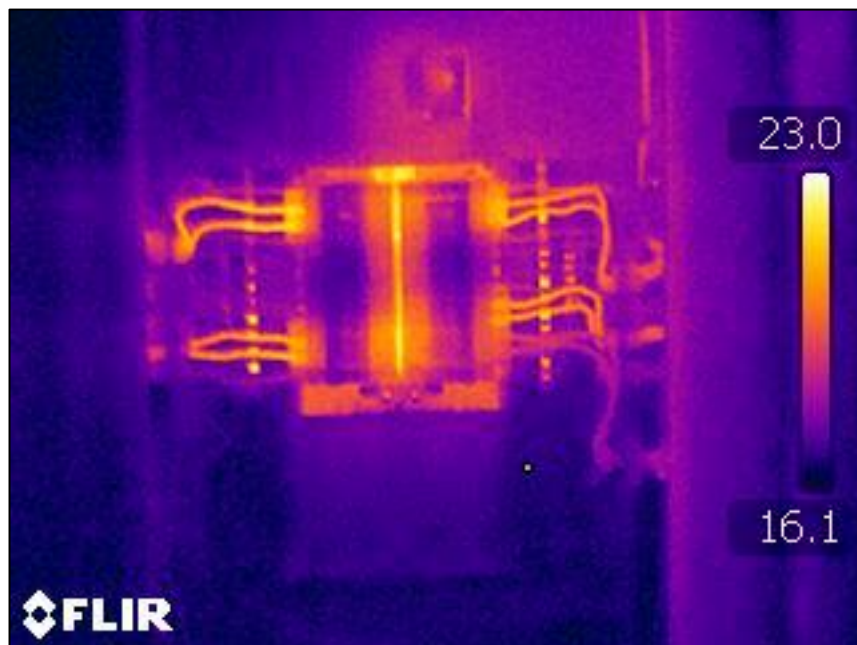
2220. Electric Panel With the panel cover removed, the interior of the electric panel was scanned and no hot spots were observed at time of inspection. The scan of the panel is considered limited since all circuits were not loaded at time of inspection. No visual signs of scorching were noted on the wires.

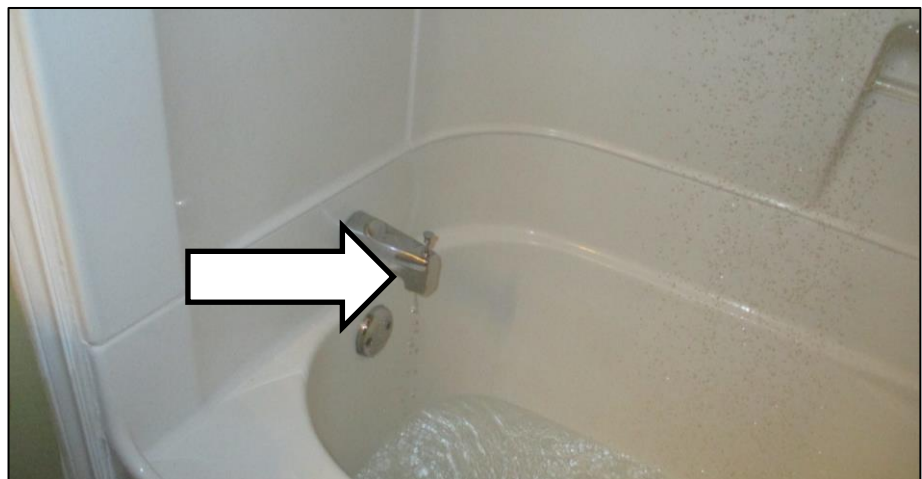
Step #	Component	Comment
2601.	Floor	Serviceable. Ceramic.
2602.	Walls	Serviceable. Drywall, Paint.
2603.	Ceilings	Serviceable. Drywall, Paint.
2604.	Doors	Serviceable. Hollow core.
2607.	Heat Source	Serviceable. Baseboard Heater.
2608.	Electrical	The GFCI was not tripping properly. Recommend review by a qualified electrician for repair or replacement as needed.
2609.	Exhaust Fan	Serviceable. The air exchanger and the exhaust fan were operating normally at time of inspection.
2610.	Tub/Whirlpool	Serviceable.
2611.	Tub Surround	Serviceable. This tub is a part of a tub enclosure.
2612.	Tub Faucet	The spigot was loose and not flush at the surround wall. Recommend this is corrected by a qualified plumbing contractor. Rust was observed on the escutcheon plates inside the cabinet. Recommend consulting with the homeowner regarding any humidity issues and further review by a qualified plumber.

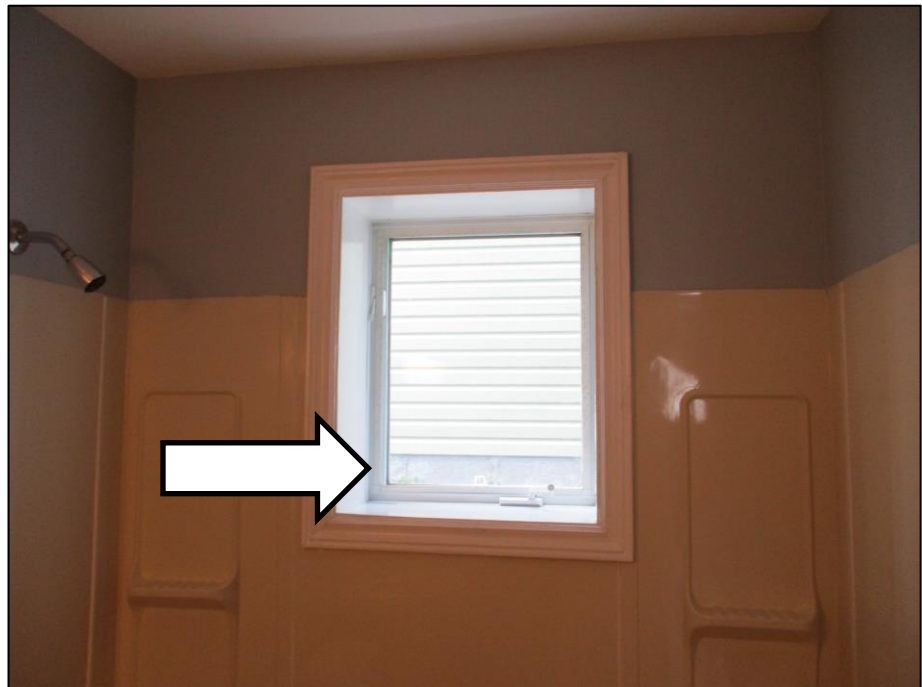
- 2609.2. Exhaust Fan Serviceable. The air exchanger and the exhaust fan were operating normally at time of inspection.
- 2610.2. Tub/Whirlpool Serviceable.
- 2611.2. Tub Surround Serviceable. Plastic.
- 2612.2. **Tub Faucet** The faucet is not flush to the surround. Recommend sealing to prevent moisture from penetrating.
- 2617.2. Sinks Serviceable.
- 2618.2. Sink Faucets Serviceable.
- 2619.2. Traps / Drains / Supply Serviceable. Flow and drainage were serviceable during the inspection. Recommend all faucets, supply lines and drains are tested prior to close.
- 2620.2. Toilet Serviceable.
- 2621.2. Counter / Cabinets Serviceable. Laminated.
- 2625.2. **Comments** A window was noted in the shower area. The trim should be regularly monitored for cracks and openings.
