Doc #:	AB-210730	Inspector:	Andrew LaRoche
Date:	2021-07-22		
Dwelling Address:	1 Main Street Any City Ontario A1A 2B2		
Client Name:	ABC Company		
Client's Agent:		Real Estate Company:

This is a Property Condition Report "PCR" using the ASTM E2018 as a standard guideline to describe the condition of building or buildings for the property inspected. This process involves observation of the property by a person or entity. It can include interviews of sources, and reviews of available documentation for the purpose of developing an opinion and preparing a PCR of a commercial real estate's current physical condition. At the option of the user, a PCA may include a higher level of inquiry and due diligence than the baseline scope described within this guide or, at the user's option, it may include a lower level of inquiry or due diligence than the baseline scope described in this guide. If there are such deviations from this guide's scope it should be disclosed here on this page. A PCR is a written report, prepared in accordance with the recommendations contained in this guide, that outlines the consultant's observations, opinions as to the subject property's condition, and opinions of

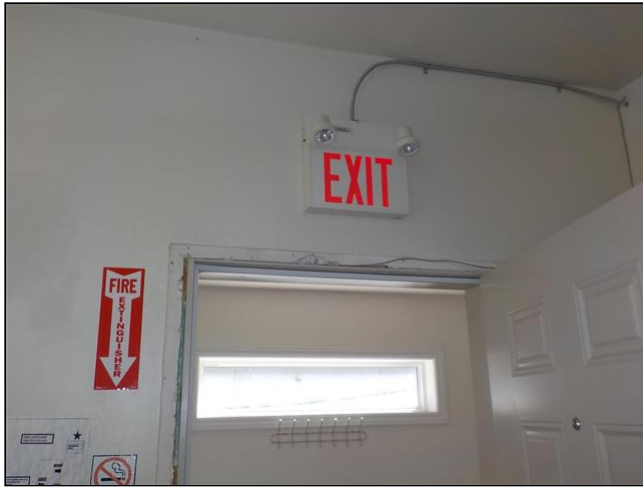
A. Item 1(Picture) Exit sign

Exit signs and emergency lighting with battery backup and fire extinguishers with out of date inspection tags were noted in the building. Fire safety plans are posted. Smoke detectors are present. We recommend the existing fire systems be reviewed and regular inspections be completed by a fire safety company.

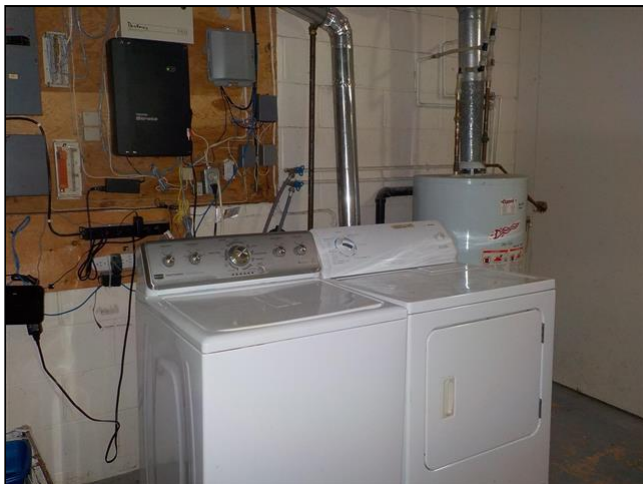
C. Item 1(Picture) Laundry facilities

A MAYTAG washer and KENMORE gas dryer are present in the basement. We recommend the flexible gas line to the dryer be upgraded to enhance safety.

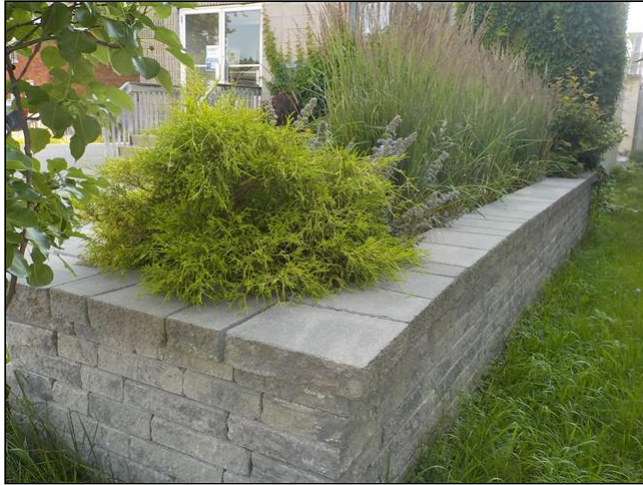
E. Item 1(Picture) Flower beds

Raised flower beds are present along the right side of the parking area and front of the building. Vegetation overgrowth noted on the front siding. We recommend removal as required.

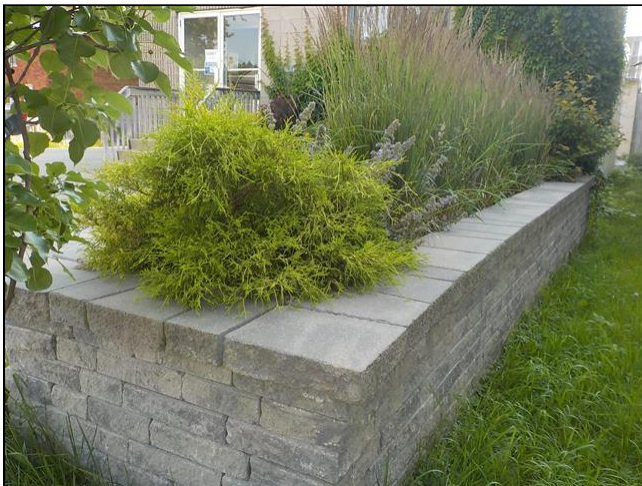
E. Item 1(Picture) Flower beds

E. Raised flower beds are present along the right side of the parking area and front of the building. Vegetation overgrowth noted on the front siding. We recommend removal as required.

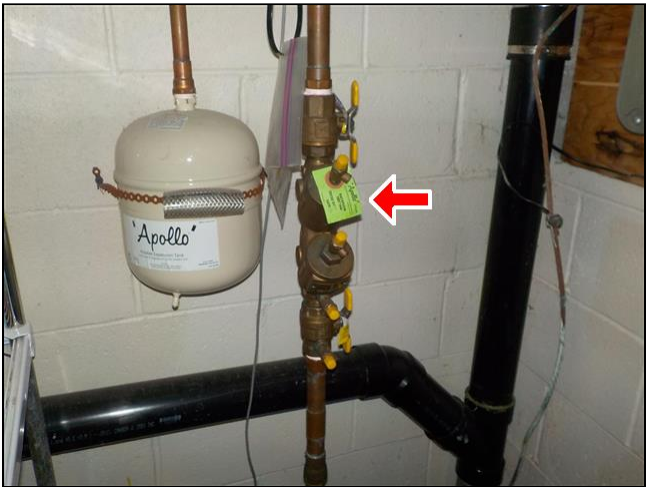
A. Item 1(Picture) Cross connection control

A. The water source is the public utility company. A municipal cross connection control and expansion tank has been installed. Yearly inspections have been completed as required.

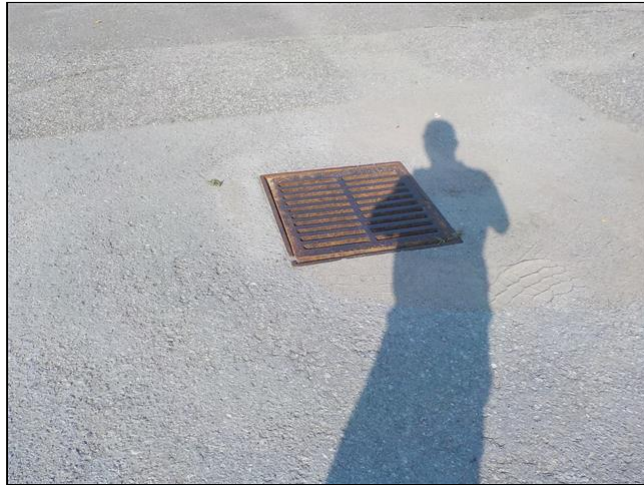
E. Item 1(Picture) Storm drain

E. (1) The storm drain is located in the parking lot.

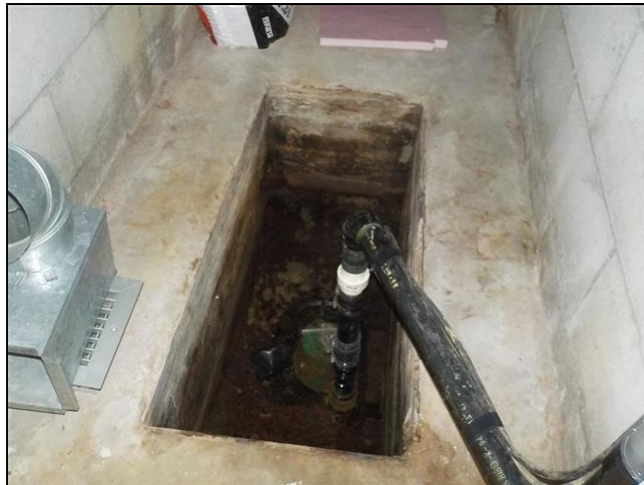
E. Item 2(Picture) Sump

E. (2) A sump pit and pump is present in the basement. The pump tested operable at the time of the inspection. A check valve is present. The sump pump discharges into the storm drain.

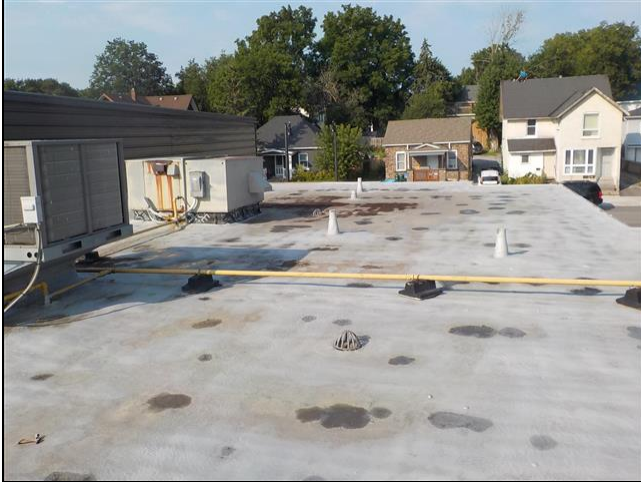
E. Item 1(Picture) Flat roof condition

E. (1) The main flat roof is comprised of spray foam roofing with a top silicone sealant layer in overall good repair. Two interior drains were present and the overall roof drainage was adequate to good. Roof maintenance should be completed on a regular basis. Metal roofing has been installed over the rear extension.

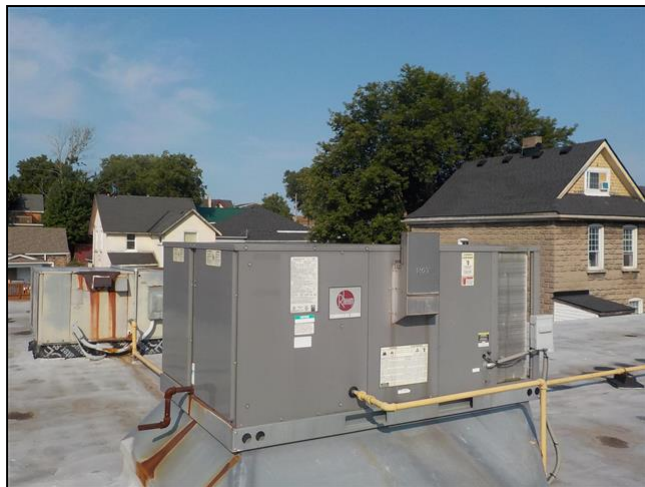
D. Item 3(Picture) RHEEM unit

D. (2) The RHEEM unit was manufactured in 2013. It is rated at 135,000 Btu/hr. with a RLA of 26.3. The model number is RKNL-A060JK13E and serial number 2G7499ADAAF131304065.

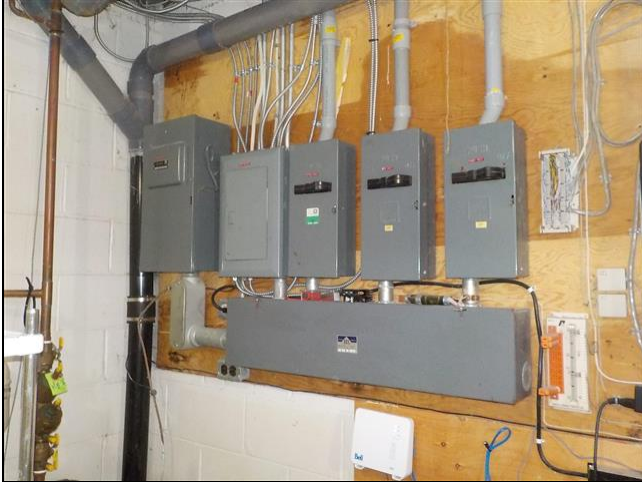
F. Item 1(Picture) Main service

F. (1) The main service enters underground at the left side. The main electrical panel is located in the basement. It consists of a 200 amp main disconnect with a splitter box dividing the system into two 100 amp circuit breaker panels and two 60 amp disconnects for the rooftop package units. A circuit breaker sub panel is in the rear office on the main floor. Directories are provided identifying the panels and circuit breakers.

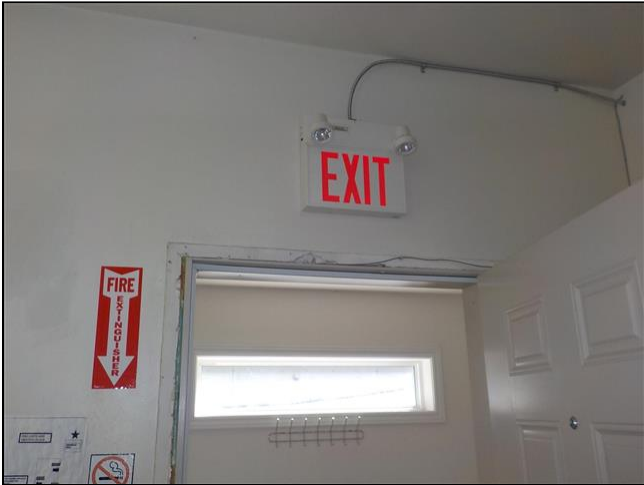
A. Item 1(Picture) Exit sign

A. Exit signs and emergency lighting with battery backup and fire extinguishers with out of date inspection tags were noted in the building. Fire safety plans are posted. Smoke detectors are present. We recommend the existing fire systems be reviewed and regular inspections be completed by a fire safety company.

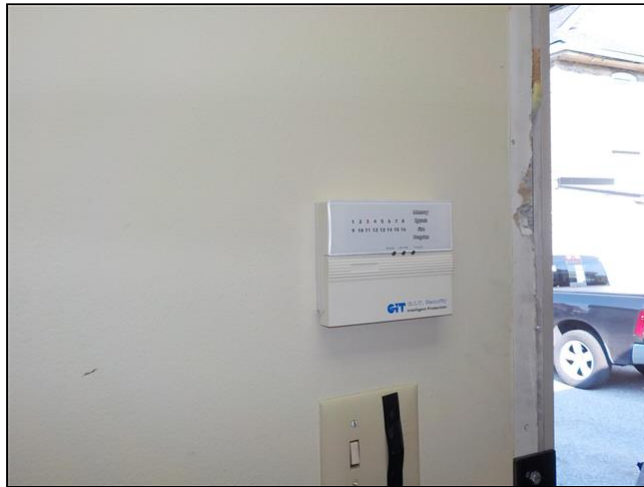
B. Item 1(Picture) Alarm system

B. A monitored alarm system is present.

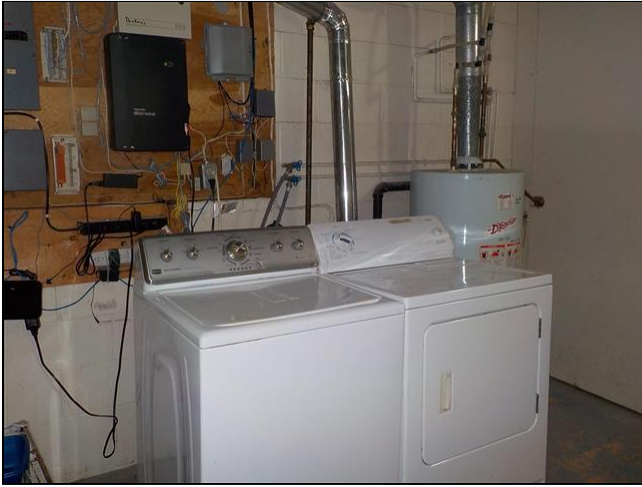
C. Item 1(Picture) Laundry facilities

C. A MAYTAG washer and KENMORE gas dryer are present in the basement. We recommend the flexible gas line to the dryer be upgraded to enhance safety.
