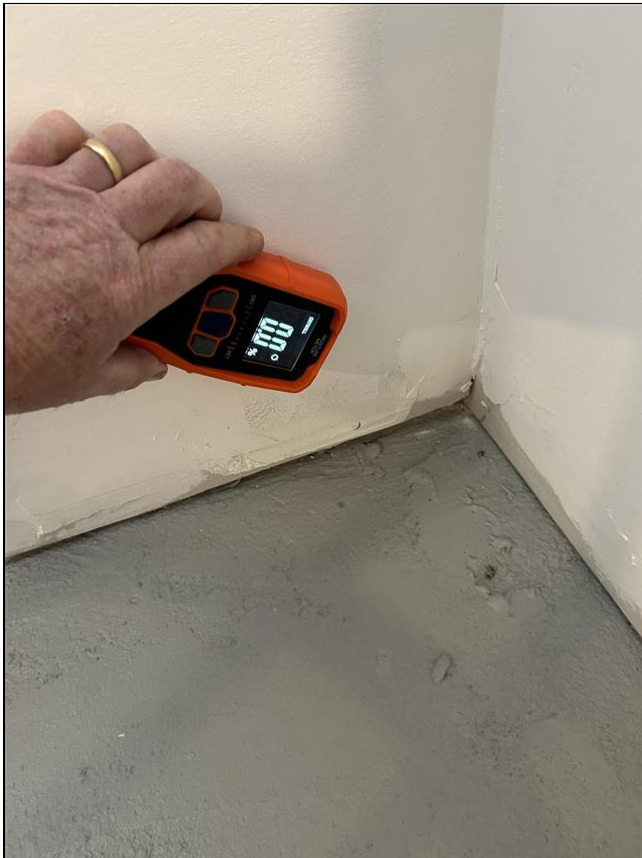
4.3 Item 1(Picture) normal moisture reading

4.3 The basement walls were inspected for the presence of moisture at visibly accessible areas through non-intrusive means using thermal imaging, a moisture meter, touch, and visual inspection. No evidence of active moisture was noted in the visibly accessible areas of the basement/crawlspace walls.

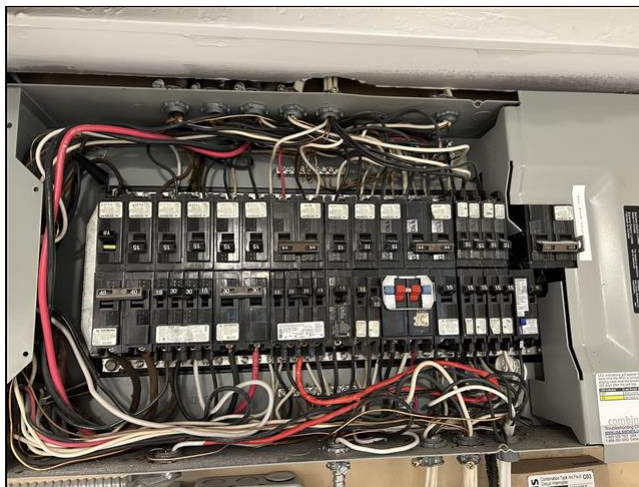
6.2 Item 1(Picture) main panel

6.2 (1) Inspected

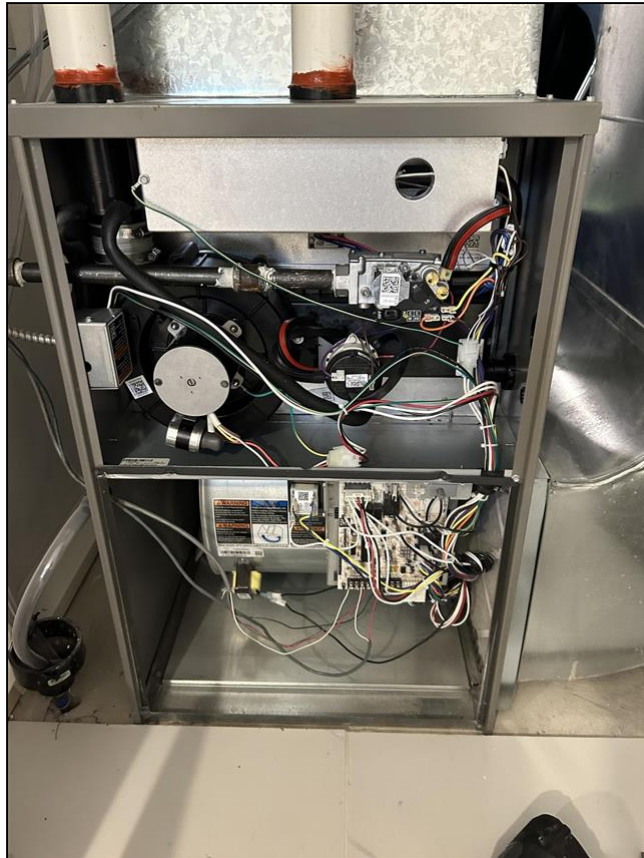
7.0 Item 1(Picture) furnace conditions

7.0 (1) The gas furnace was tested using normal operating controls and functioned properly at time of inspection.

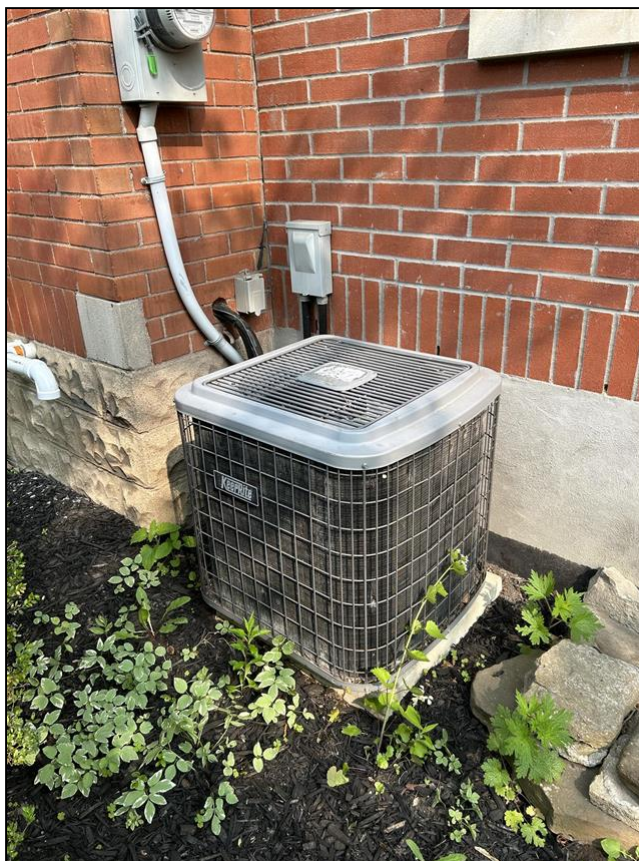
8.0 Item 1(Picture) air condenser

8.0 (1) The air conditioner was activated to check the operation of the motor and the compressor, both of which are in serviceable condition. As a detailed review of the cooling capacity of this unit is beyond the scope of this inspection, we make no warranty as to the system's adequacy.

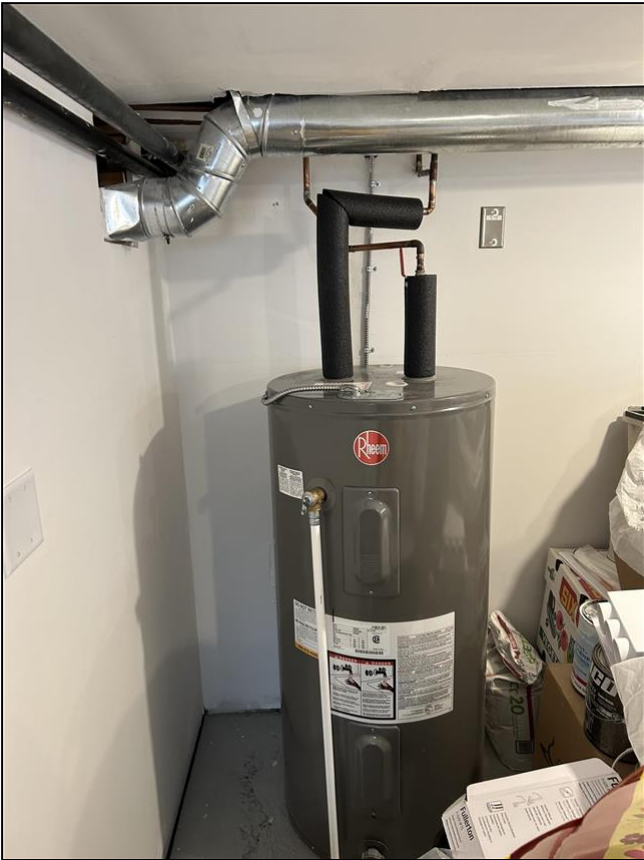
9.0 Item 1(Picture) water heater

9.0 Inspected

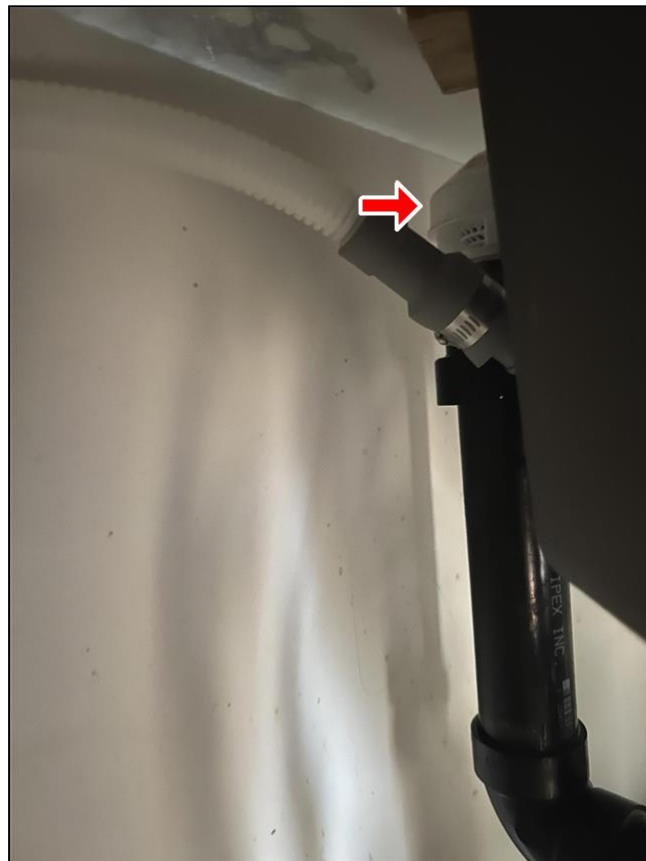
10.7 Item 1(Picture) air admittance valve

10.7 Air admittance valve(s) noted.
Please refer to the Plumbing System
section for additional information.

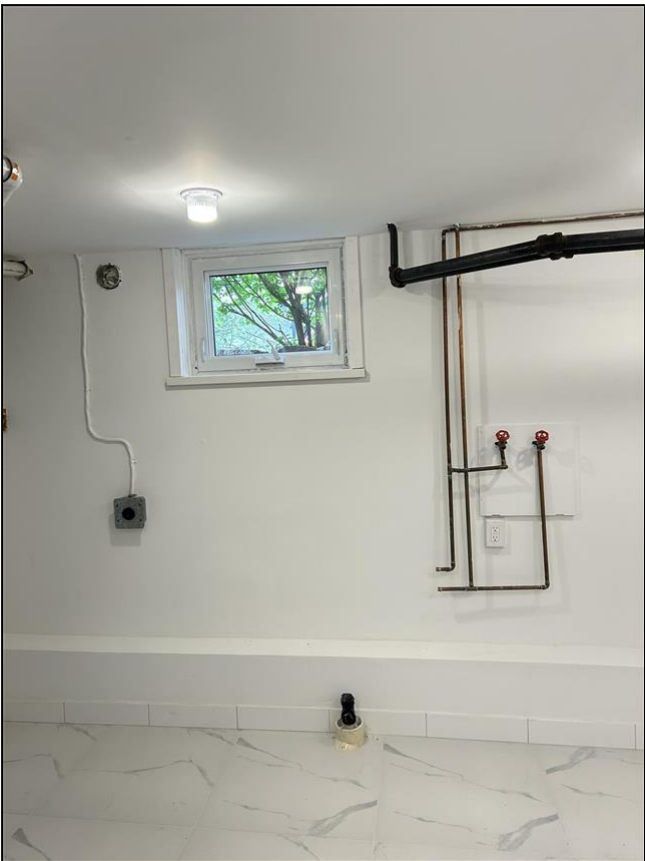
12.7 Item 1(Picture) roughed in laundry area

12.7 Roughed in.

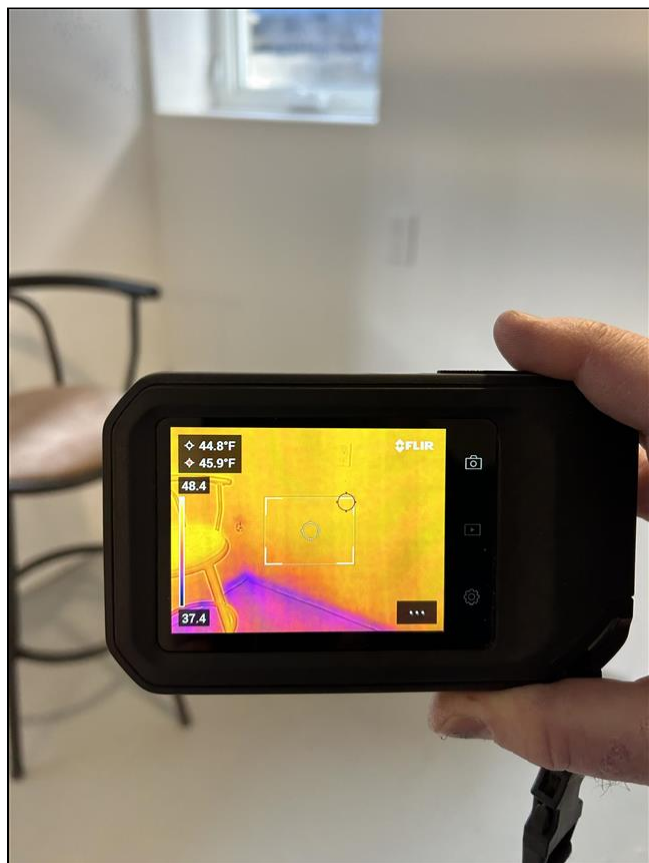
13.10 Item 1(Picture) thermal imaging

13.10 The interior rooms and areas were inspected for the presence of moisture at visibly accessible areas through non-intrusive means using thermal imaging, a moisture meter, touch, and visual inspection. No evidence of active moisture was noted in the visibly accessible areas of the walls and ceilings.

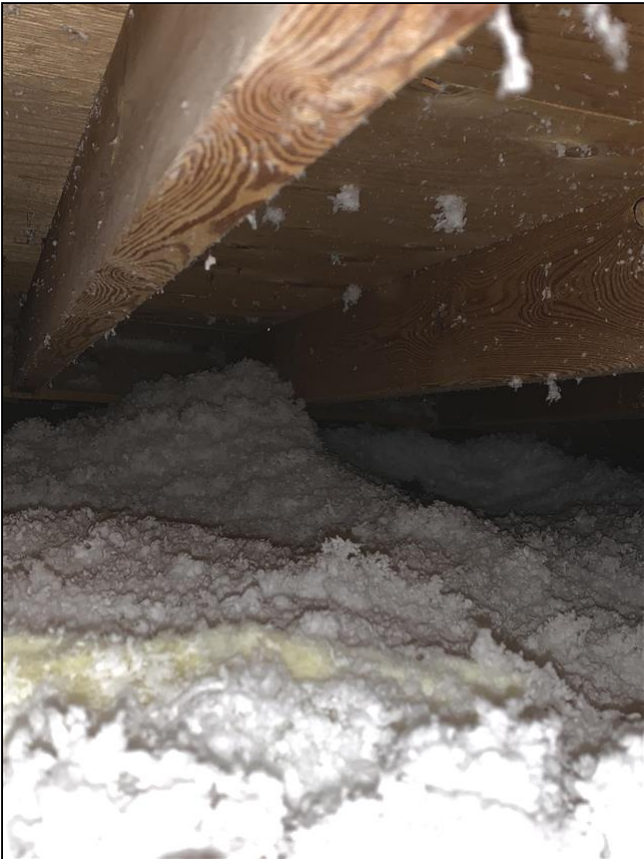
14.3 Item 1(Picture) insulation conditions

14.3 Inspected where visible.
