Inspection Report

Property Address:
123 Main Street
Anytown ON ABC 123

Amerispec Waterloo Region/Guelph/Brampton and Orangeville

Date: 2018-05-04	Time: 08:20 AM	Report ID: 123456789
Property: 123 Main Street Anytown ON ABC 123	Customer: John Smith	Real Estate Professional:

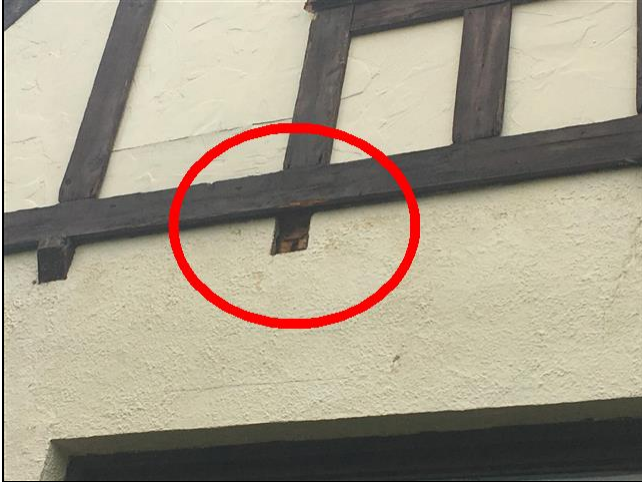
1.2 Item 3(Picture)

1.2 (3) Openings/breaches were noted around the exterior of the home. We recommend sealing any openings to prevent potential moisture damage to exterior/interior walls and pest incursion. Should water seepage into the home occur, it may not always be visible to the inspector (dry conditions, for example), however the Client should be aware that water entry into the home can lead to deterioration of the structure over time, mold growth and other issues. If

you are concerned about this possibility, we recommend further review by a specialist which could include an intrusive inspection.

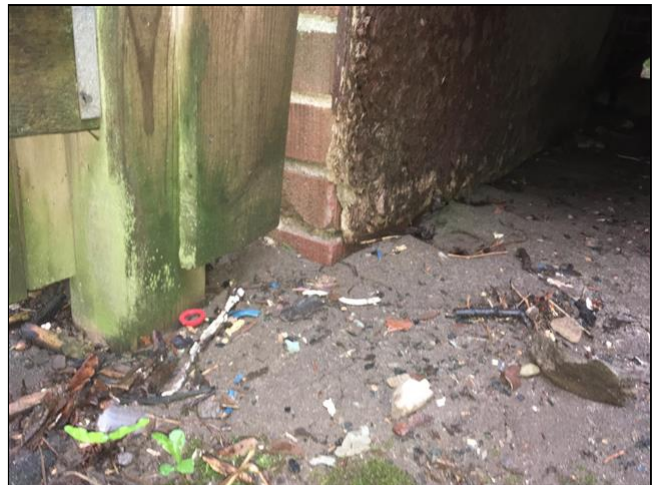
1.2 Item 6(Picture)

1.2 (5) The exterior is covered with a hard coat stucco, or a hybrid of systems. Few installations of these materials meet all of the manufacturers' recommendations, but the system may perform well. Most residential stucco systems must be kept well sealed to prevent moisture penetration and subsequent damage to the underlying wall. The deterioration, which can be caused by water penetration, is most often not apparent to a visual review of the surface. Underlying rot, moisture in construction materials and flashing integrity are therefore outside the scope of our visual review. If such a review is desired, we recommend consulting a siding expert who is trained and equipped for invasive inspection and testing.

Vulnerable areas in regards to moisture related issues were observed at the stucco/wood member intersections.

The wood sections may create ledges enabling water to collect, if moisture is allowed to get in behind the stucco surface it will cause damage quickly.

We recommend monitoring these areas for localized deterioration, and performing regular maintenance, as required.

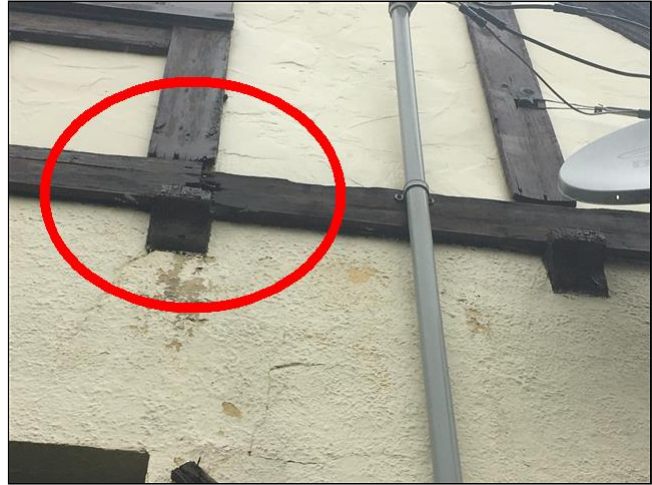
1.3 Item 2(Picture)

1.3 (2) Moisture damaged trim observed at various areas. The extent of damage could not be determined without destructive analysis (maintenance and/or repairs should be performed).

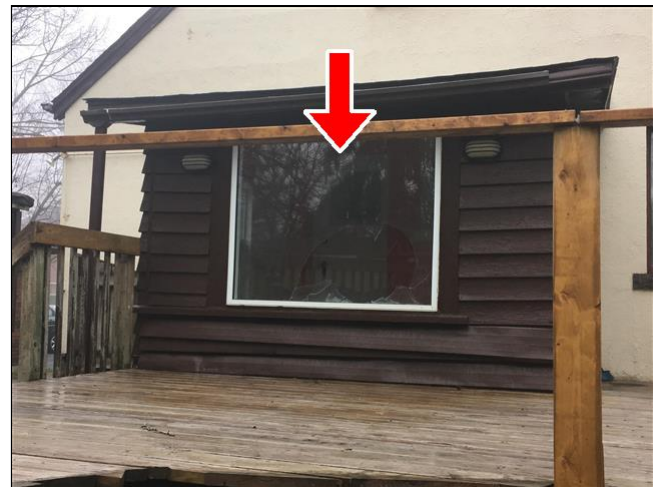
1.4 Item 2(Picture)

1.4 (3) Broken/damaged windows(s) observed at the several locations. Recommend review for repair or replacement as necessary.

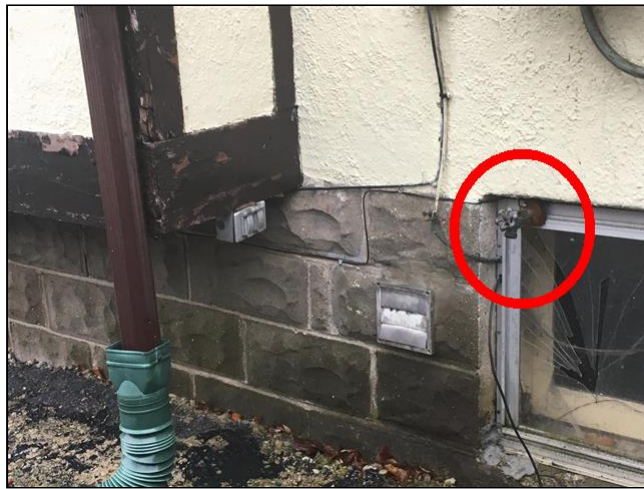
1.11 Item 1(Picture)

1.11 It is important to winterize all exterior faucets by shutting of the valve inside the home prior to the first frost each Fall.

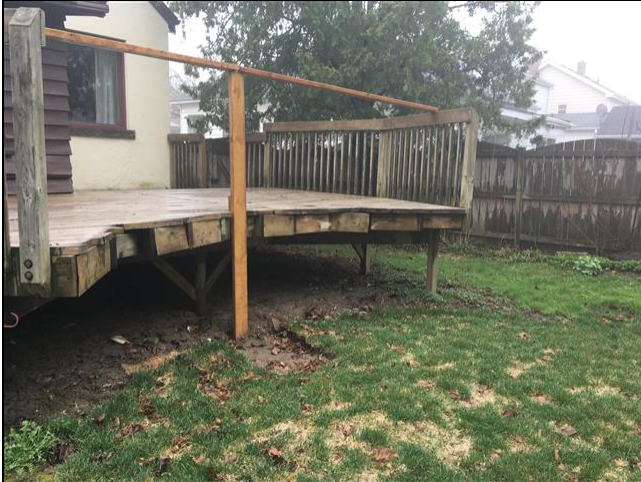
1.18 Item 1(Picture)

1.18 (1) Missing/loose guardrails observed. This is a "Safety Concern". Although guardrails may not have been required when the home was built, we recommend client consider installing guardrails as a safety enhancement.

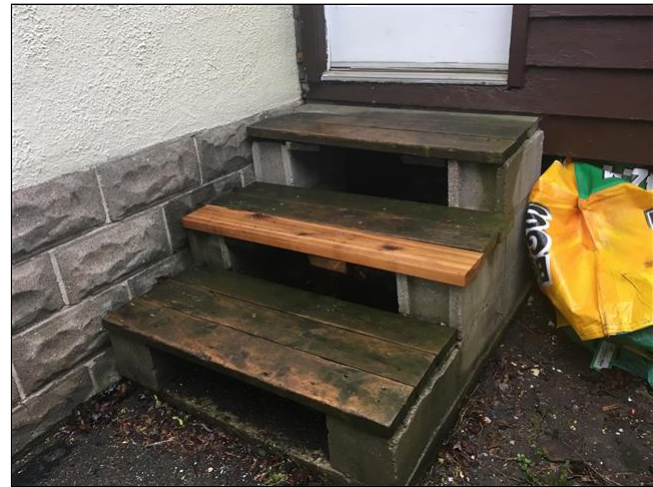
1.21 Item 2(Picture)

1.21 (1) No handrailings noted, recommend installing handrails for safety.

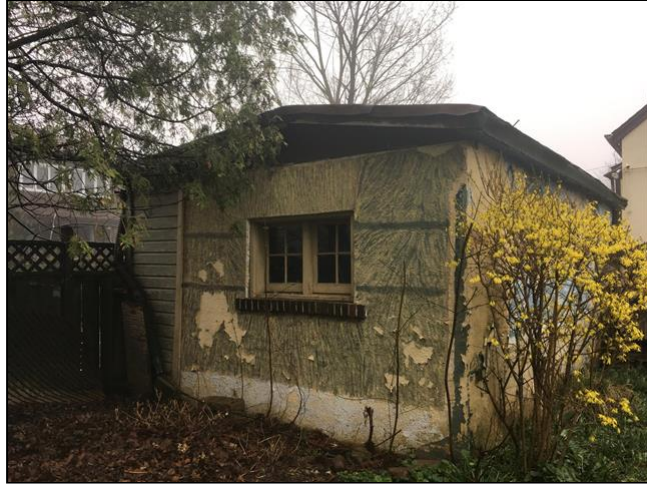
3.0 Item 1(Picture)

3.0 Garage/Carport is not attached to house and therefore was not fully inspected the same as the balance of the home.

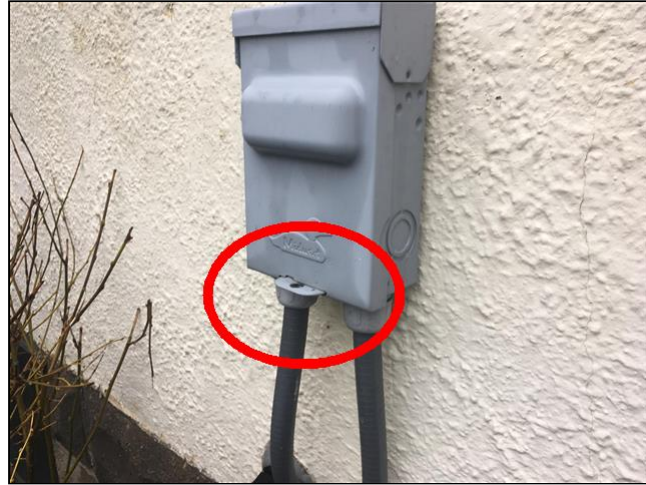
5.1 Item 1(Picture)

5.1 Electrical disconnect observed. It is recommended that the disconnect be kept locked at all times to prevent access by children.

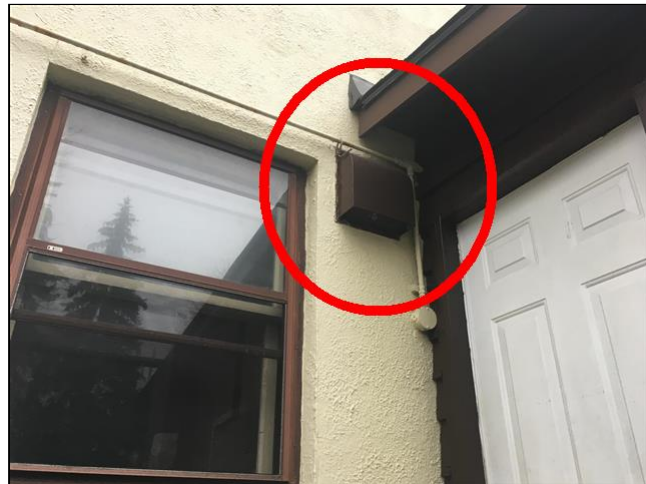
8.18 Item 1(Picture)

8.18 The range hood appears to be vented to the exterior, suggest providing an over the range unit.

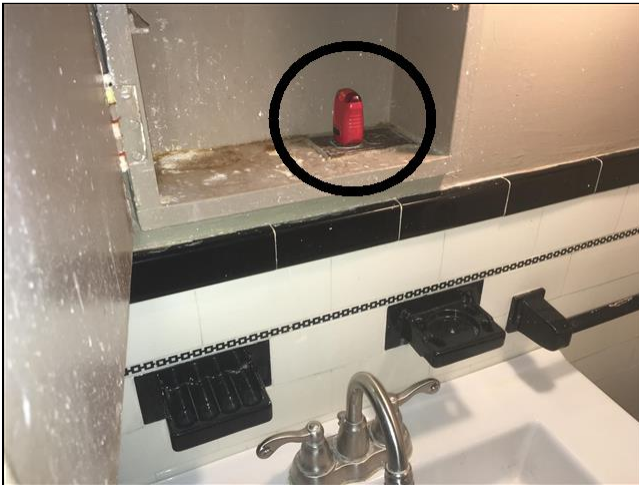
9.6 Item 1(Picture)

9.6 A Ground Fault Circuit Interrupter (GFCI) is not present at bathroom locations, suggest installing GFCI protected outlets for safety. A qualified electrical contractor is needed for further review and to make necessary repairs/corrections.

Electrical switches were noted in close proximity to the shower/tub area in the basement bathroom. Typically all electrical wiring, switches, etc are located @ 3' from these areas. We suggest further review from a licensed electrician to ensure safety.

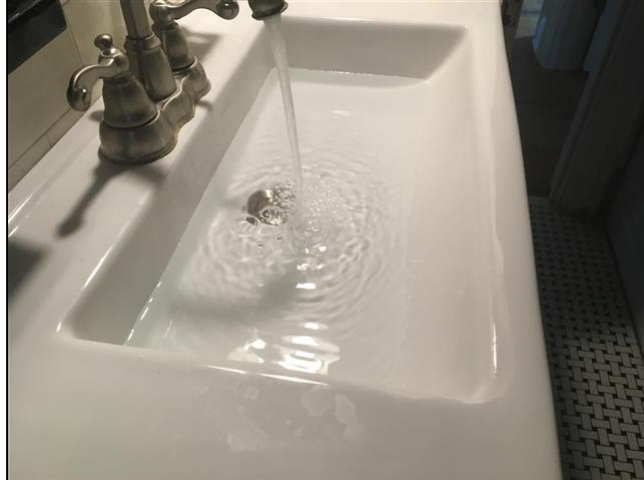
9.14 Item 1(Picture)

9.14 No overflow drain was noted associated with the sink. We recommend installing a sink with an overflow drain to reduce the potential for water damage in the bathroom.

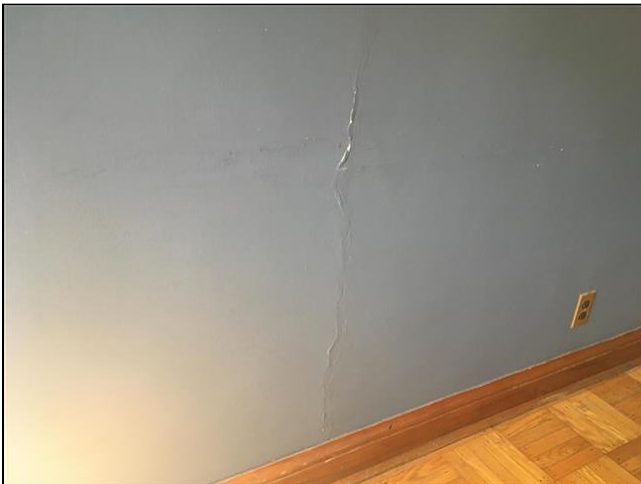
12.1 Item 1(Picture)

12.1 Stress cracking observed in drywall/plaster at different locations, typical for age of dwelling. This condition is possibly related to localized minor settlement. No further signs of settlement were observed in general area.

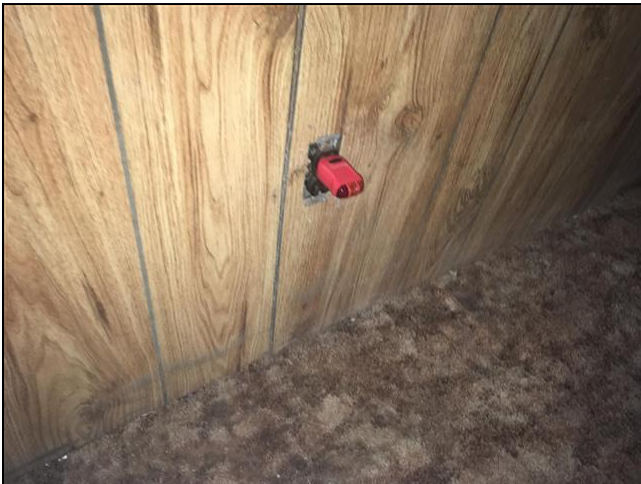
13.9 Item 2(Picture)

13.9 (2) Receptacle(s) is inoperable inoperable in the basement family room. Recommend review by licensed/qualified professional for repair or replacement as necessary.

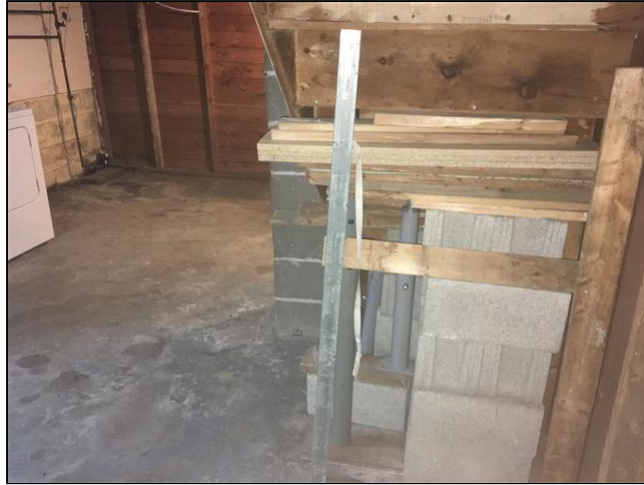
15.10 Item 1(Picture)

15.10 Additional support piers have been added at various locations in basement/crawlspace. Piers appear to have been added to assist in leveling floor. Client is advised to consult sellers or a building contractor for additional information.

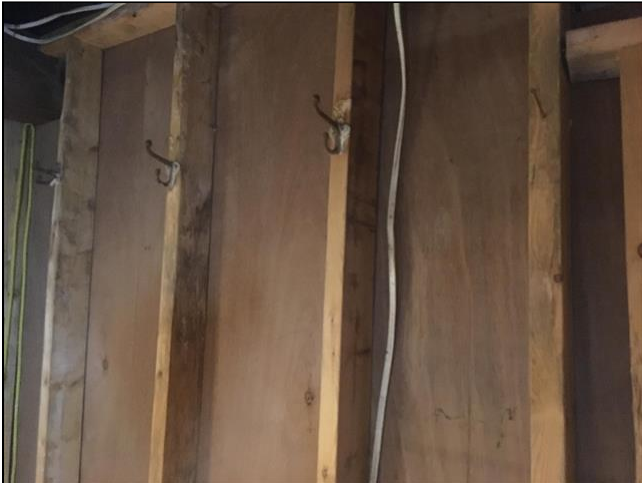
15.13 Item 1(Picture)

15.13 (1) Wiring observed at the basement is not secured to framing properly and is subject to physical damage, corrections needed.

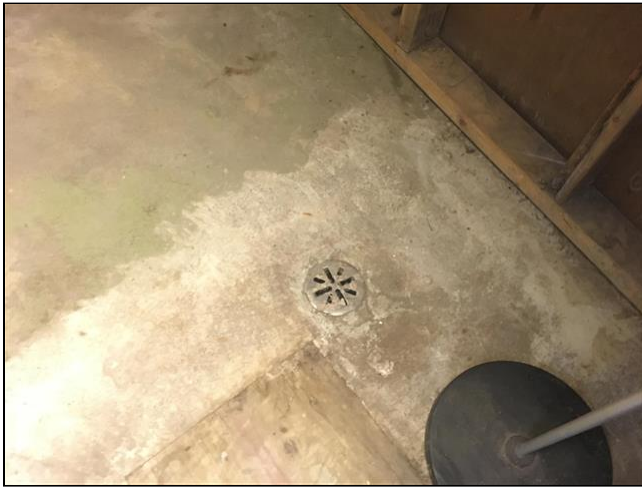
15.20 Item 1(Picture)

15.20 Floor drain was observed at the basement utility room.

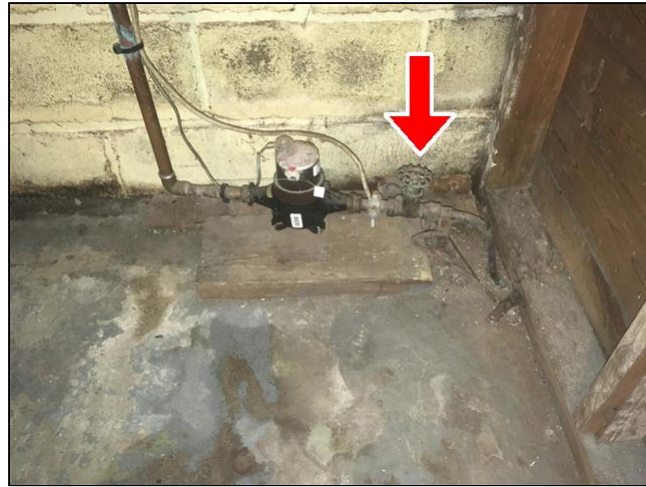
16.0 Item 1(Picture)

16.0 Gate-type valve observed. Since main shut-off valves are operated infrequently, it is not unusual for them to become frozen over time. They often leak or break when operated after a period of inactivity. For this reason main shut-off valves are not tested during a home inspection. We suggest caution when operating shut-offs that have not been turned for a long period of time. We recommend that the client consider upgrading the shut-off valve to a high quality ball-type valve which tend to be more reliable than gate valves.

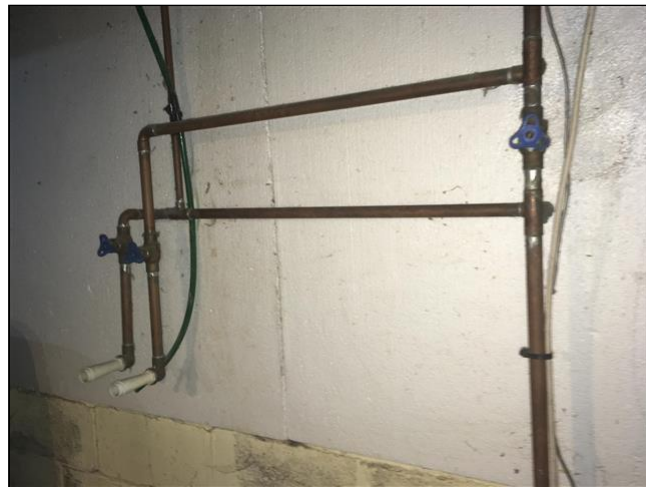
16.1 Item 1(Picture)

16.1 Poorly supported supply piping observed at the basement. Recommend installing additional pipe hangers as necessary, review by a licensed plumber for repair or replacement, as necessary.

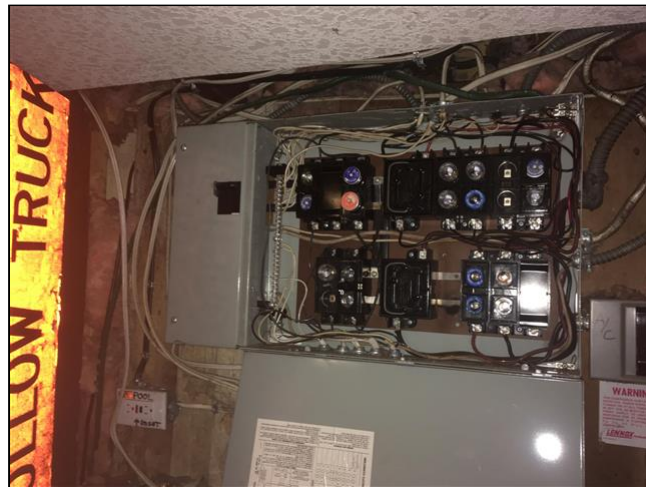
17.5 Item 1(Picture)

17.5 (2) Overfusing observed in main electrical panel. Wire size does not appear to be compatible with the over-current protection device (breaker/fuse) at these positions. This condition could allow excessive current to be carried by the conductors (wires). Recommend review by a licensed electrician for repair or replacement as necessary.

17.5 (3) Open fuse positions observed; suggest installing fuses or blanks for safety.
