# "Canada's leading Home Inspection Company"

Doc #: Sample Report Inspector: Terry Fulljames

Date: July 25, 2014

Dwelling Address: Terrace B.C.

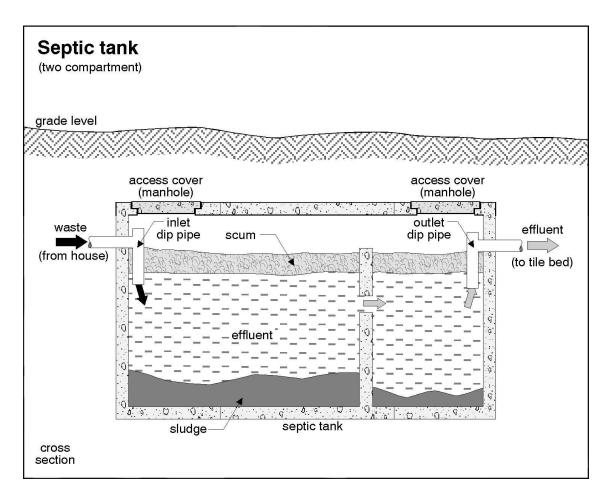
Consider consulting with septic Service Company regarding the interior of the septic tank condition. It is important to know if solids have filled the tank and migrated into the field which can be very costly as than the septic field may need costly repairs or replacement.

The above diagram indicates an ideal septic tank. Note the baffle and dip pipes.

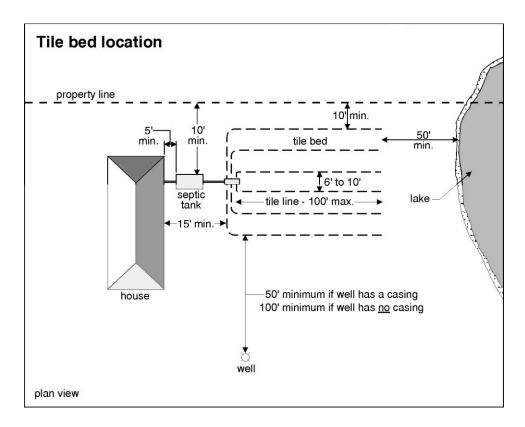
The above diagram is provided as a reference and refers to typical setbacks for septic items. These clearances were not verified, consider consulting the seller for more information regarding the location of the septic field and the septic tank. The actual distance between the well and the septic tank was not measured.
