SUMMARY REPORT

AmeriSpec Inspection Services of Hamilton, Brantford and Stratford
32 Livingstone Cres
Cambridge ON N3H 5S7
226-341-9569

URGENT REVIEW SUMMARY

Doc #: 071721SH8

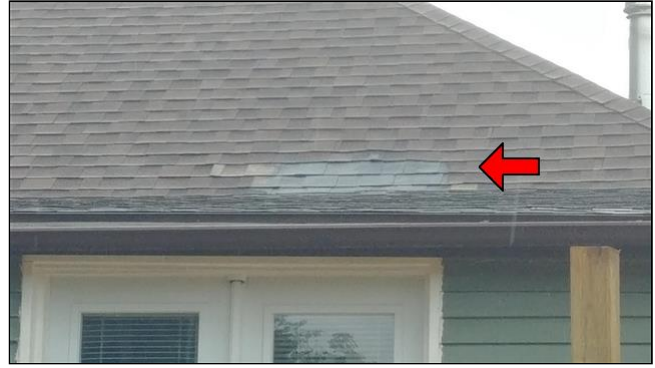
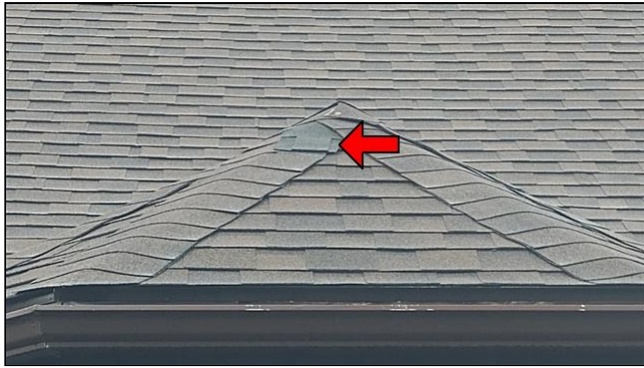
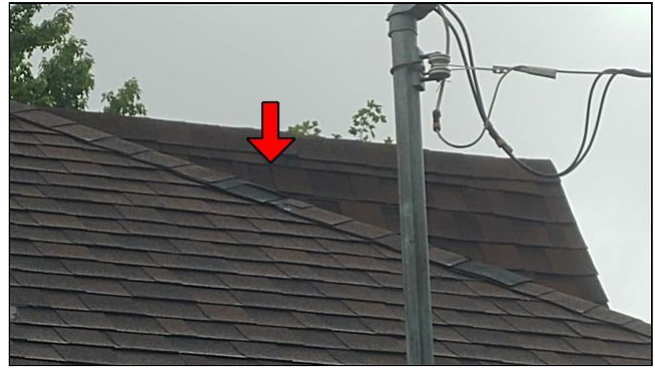
Damaged shingles observed at several locations. We recommend review by a licensed roofer for repair or replacement, as necessary.

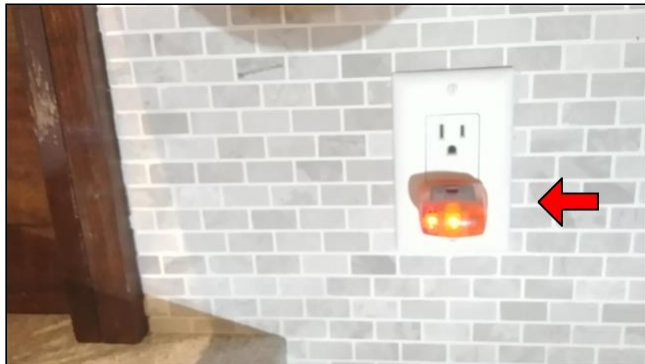
6.7 Item 2(Picture)

(2) Reversed polarity wiring conditions were observed. A reversed polarity condition occurs when the hot and neutral wires are connected to the opposite terminal connections of the outlet (i.e. hot wire connected to neutral terminal and neutral wire connected to hot terminal). This can be a safety hazard. This condition is usually easily corrected by minor wiring adjustments at the specific outlet(s)

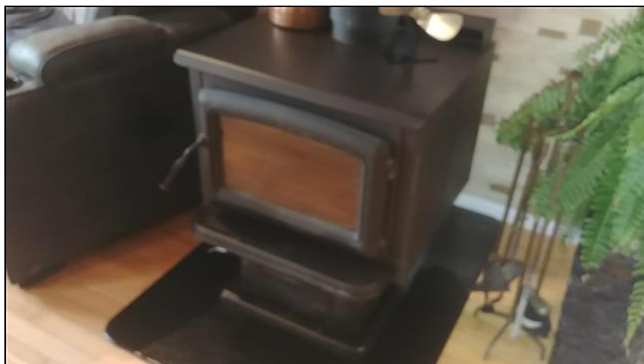
10.7 Item 1(Picture)

(1) A wood burning appliance is noted. A detailed assessment of the adequacy of the installation, clearances to combustible materials and shielding was not completed as part of the home inspection. We recommend consulting with a Wood Energy Transfer Technology (WETT) certified inspector or contractor for further assessment to ensure safe and proper installation prior to use. Given that more recently home insurance companies have very restrictive policies regarding the presence of wood stoves in homes, we recommend consulting with your insurance company to obtain policy information regarding wood burning appliances and verify proper installation in accordance with their requirements.

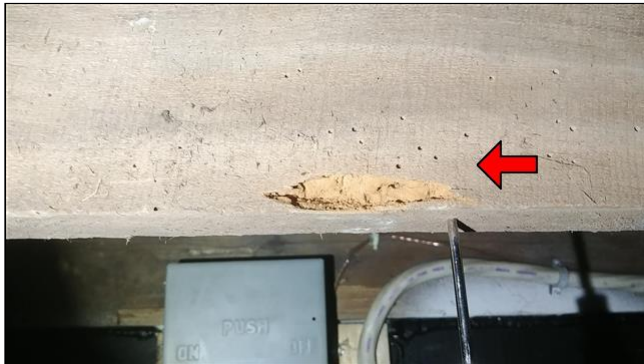
12.6 Item 1(Picture)

(1) Evidence of prior wood destroying insects observed at basement and crawlspace. We recommend review by a qualified exterminator for evaluation and further treatment, as necessary.

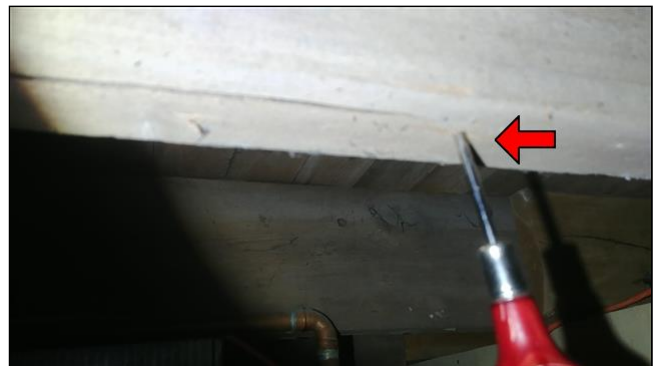
12.6 Item 4(Picture)

(2) Wood deterioration observed to floor framing members at several locations in the basement. Review is needed by a licensed contractor for repairs as needed.

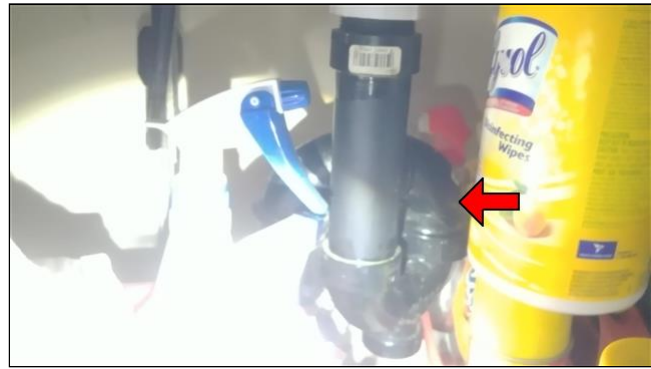
6.12 Item 2(Picture)

An S trap was noted at kitchen sink drain assembly. We recommend replacing with a P-trap to help prevent the venting of sewer gases inside the structure.

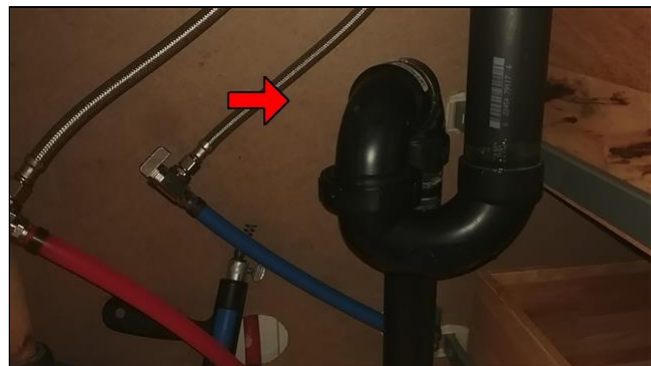
7.16 Item 2(Picture)

(1) An S trap was noted at main floor bathroom (with the laundry). We recommend replacing with a P-trap to help prevent the venting of sewer gases inside the structure.

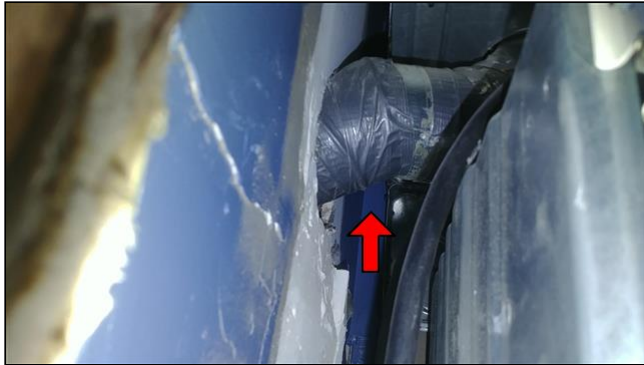
8.12 Item 1(Picture)

(2) Flexible tape used on the dryer discharge pipe. Flexible tape (duct tape) is not designed for high temperature applications and becomes brittle quickly. We recommend removal of the tape and replacement with an appropriate vent pipe sealant or tape.

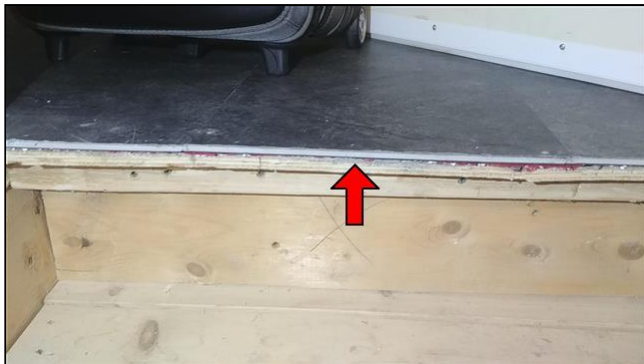
9.0 Item 1(Picture)

Missing transition observed at the head of the basement stairs. This arrangement presents a fall/trip hazard and is subject to physical damage. We recommend installing a proper transition to protect the flooring and improve safety.

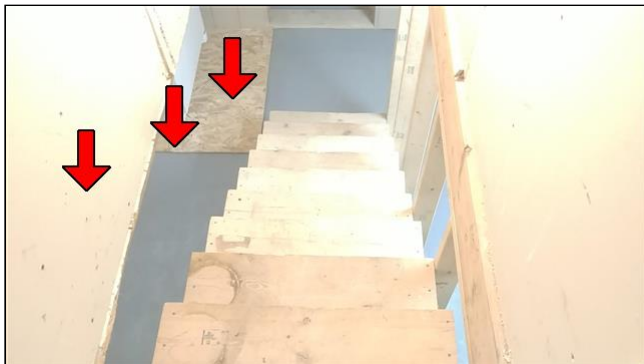
9.8 Item 1(Picture)

(1) No handrailings or guardrails noted at the basement stairs. We recommend installing handrails and guardrails for safety.

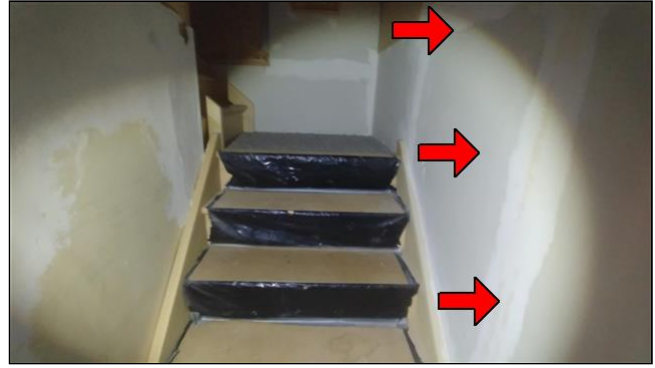
9.8 Item 3(Picture)

(2) No handrailings or guardrails noted at the stairs to upper level. We recommend installing handrails and guardrails for safety.

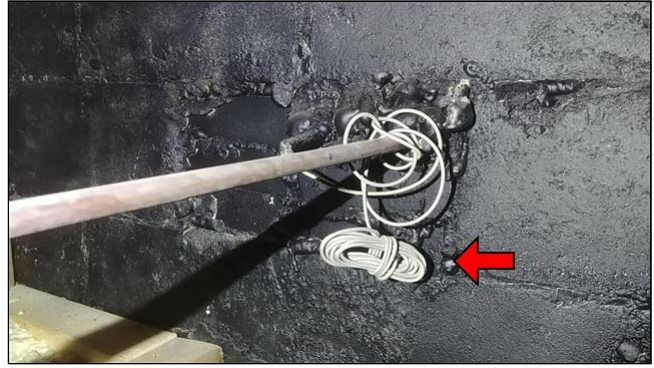
13.7 Item 2(Picture)

(1) Water meter reader installation is incomplete. Recommend follow-up with the township to complete the installation.

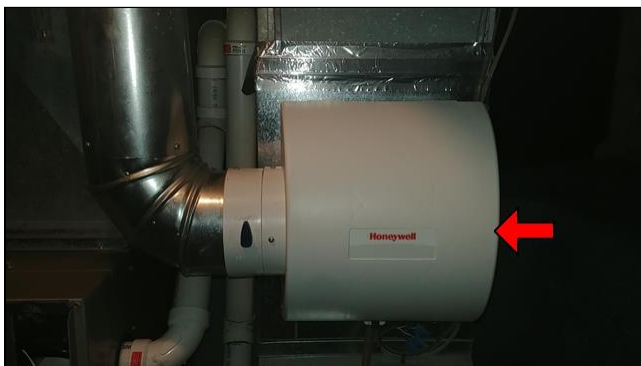
11.7 Item 1(Picture)

A humidifier is connected to the homes air handling system. In accordance with the CAHPI Standards of Practice, inspection of humidifier systems is not within the scope of a home inspection. We recommend consulting with the current owner or a qualified contractor to determine/obtain operations and maintenance information associated with the humidifier.

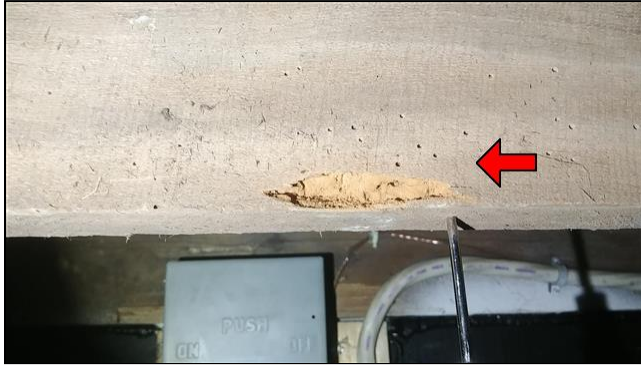
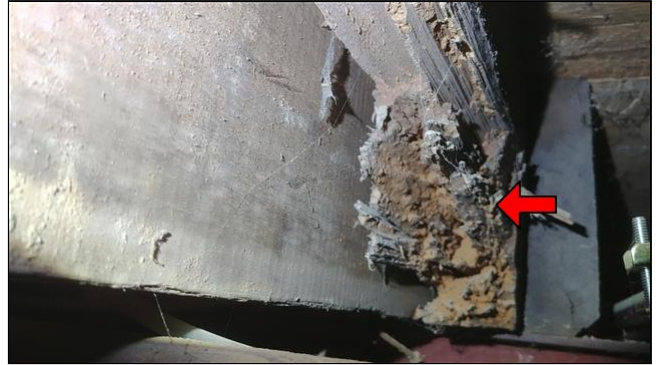
(1) Evidence of prior wood destroying insects observed at basement and crawlspace. We recommend review by a qualified exterminator for evaluation and further treatment, as necessary.

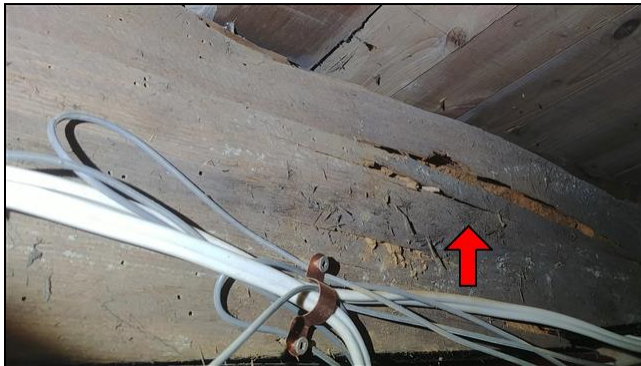
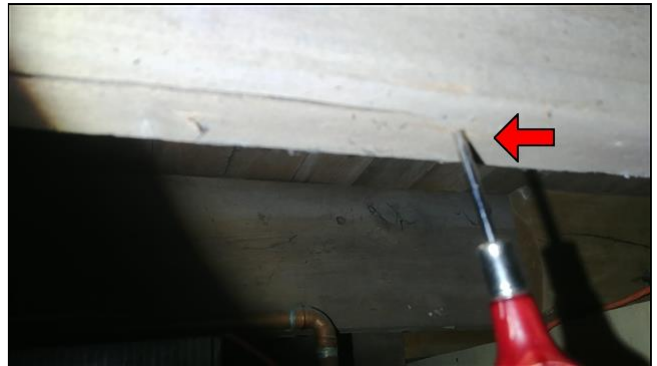
(2) Wood deterioration observed to floor framing members at several locations in the basement. Review is needed by a licensed contractor for repairs as needed.

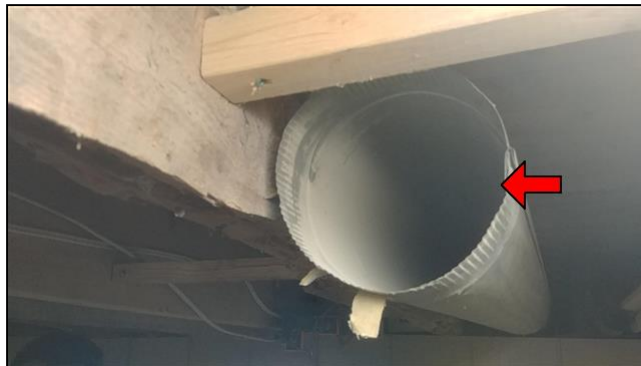
12.12 Item 1(Picture)

(1) Air register missing at the basement. Replacement is recommended.

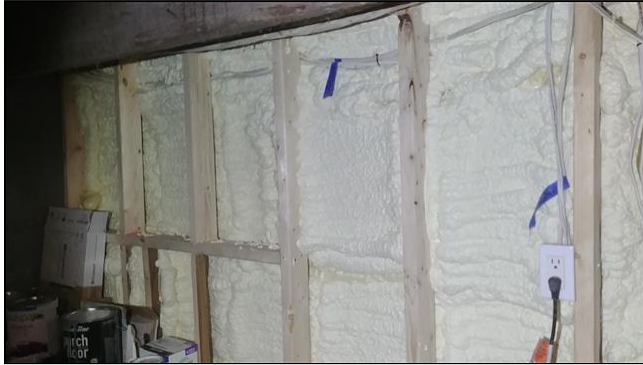
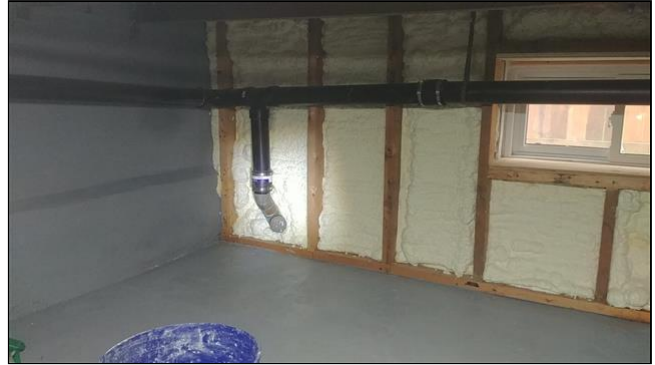
Exposed spray foam insulation noted. This type of insulation may be a fire hazard and should be covered with a fire resistant barrier for safety.

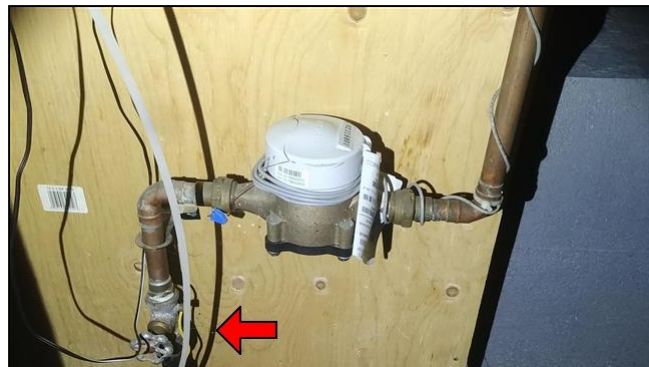
13.0 Item 1(Picture)

Gate-type valve observed. Since main shut-off valves are operated infrequently, it is not unusual for them to become frozen over time. They often leak or break when operated after a period of inactivity. For this reason main shut-off valves are not tested during a home inspection. We suggest caution when operating shut-offs that have not been turned for a long period of time. We recommend that the client consider upgrading the shut-off valve to a high quality ball-type valve which tend to be more reliable than gate valves.

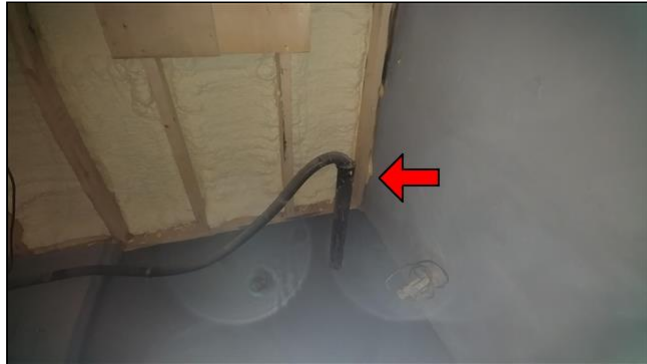
13.4 Item 1(Picture)

Flexible hosing and no backflow valve observed at the sump pump discharge. Also, the sump pump turns on at a relatively high water level. We recommend review by a licensed plumber to ensure proper installation and operation, as necessary.

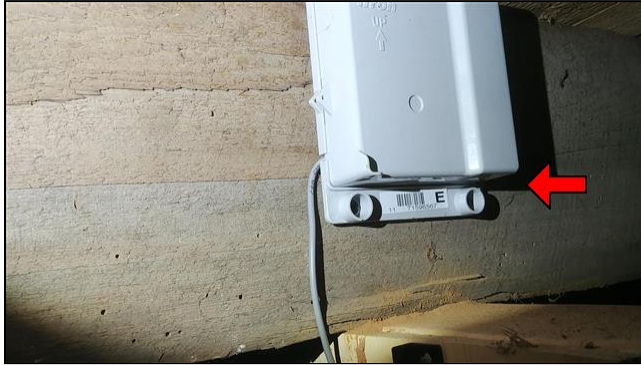
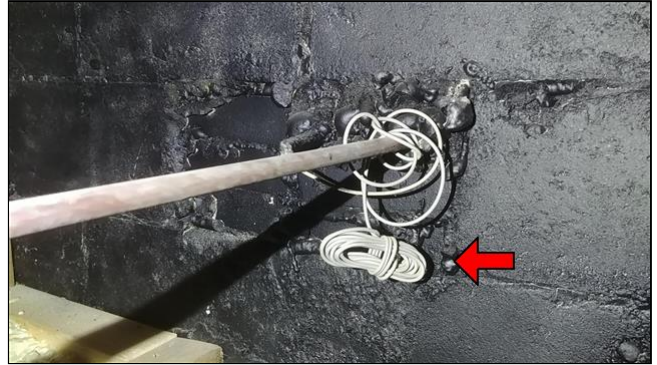
(1) Water meter reader installation is incomplete. Recommend follow-up with the township to complete the installation.

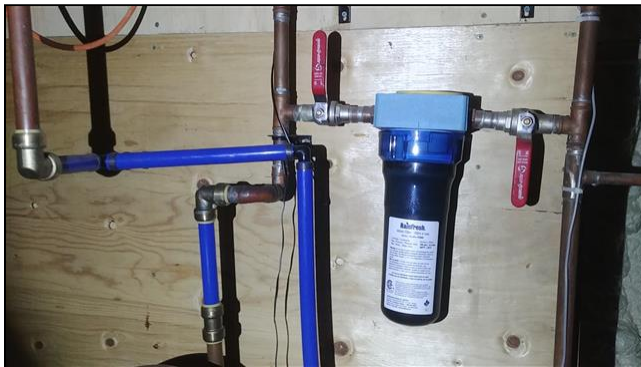
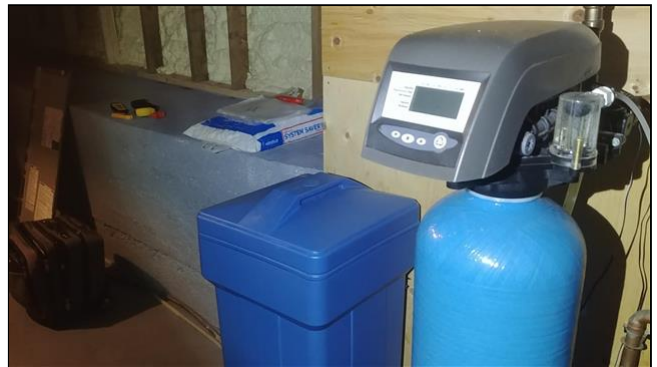
(2) Water treatment equipment consisting of a water softener, and water filter was present in the home at the time of the inspection. In accordance with the scope of work, the assessment of the homes water treatment system(s) was not completed as part of the home inspection. If concerned, we recommend consulting with the current owner and/ or a qualified water treatment contractor to determine operations and maintenance requirements for the water treatment system(s) and to verify proper operation.

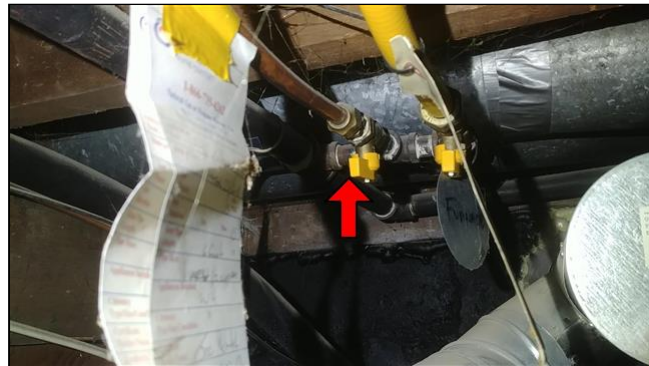
15.3 Item 1(Picture)

Natural gas. Gas shut-off valve was observed near this appliance.
